# **Pigeon Creek Channel Review**

**Warrick County, Heim Road to  
Vanderburgh County, Green River Road**

**Indiana Department of Natural Resources**

October, 2000

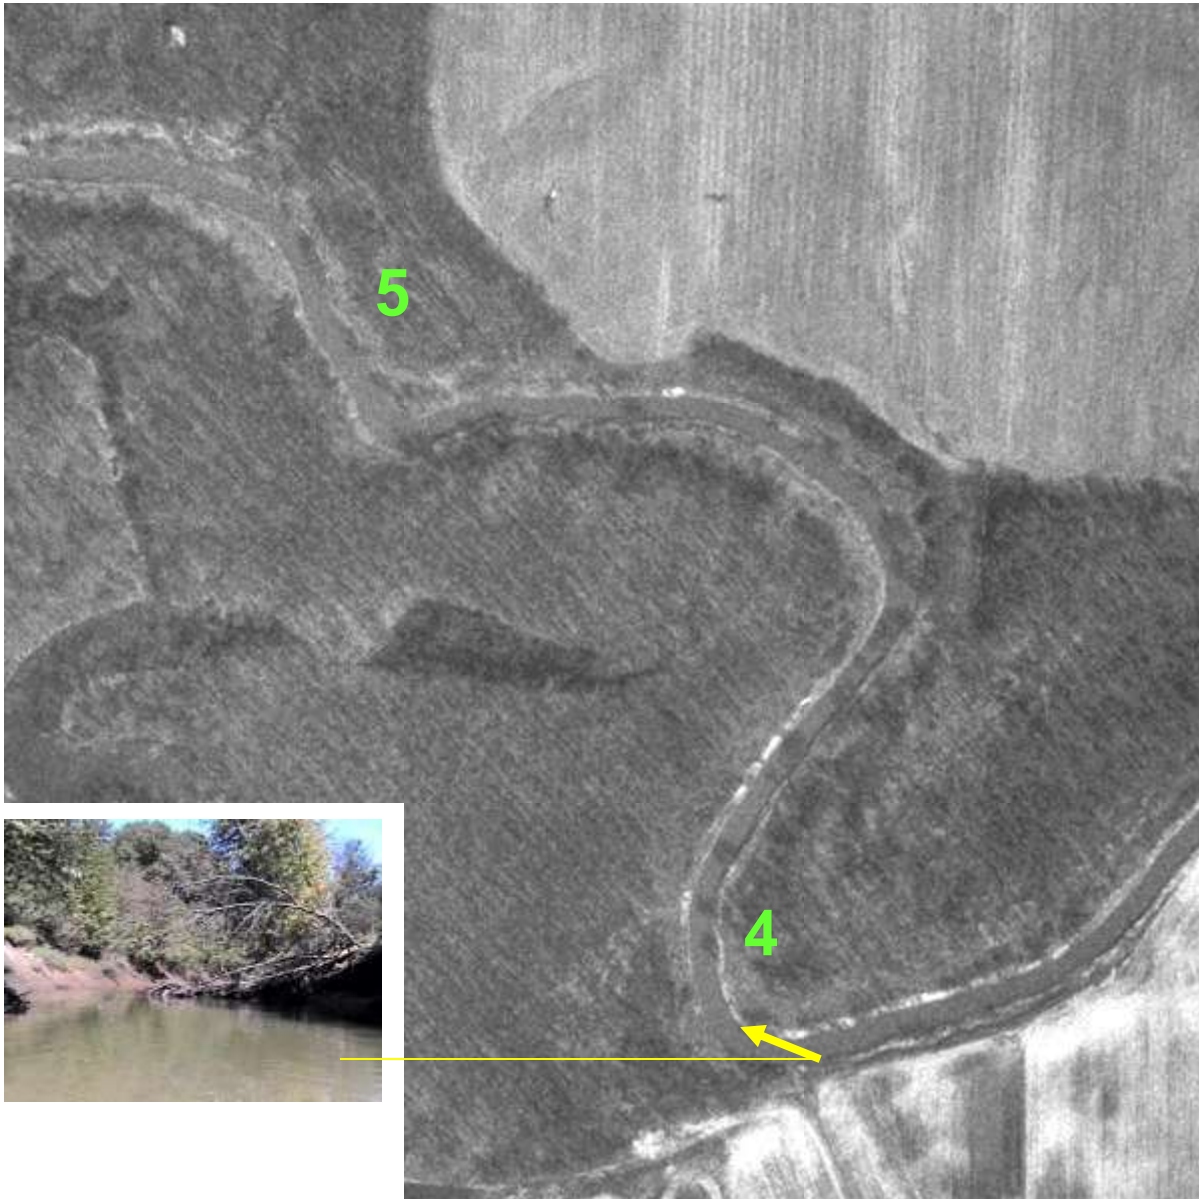
Figure 6

This site is located in the first significant bend in the stream. It consists of a minor amount of woody debris along the right bank of the stream. The debris is located along the point bar portion of the stream but does not appear to be causing left, cut bank erosion. No corrective action should be required for this site.

This site is located downstream of site 4 along the right bank of the stream. It consists of a significant amount of woody debris in channel for a distance of up to 100 feet. No evidence of bank erosion was observed. No corrective action should be required.

Site 4 consists of a minor amount of brush and small trees along the north bank.

Site 5 has minor amounts of brush and logs in the water.

Neither site appears to be causing any erosion, flow reduction, or access problems.

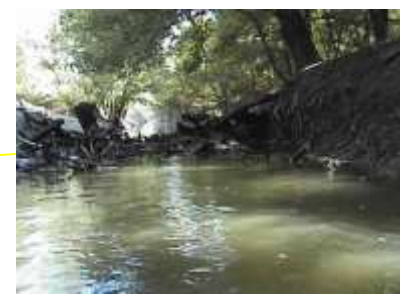
This site is located approximately ¼ mile downstream of the Heim Road bridge. A significant logjam was found at this location. The material consisted of smaller structural logs with a considerable amount of smaller debris. The site was less than 15 feet thick parallel to flow. Stream flow appeared to be passing through the material with little resistance. No significant bank erosion was observed. Some downstream debris was found associated with the site. Removal and reorientation of the debris is recommended for this site.

**1** Site 1 consists of a cross channel log jam containing several logs, brush and debris. No associated erosion was observed. Water was moving effectively through or under the pile and the pile was only 1 to 3 feet above water level in a channel 4 to 5 feet above water level. The water depth exceeded 4 feet. Heim Road bridge was observed from the log jam. Crossed by dragging the canoe over the log jam.

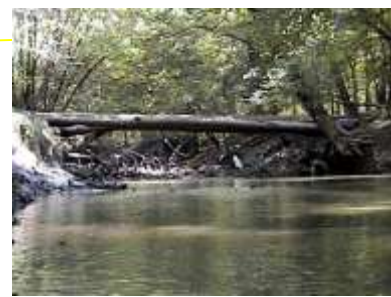
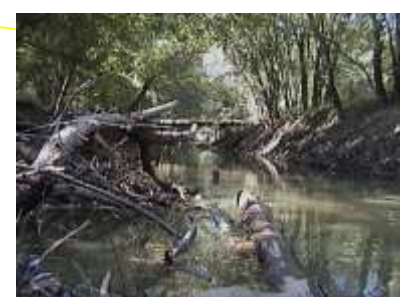
This site is located in the first bend of the ditched section of the stream, a 200 to 300 feet downstream and within sight of Site 1. It consists of debris much like Site 1 with larger structural logs and less small debris. Removal and reorientation of the debris is recommended for this site.

**2** Much the same as site 1. Site 2 has potentially more downstream debris and rippling. With mud deposition in channel.

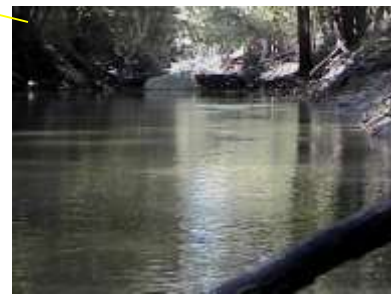
This site is located approximately 300 feet downstream of Site 2. It consists of a few structural logs and a considerable amount of smaller woody debris. Included in the debris is a refrigerator cabinet as can be seen on the photographs. Flow was passing through the logjam mostly along the left bank. Some logs and woody debris are located in channel for a distance of 50 to 100 feet downstream of the site along with a mud bar along the left bank. This debris does not appear to be hindering flow, however the channel meander associated with the area and mud bar could be a result of channel diversion and erosion associated with the logjam. The logjam was about 2 to 3 feet above water level. Removal and reorientation of the debris is recommended for this site.

**3** Much the same as site 1. Site 3 also contains a refrigerator cabinet in the debris mix.

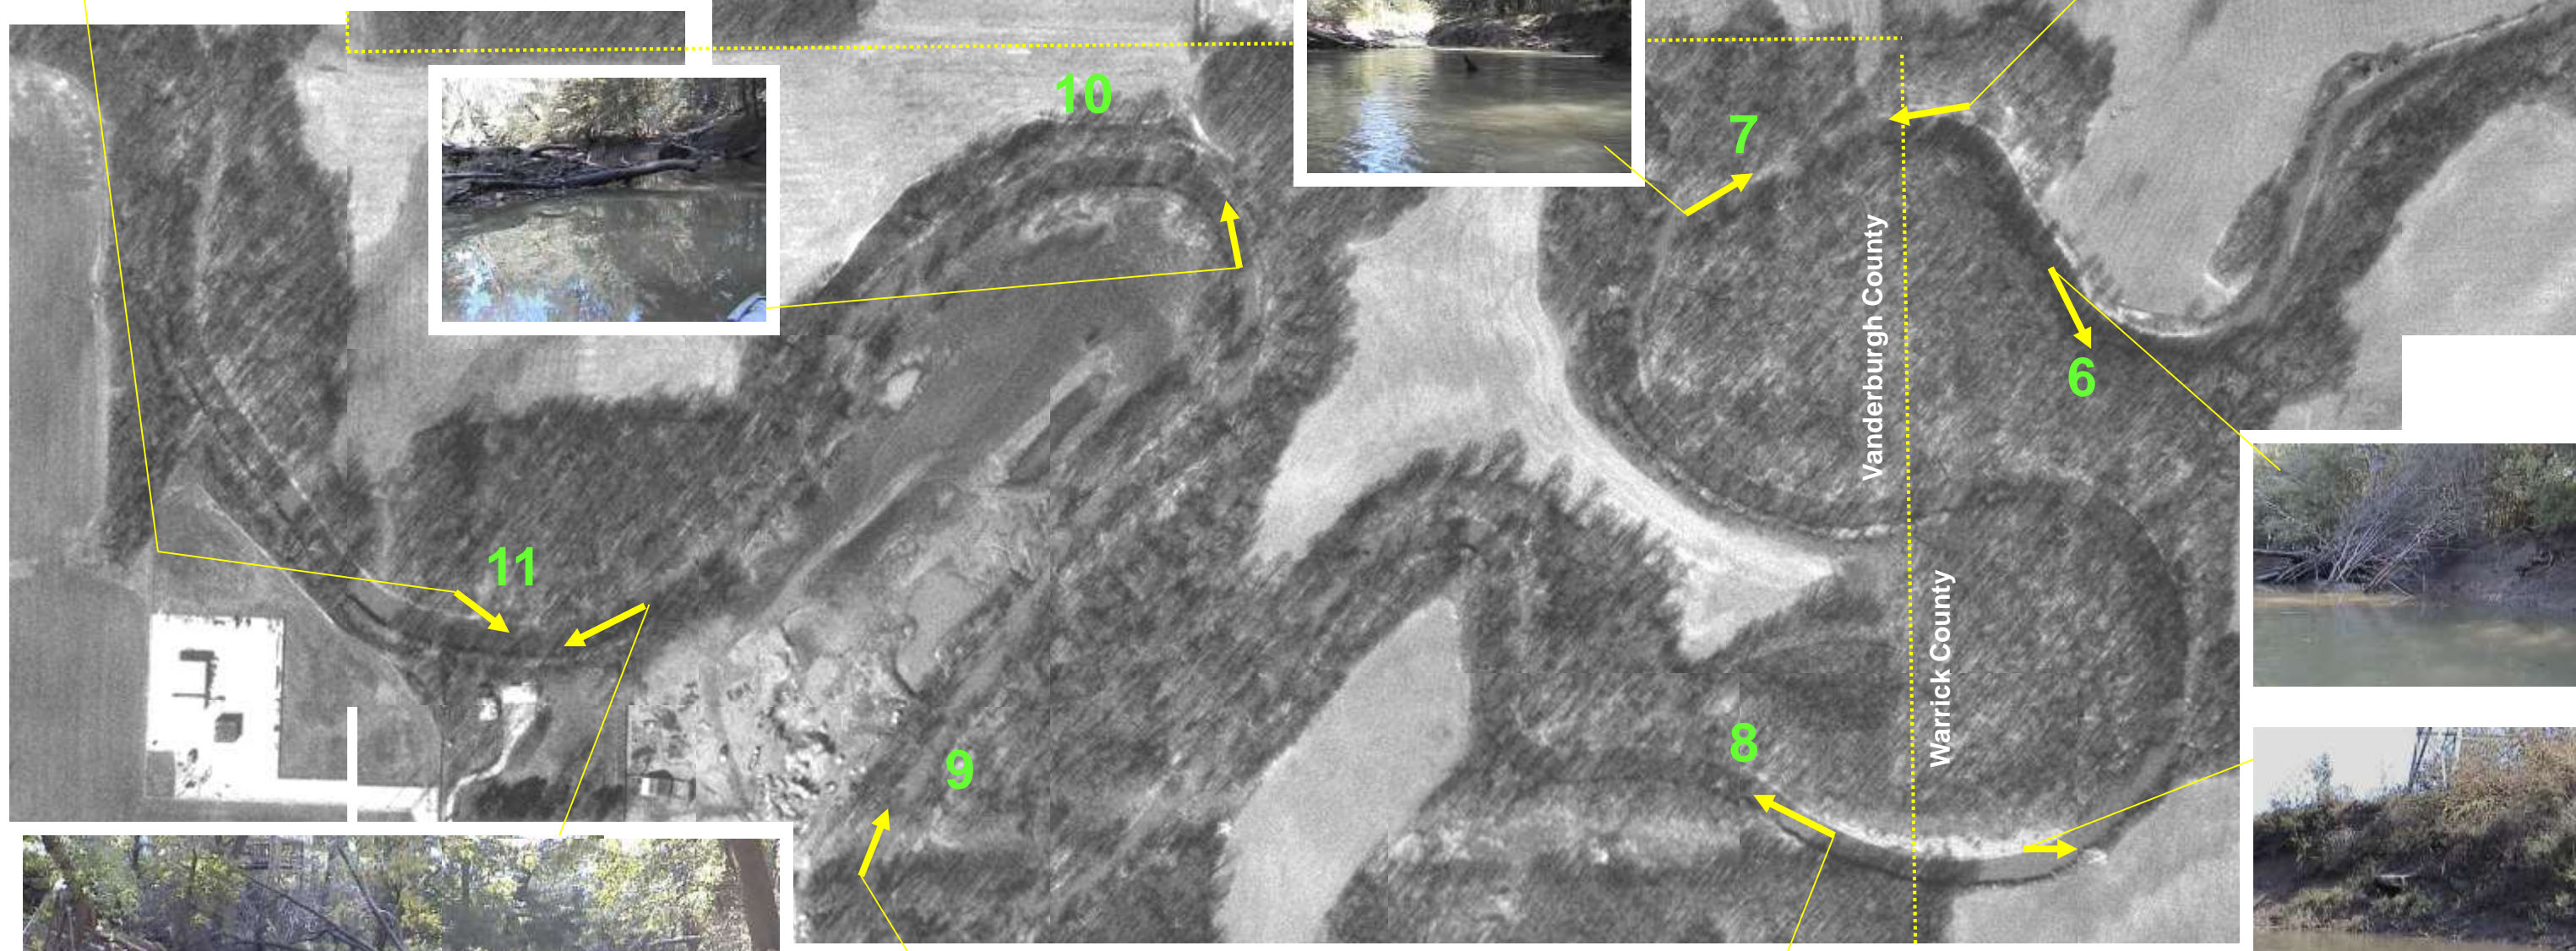
Figure 7

This site is located just upstream of the first county line crossing. It consists of a minor amount of woody debris captured by a cluster of trees that have slid into the channel on the left, cut bank side of the stream in a significant meander loop. The bank failure and debris appears to be increasing the rate of erosion of the cut bank in an area where the meander loop may be less than 300 feet from the downstream channel. Although presently minor in appearance and size, corrective action is recommended to stabilize this section of cut bank and decrease the chance for a meander loop cut off.

This site is located just downstream of the first county line crossing in Vanderburgh County. It consists of a considerable amount of logs and woody debris in the channel and may be more than 300 feet long. Most of the debris is located along the cut bank side and appears to be assisting in bank protection. However, two problematic areas exist along this site. The upstream end of this site contains a rather large tree extending from the right, cut bank side. Some left bank erosion is associated with this log. Reorientation of this log / tree should prevent any further erosion or problems. The second area is near the downstream end of the site and consists of a few larger logs extending across the stream from the right, cut bank side, directing flow into the left bank. Considerable left bank erosion is associated with the site resulting in a bank failure 20 to 30 feet long and greater than 10 feet into the wall of the bank. Reorientation of the debris along the right bank and minor left bank stabilization is recommended.

This site is located just north and downstream of a power line crossing. It consists of a few structural logs extending from the right bank onto the left bank. No cut bank erosion was observed at the site. Minimal flow restriction was observed. Reorientation and or partial removal of the logs from the right bank is recommended.

This site is located just downstream of the next power line crossing. It consists of a few structural logs and some associated woody debris. No bank erosion and minimal flow restriction was observed at the site. Reorientation of the logs and partial removal from the right bank is recommended.

This site is located along the right, cut bank side of a large meander. The site is potentially greater than 300 feet long consisting of a considerable amount of logs and woody debris mostly located along the right bank. No significant erosion was noted along the site and the debris may assist in stabilization of the right bank. Further observation of the area may be warranted at a lower stream stage. Possible reorientation or partial removal may be needed.

This site is located just north of a residential structure as seen on the figure. It consists of a large logjam containing many structural logs extending across the channel and extensive smaller woody debris. Flow restriction was observed with the structure. No visible bank erosion was noted. The logjam extends to approximately full bank height of 6 to 8 feet and is 10 to 40 feet thick. Removal of most of the debris is recommended from the right bank.

- Site 6 has a bank failure on the left, cut bank side.
- Site 7 has some bank erosion associated with logs in channel.
- Site 8 is a minor log jam that is blocking the channel but not flow.
- Site 9 is much like 8 with more brush associated with the log jam.

- Site 10 is an area 100 to 200 feet long with extensive logs and brush. Some bank erosion is associated with the site.
- Site 11 contains an extensive log jam. Flow is partially blocked with the channel fully blocked to boating.

- 1) IDNR conducts a project that removes the 8 to 10 cross-channel obstructions and repairs the 3 areas of bank erosion noted in this report;
- 2) IDNR conducts a project to address only the most impacted section of the stream Sites 6 through 11 on Figures 4 and 7, removing 4 cross-channel obstructions and correcting 2 areas of bank erosion.

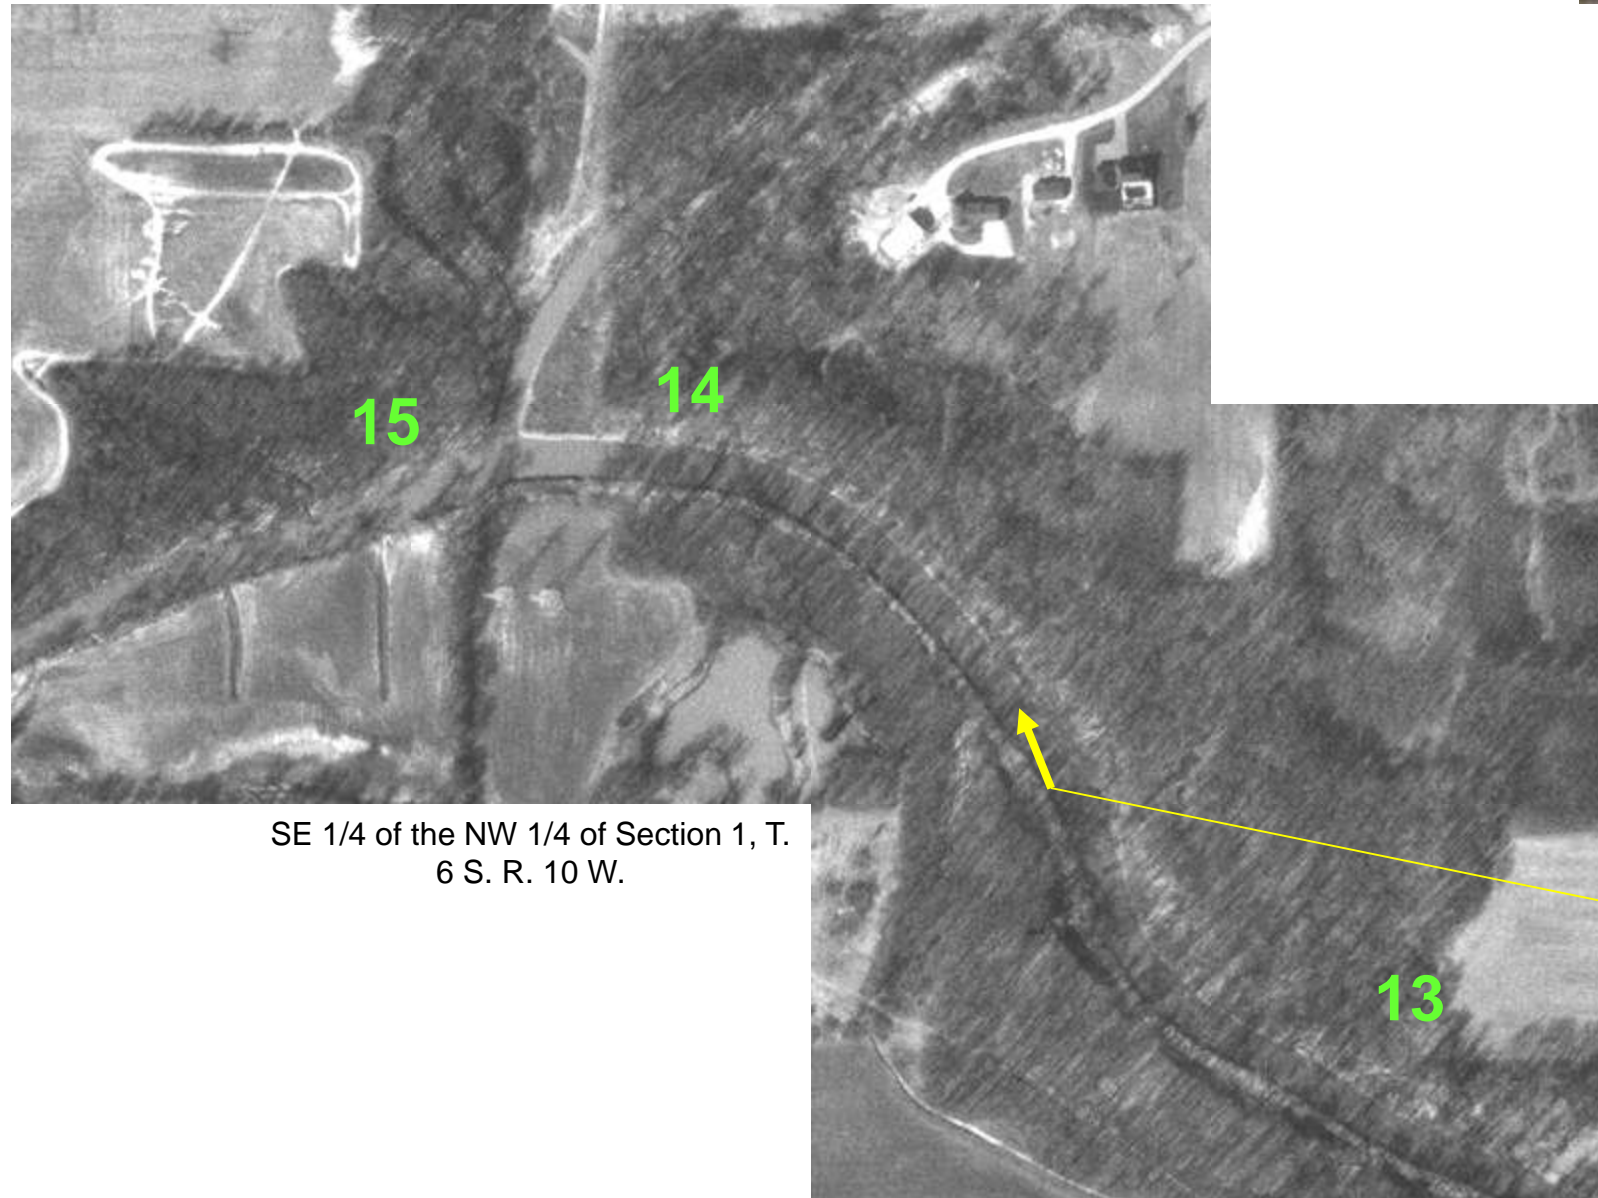
This site is located approximately ½ to ¾ mile upstream of the Green River Road bridge. It consists of an area approximately 150 feet long where rather extensive logs exist in various positions of the stream. Some significant bank erosion is associated with portions of the site. Partial removal, reorientation, and bank stabilization is recommended for the area.

This site is located just upstream of a power line crossing, approximately ¼ mile upstream from the Green River Road Bridge. It consists of a minor amount of woody debris associated with a fallen, small tree on the right bank. No corrective action is recommended.

This site is located just downstream of the power line crossing, approximately ¼ mile upstream of the Green River Bridge. It consists of an area 100 to 150 feet in length along the right bank where some logs and woody debris have collected. No bank erosion was noted at the site and no corrective action is recommended.

Site 13 contains extensive brush and logs in the stream with some significant bank erosion. The site is 100 to 150 feet long.

Site 14 is a minor tree in the stream.

Site 15 has some logs and brush along the right bank of the channel. No significant flow blockage.

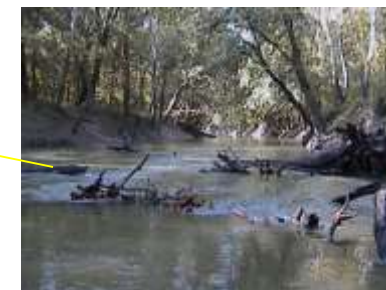
This site is located just downstream of the Interstate 164 bridge. It consists of extensive logs and woody debris mostly orientated along the right, cut bank side of the stream. No associated left bank erosion was noted at this site. The site is approximately 200 feet in length. Partial removal or reorientation may not be warranted due to the risk of destabilization of the mass. One large tree was observed just downstream of the site lying across the stream extending from the left bank. Removal of this tree lying near the top of bank height is recommended due to the ease of removal and potential for building a large logjam site.

Site 12 contains extensive brush and logs along the right, cut bank. One tree lies across channel just downstream of the site.
