Pigeon Creek Corridor Flood Risk Management Plan

Evansville, IN – Vanderburgh Co. Commissioners
Ian Hahus & Bob Barr

May 9, 2023

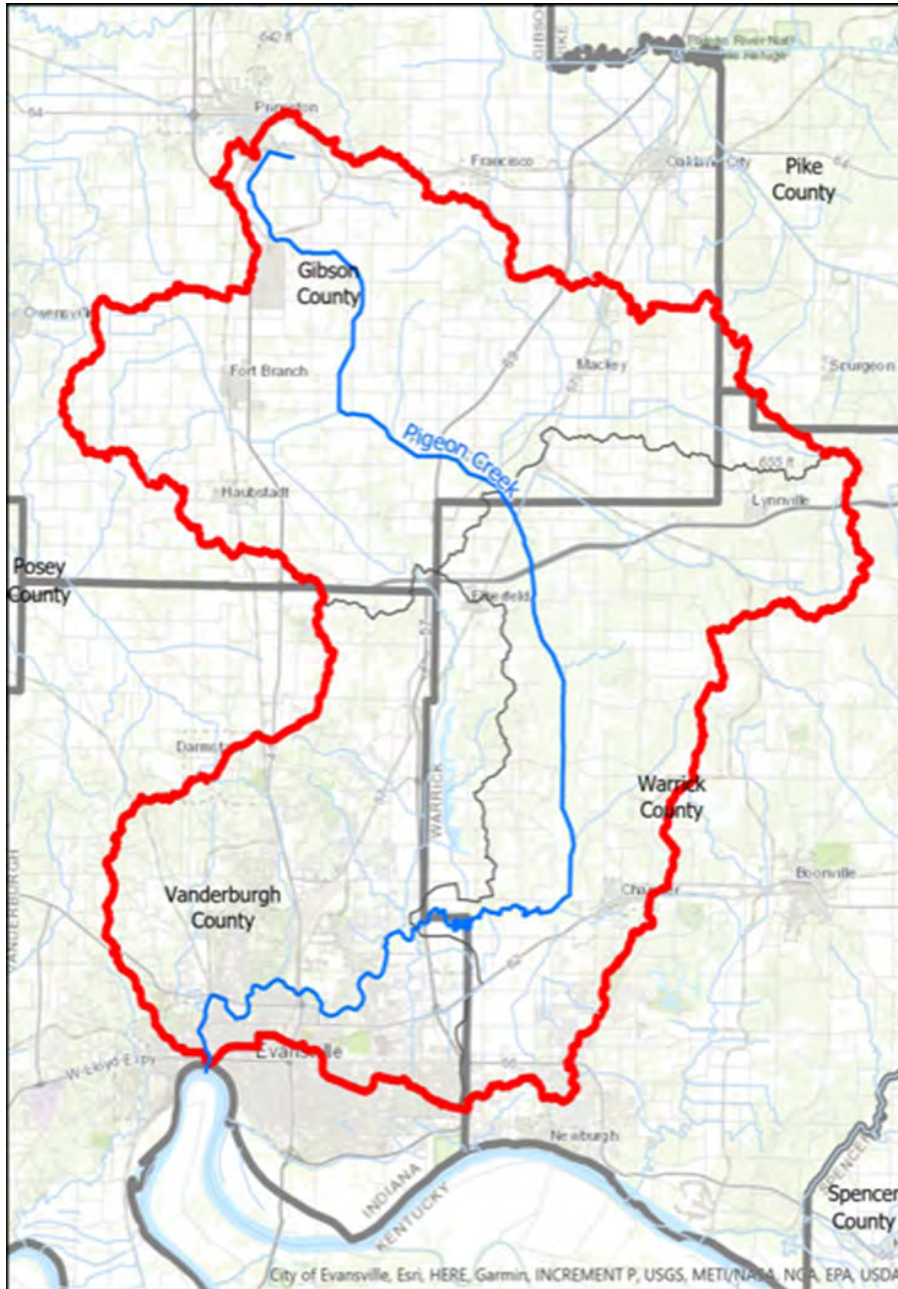
Study Area Summary

- 1. Study Reach: 16 mi in Vanderburgh County*
- 2. Drainage Area: 370 mi² (90 mi² in V'burgh)*

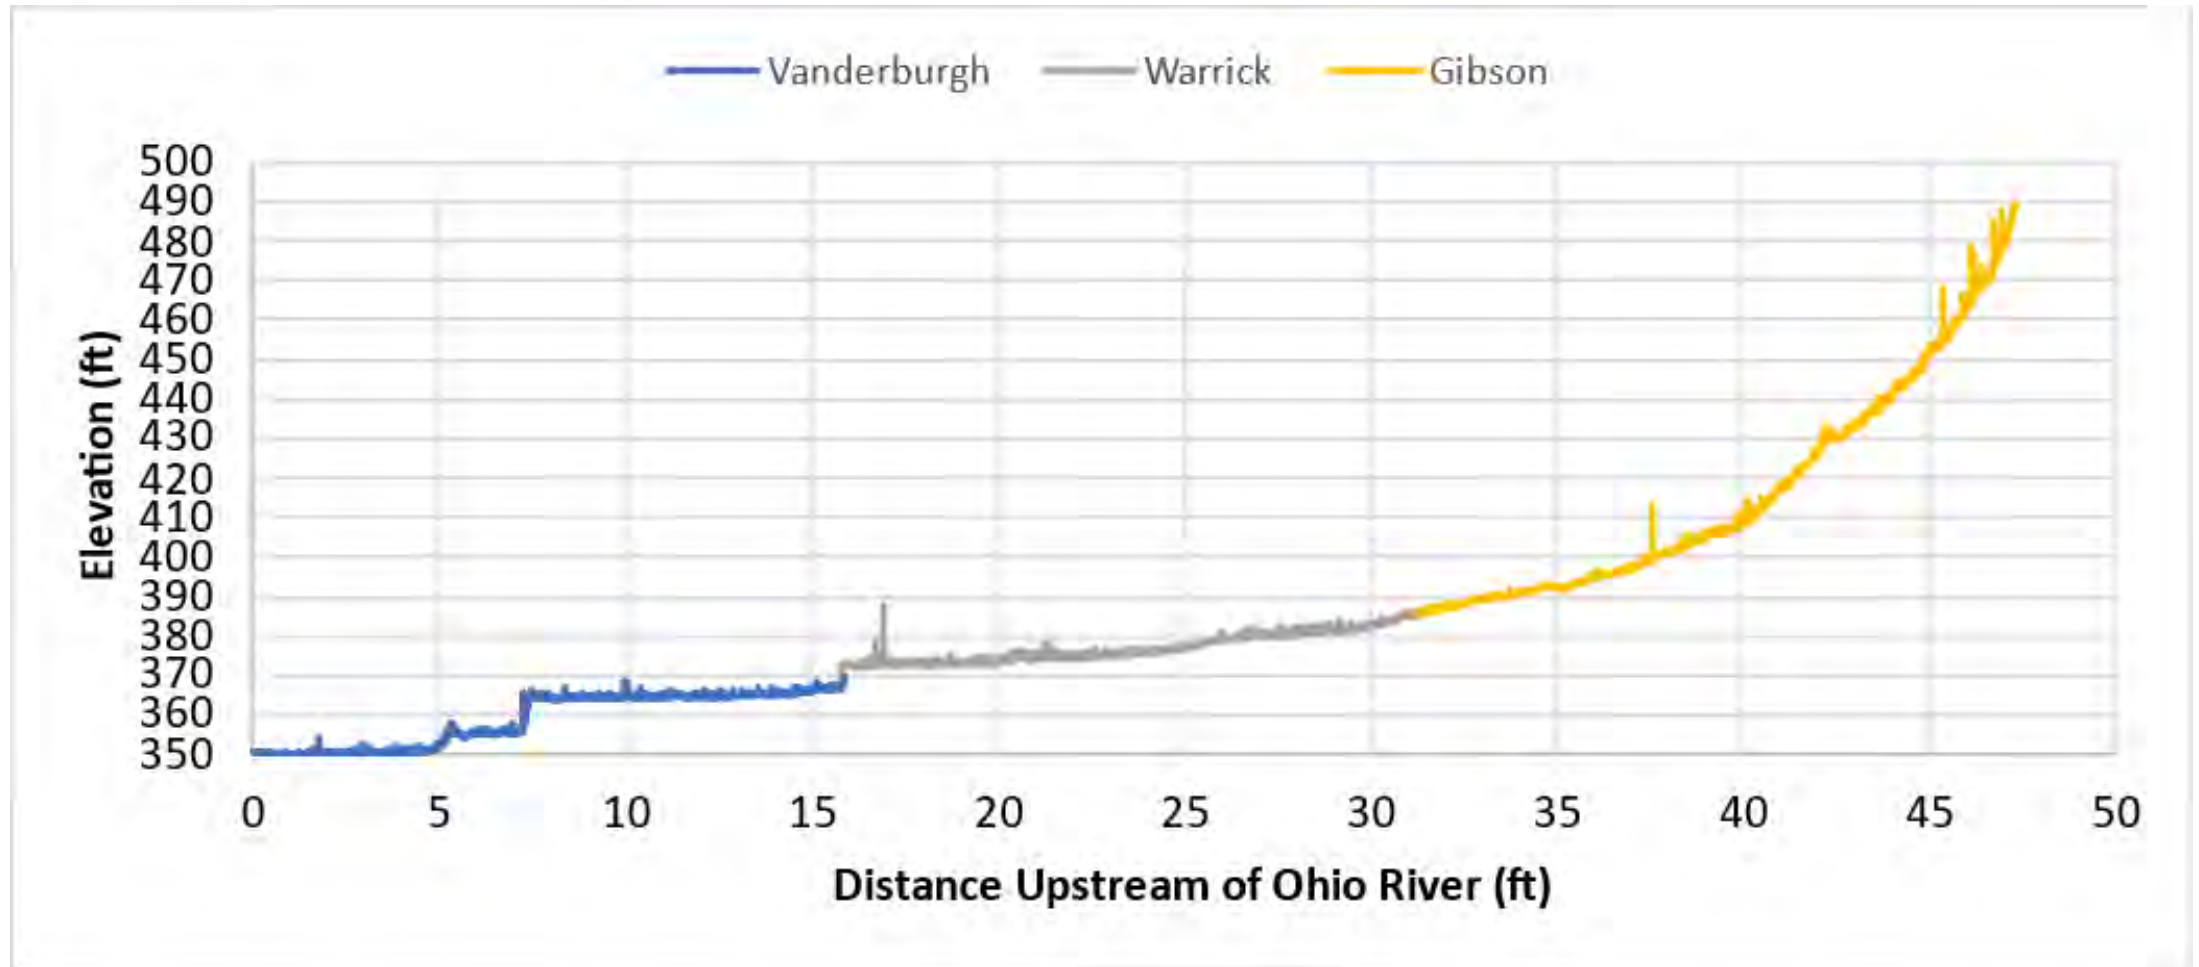
Longitudinal profile of Pigeon Creek watershed

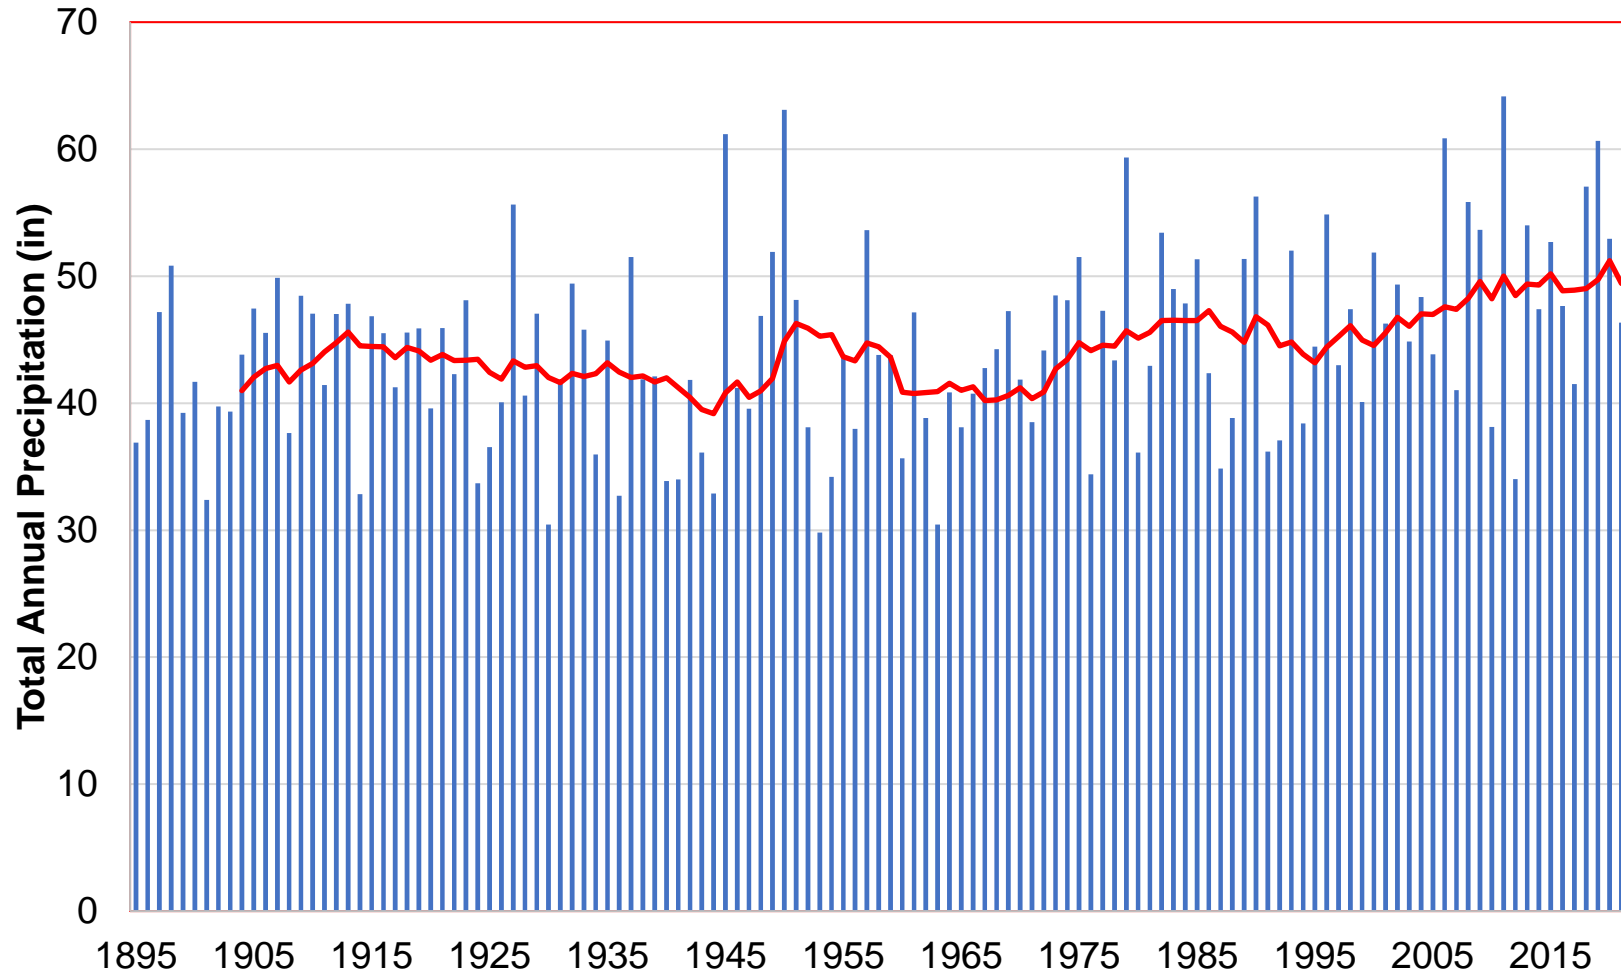
Annual Precipitation Depth, SW Indiana

Rainfall Trends

- 1. 1" increase every 16 years over full record*
- 2. 1" increase every 6 years since 1960*
- 3. Note recent lack of "dry" years*

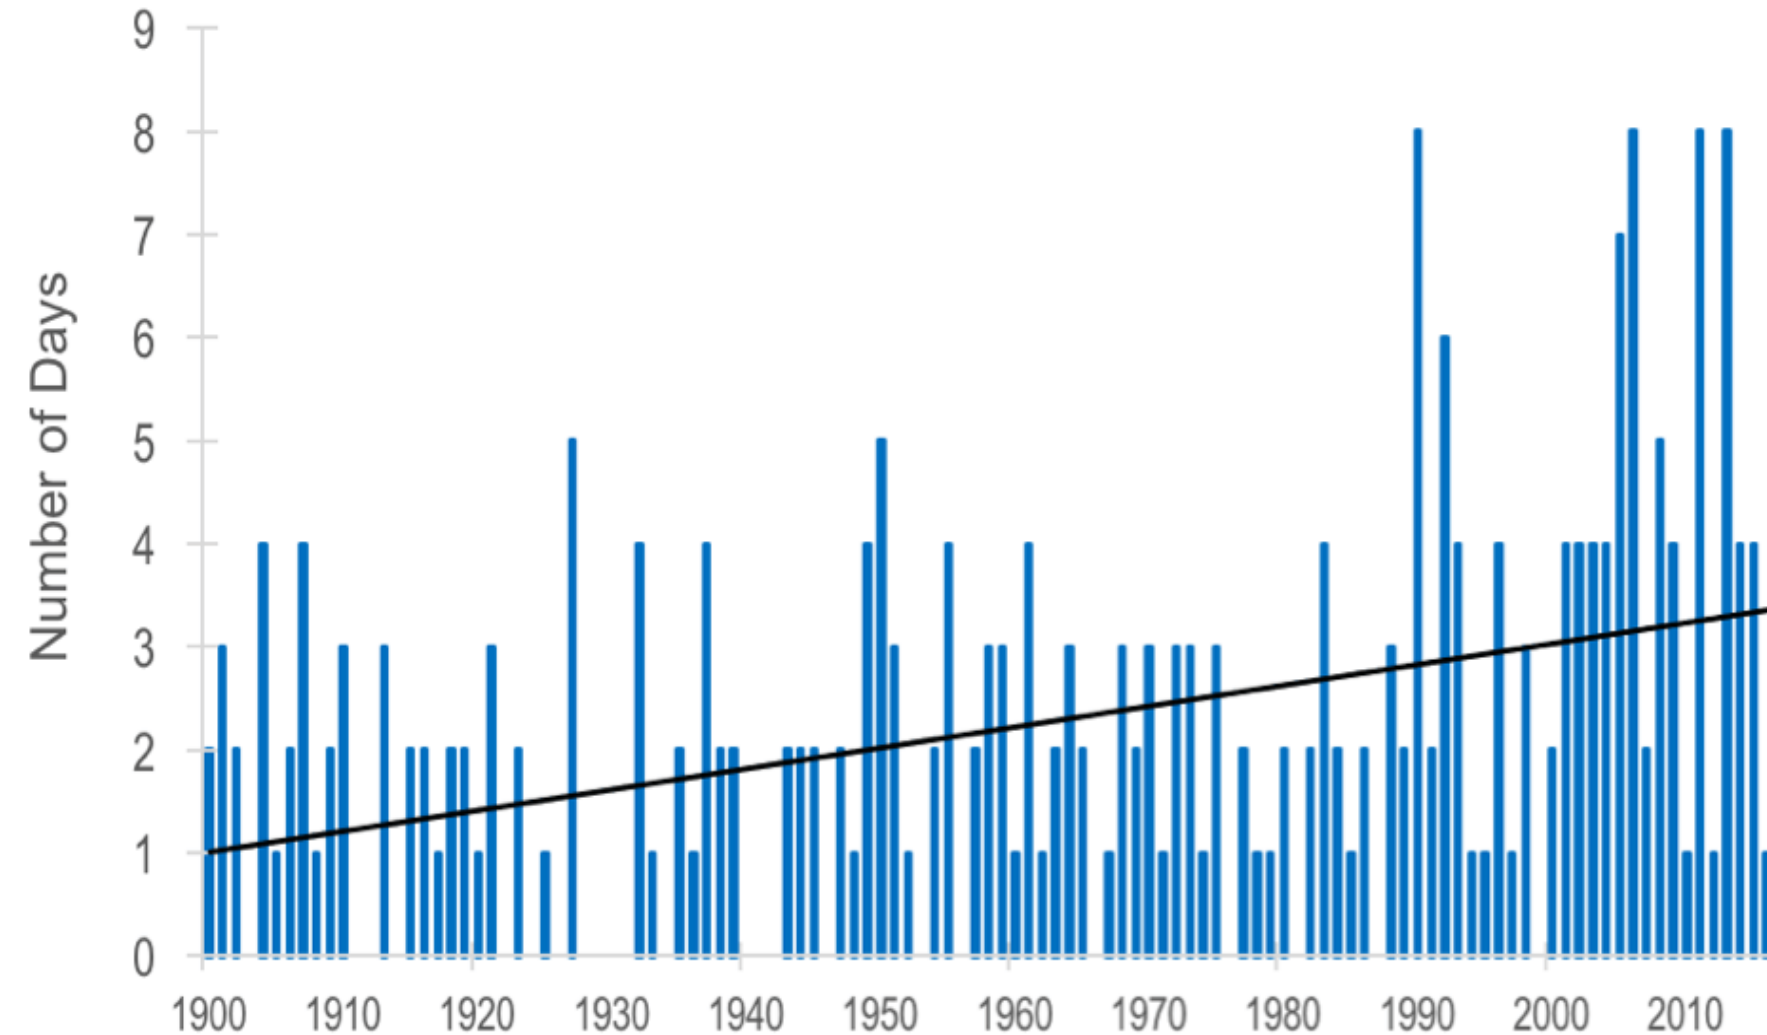
Days w/Extreme Precipitation, Indiana IN CCIA, 2018

Extreme Rainfall

1. Number of days exceeding 99th percentile increasing from 1 to 3/yr

-> Increased potential for dramatic changes to channel stability

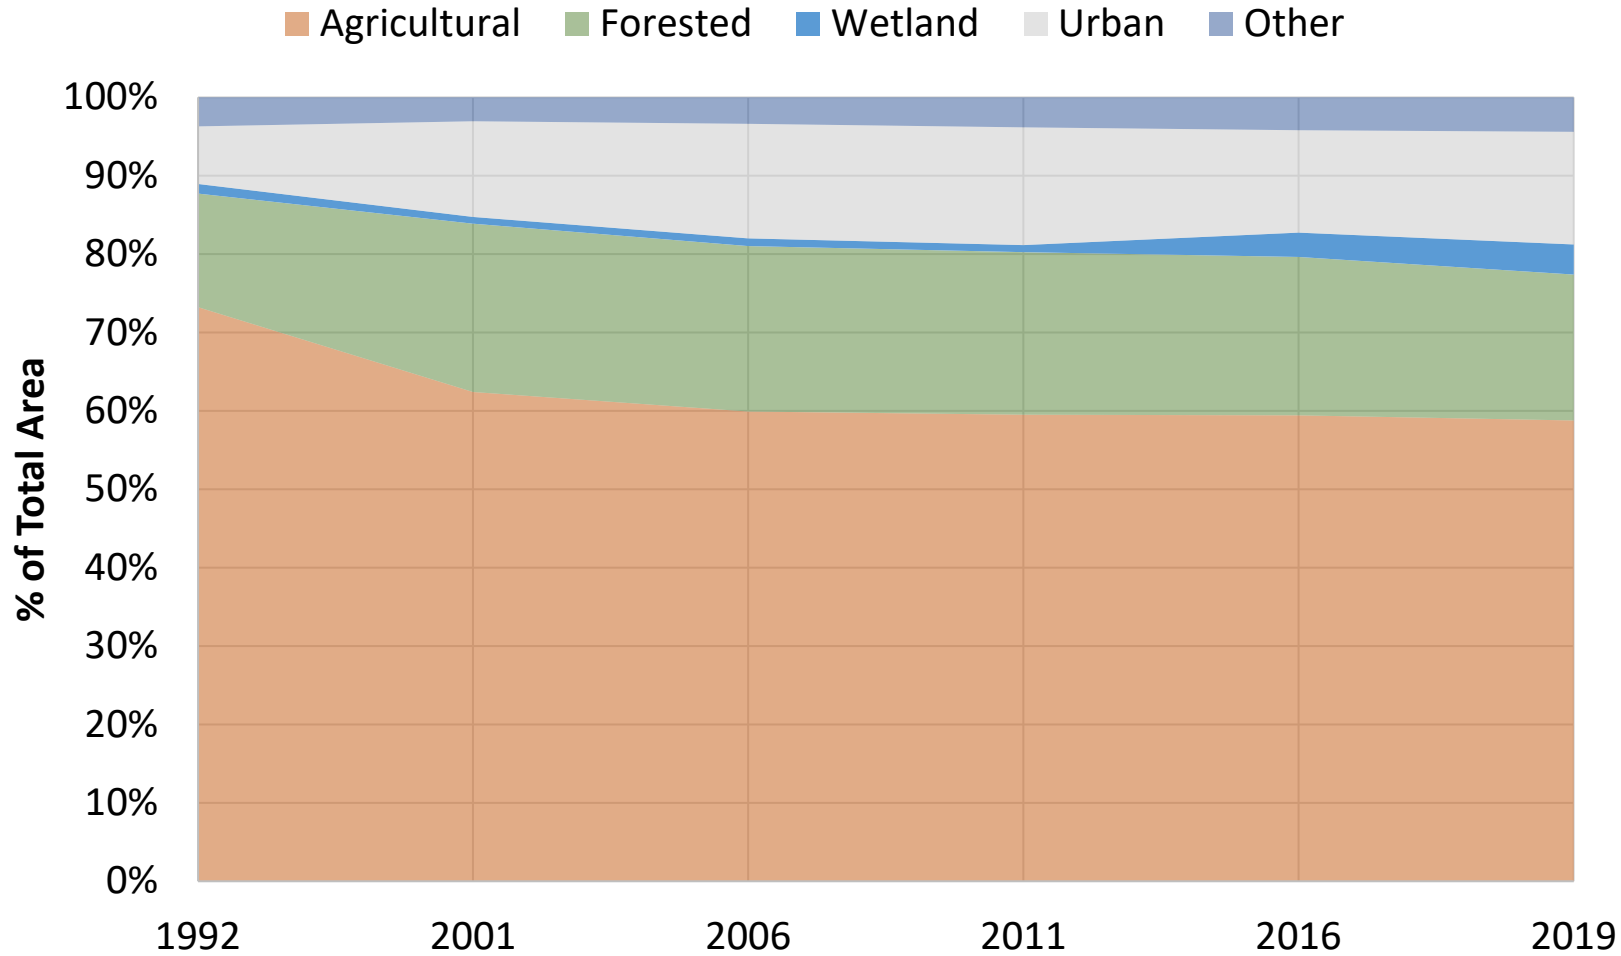
Landuse Change 1992-2019

Landuse Trends

- 1. Watershed is 60% Agricultural*
- 2. Remaining area is Urban, Forested*
- 3. Largely stable composition since 2006*

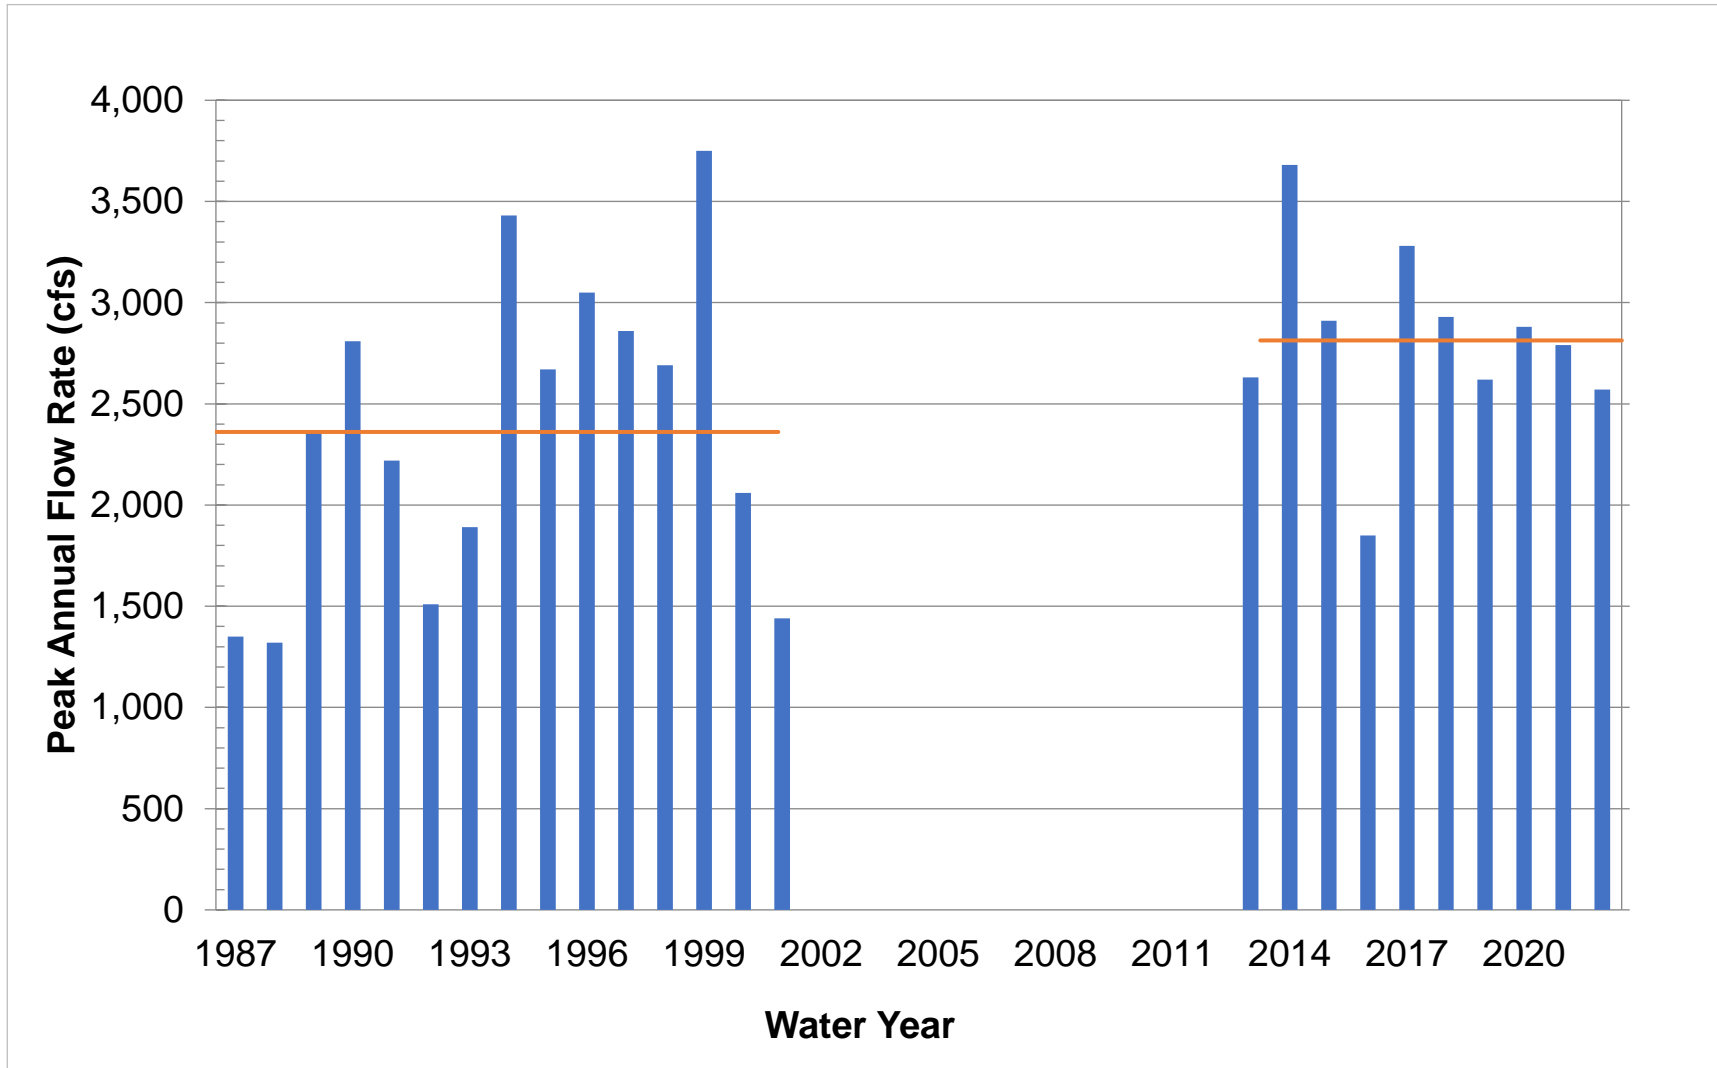
Stream Gage Analysis – Peak Flow

PC near Fort Branch, IN (USGS Gage 03322011)

Peak Flow Trends

- 1. Peak annual flowrate average increasing from 2,350 to 2,820 cfs*
 - 2. Approx. 20% increase over past 35 years*
- > Increase in flood elevations and impacts*

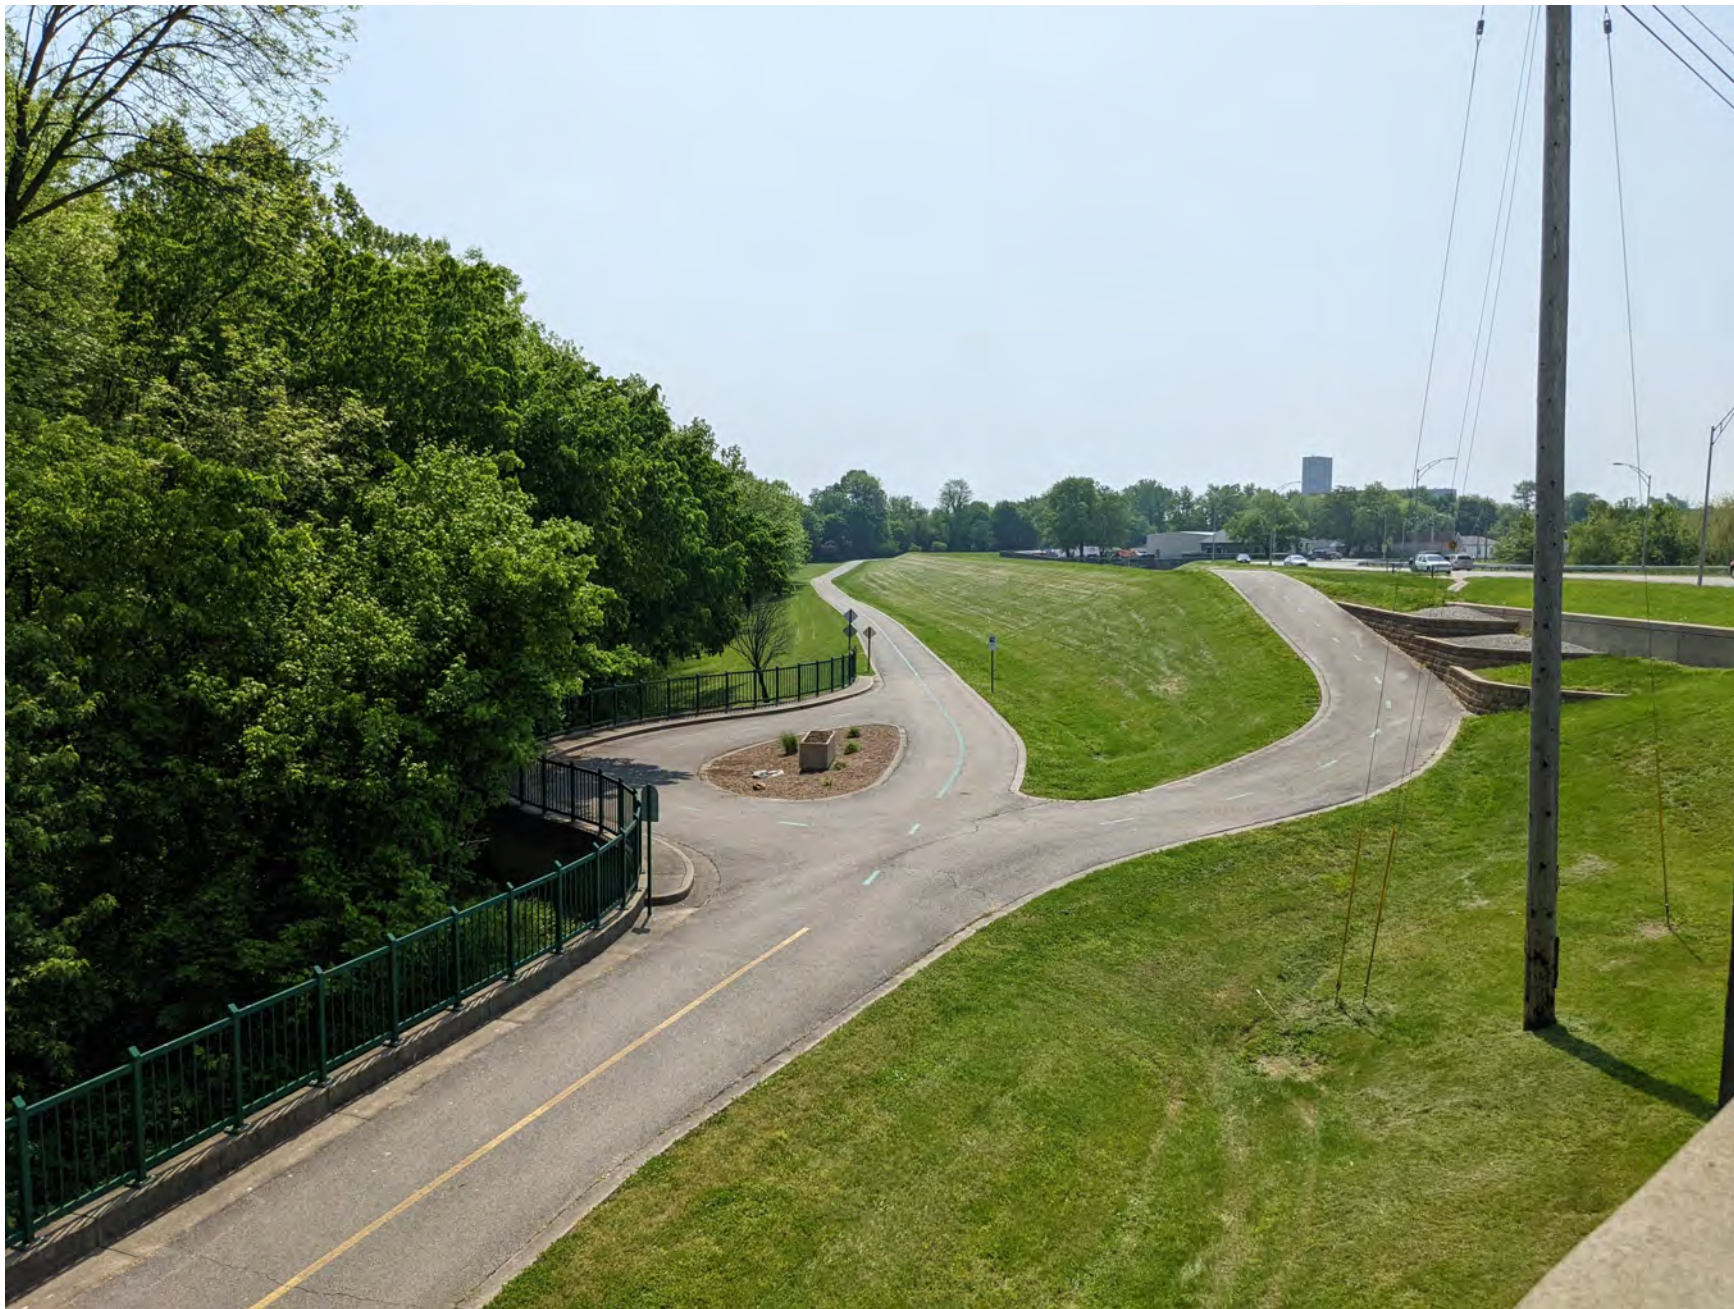
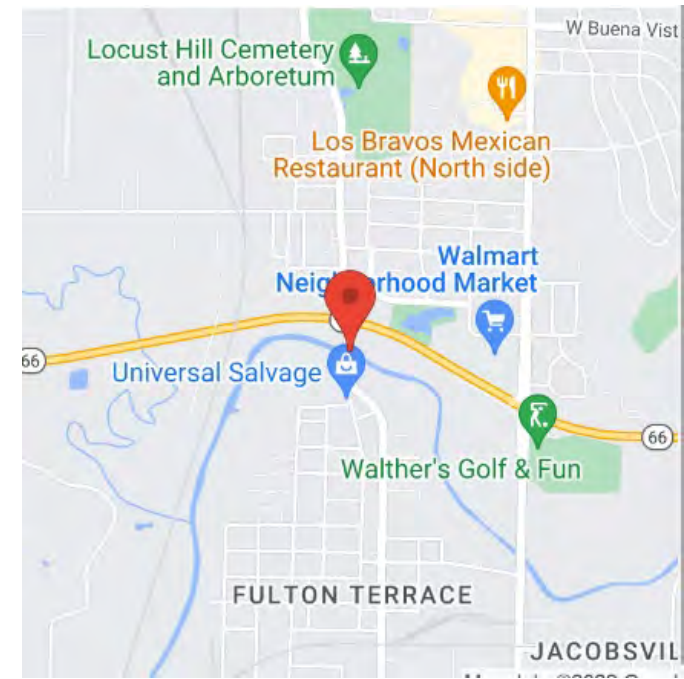
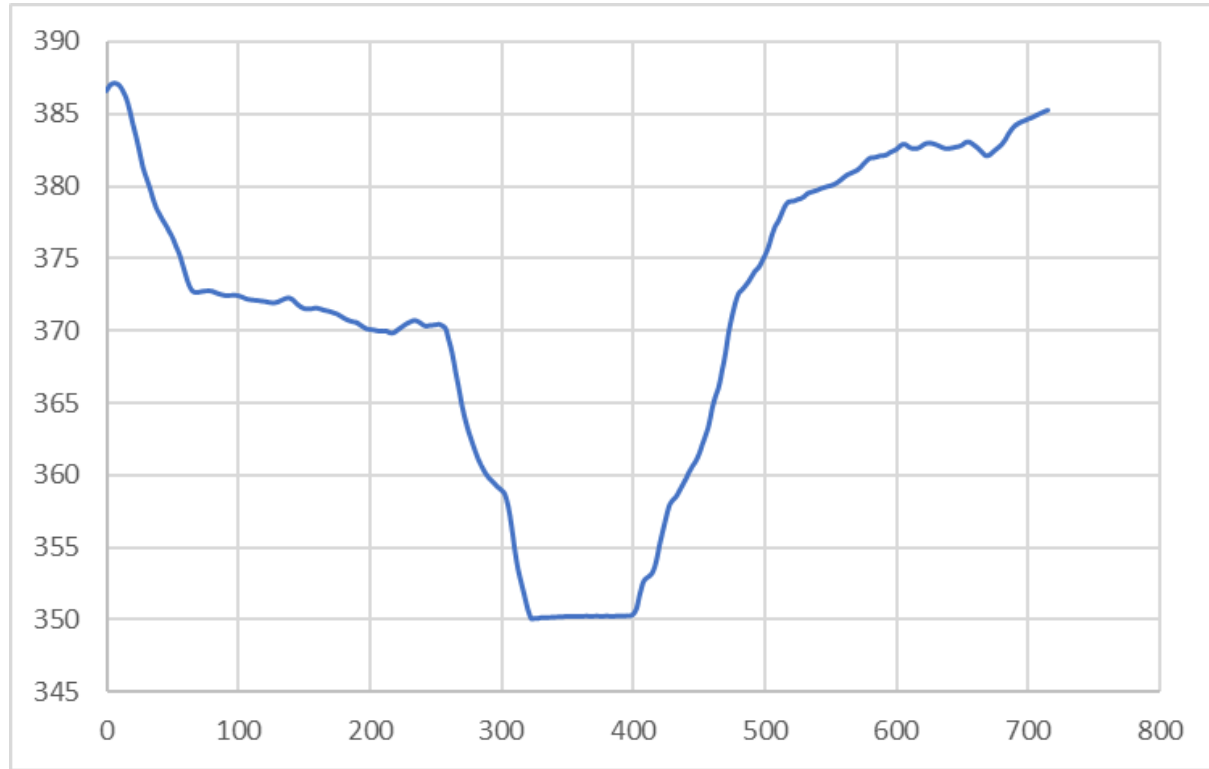
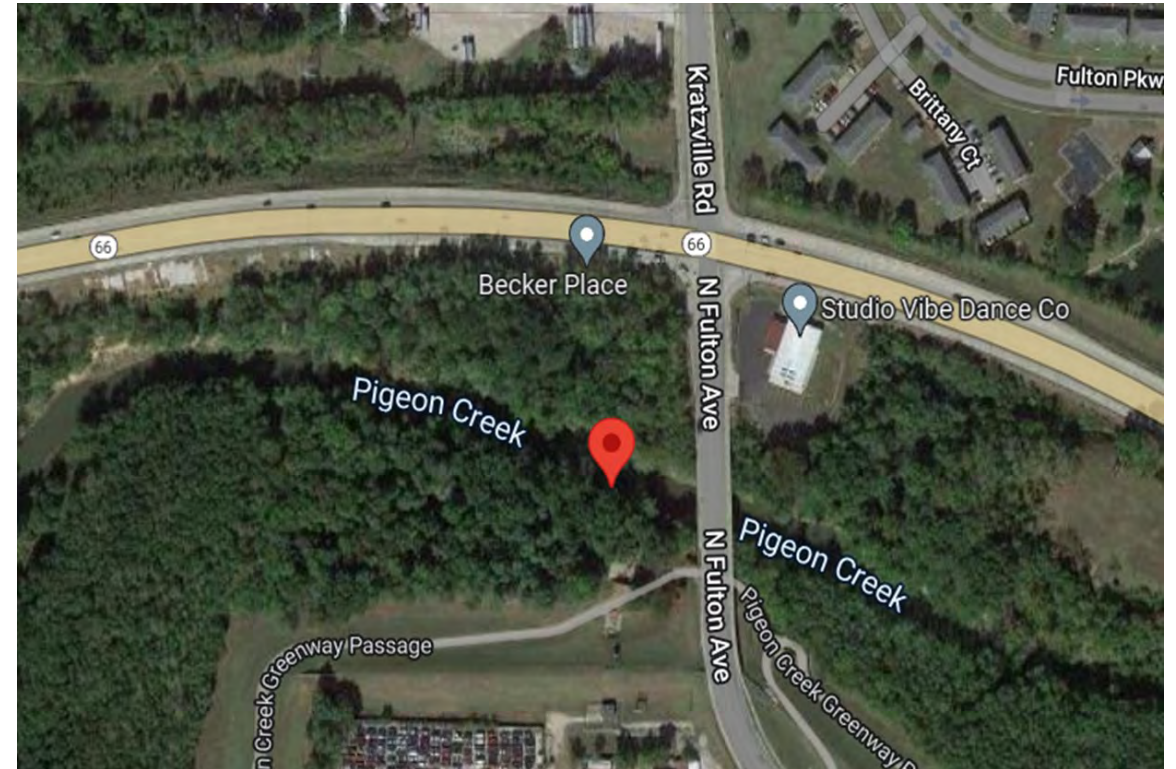
Vanderburgh County – Levee Authority

38.0027, -87.5830
 XS cut from top of levee to roadway

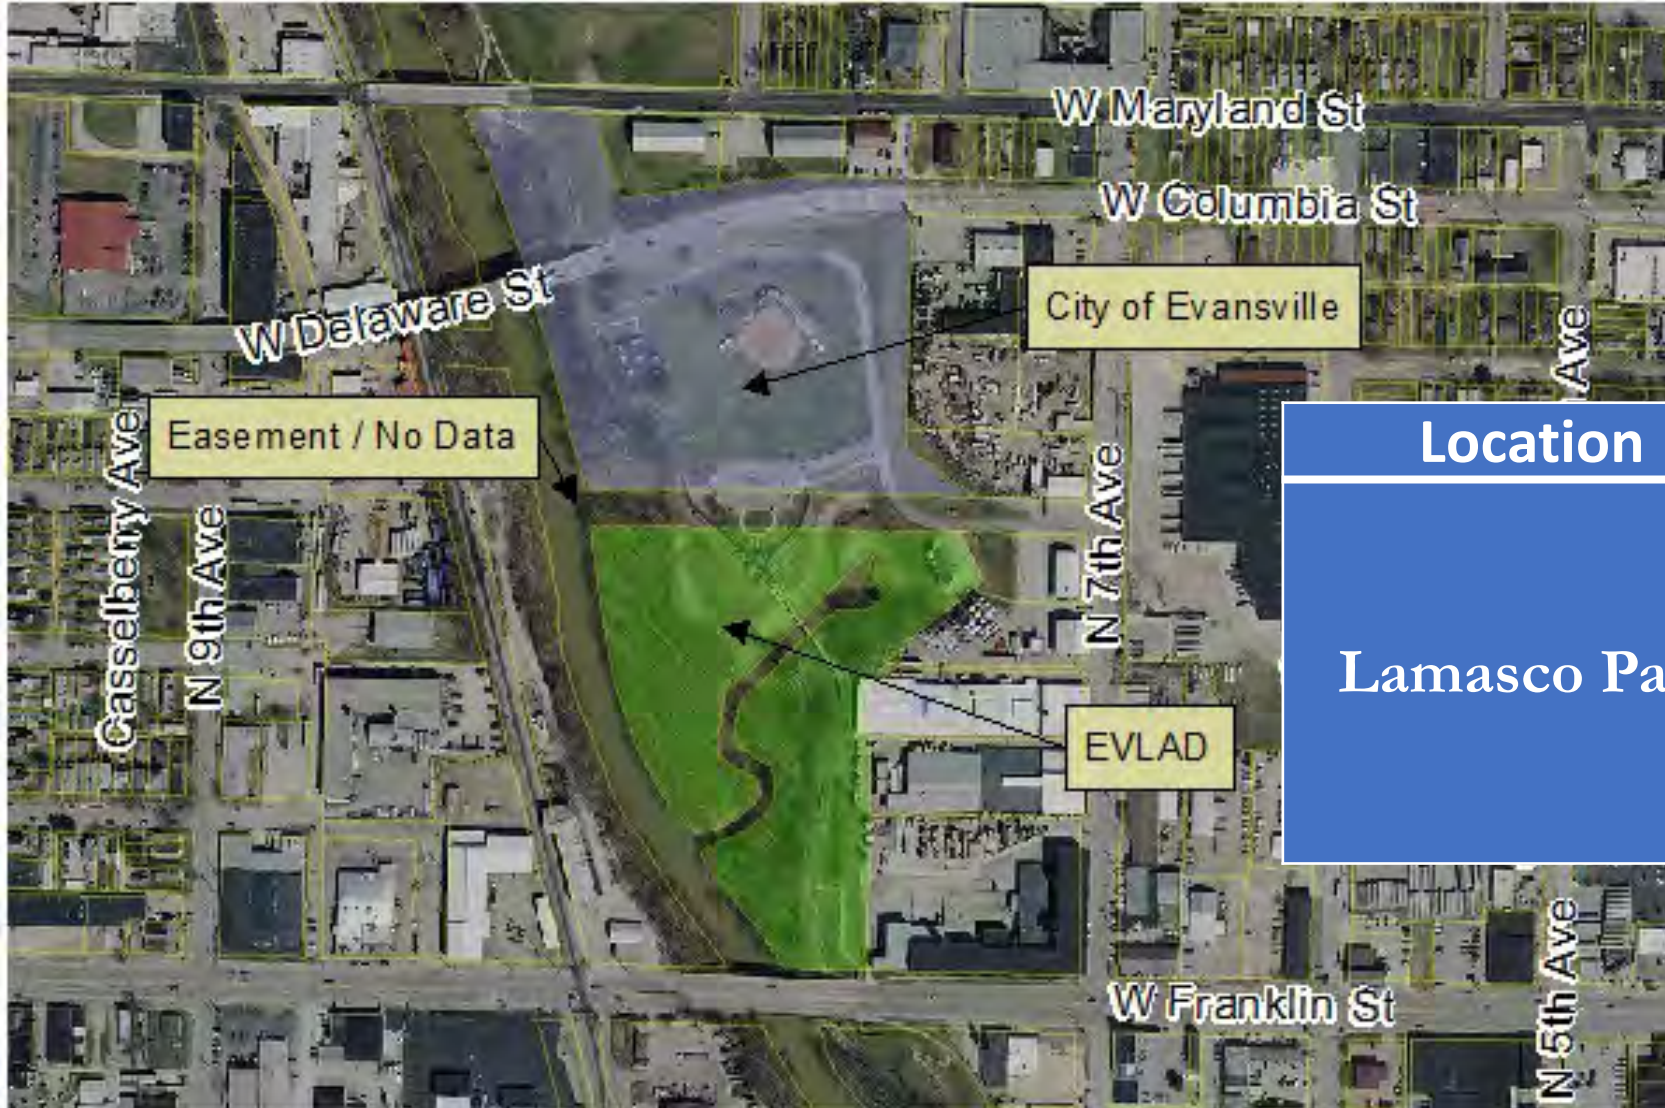
Location	Description
Lamasco Park	Adjacent to existing parking lot and greenway trail; amid City-owned land; gentle slope from greenway trail to creek

Location	Description
N Baker Ave	Existing access over levee; existing dirt/gravel path to creek; woody debris prevalent

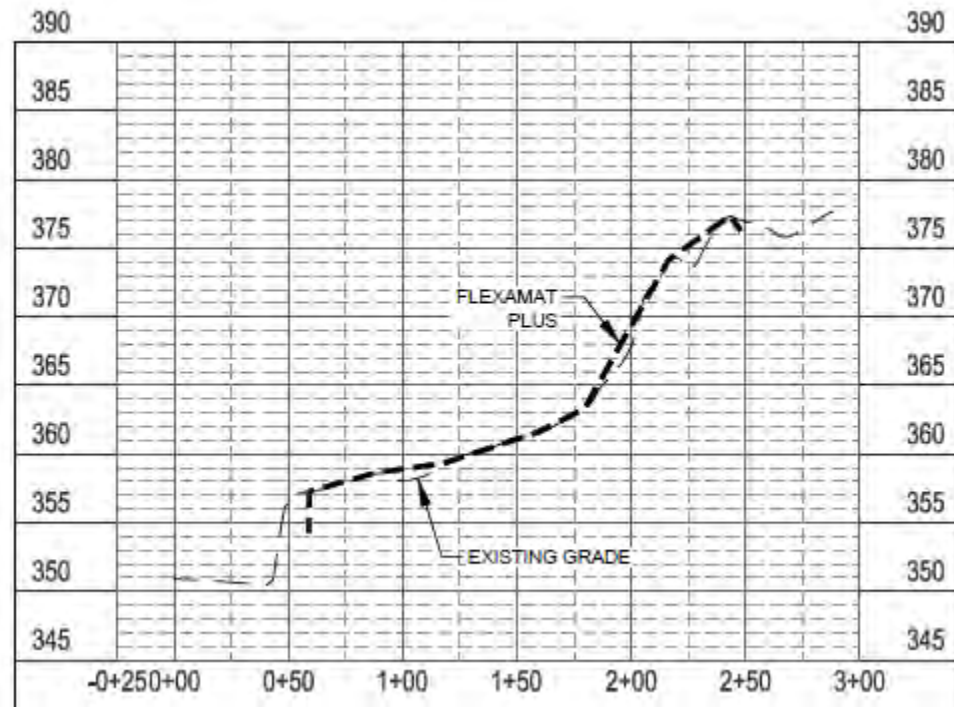
Recreational Access

1. *Take advantage of existing parking*
2. *Extend "Blue Trail" from 6 to 10 miles*
3. *Integrate pedestrian and canoe/kayak activities*

- > *Minor surface grading*
- > *Install concrete block mat*
- > *Seed disturbed areas*

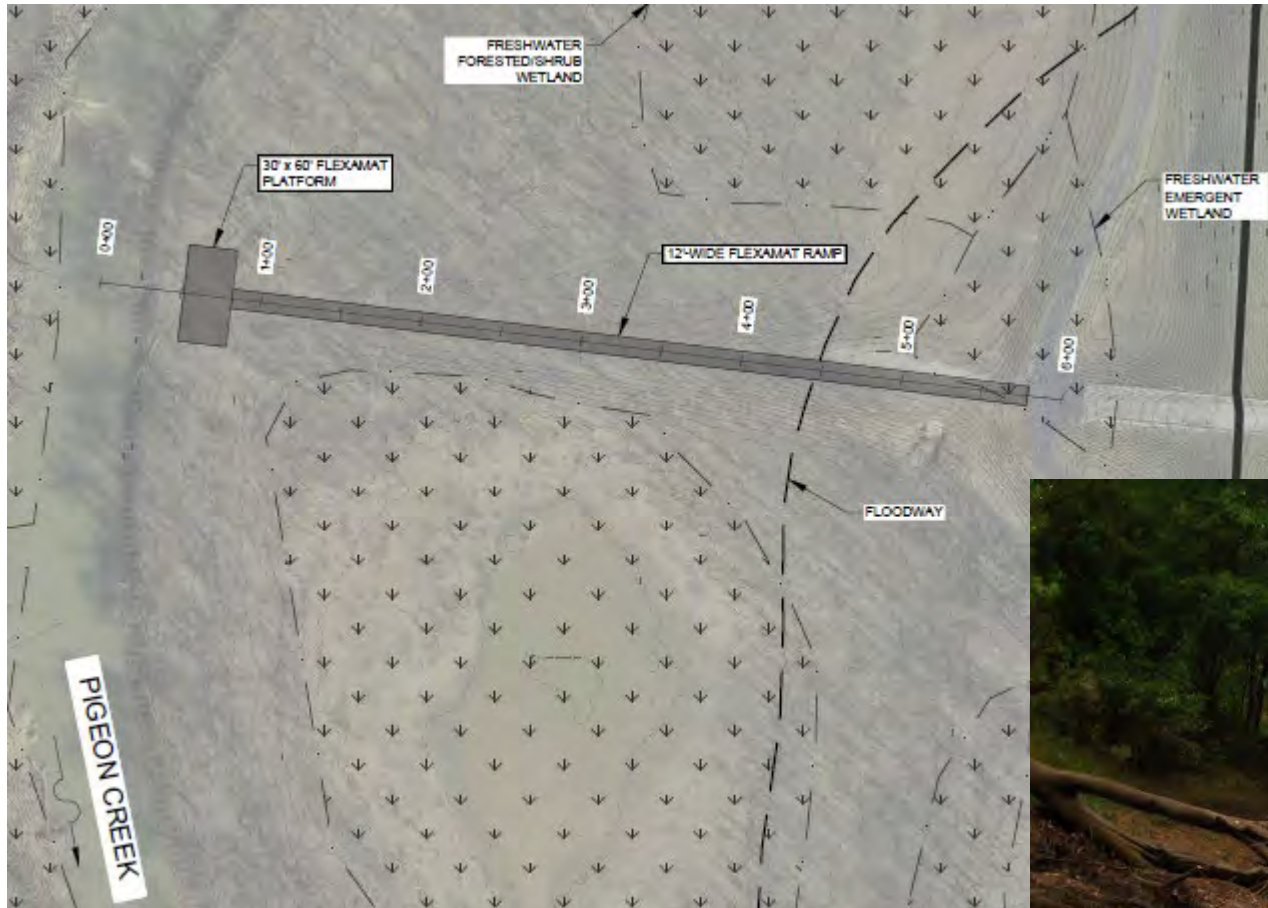
Logjam Removal Access

- 1. Take advantage of existing levee access*
- 2. Clearing of existing wooded corridor minimal*

-> Minor surface grading

-> Install concrete block mat

-> Seed disturbed areas

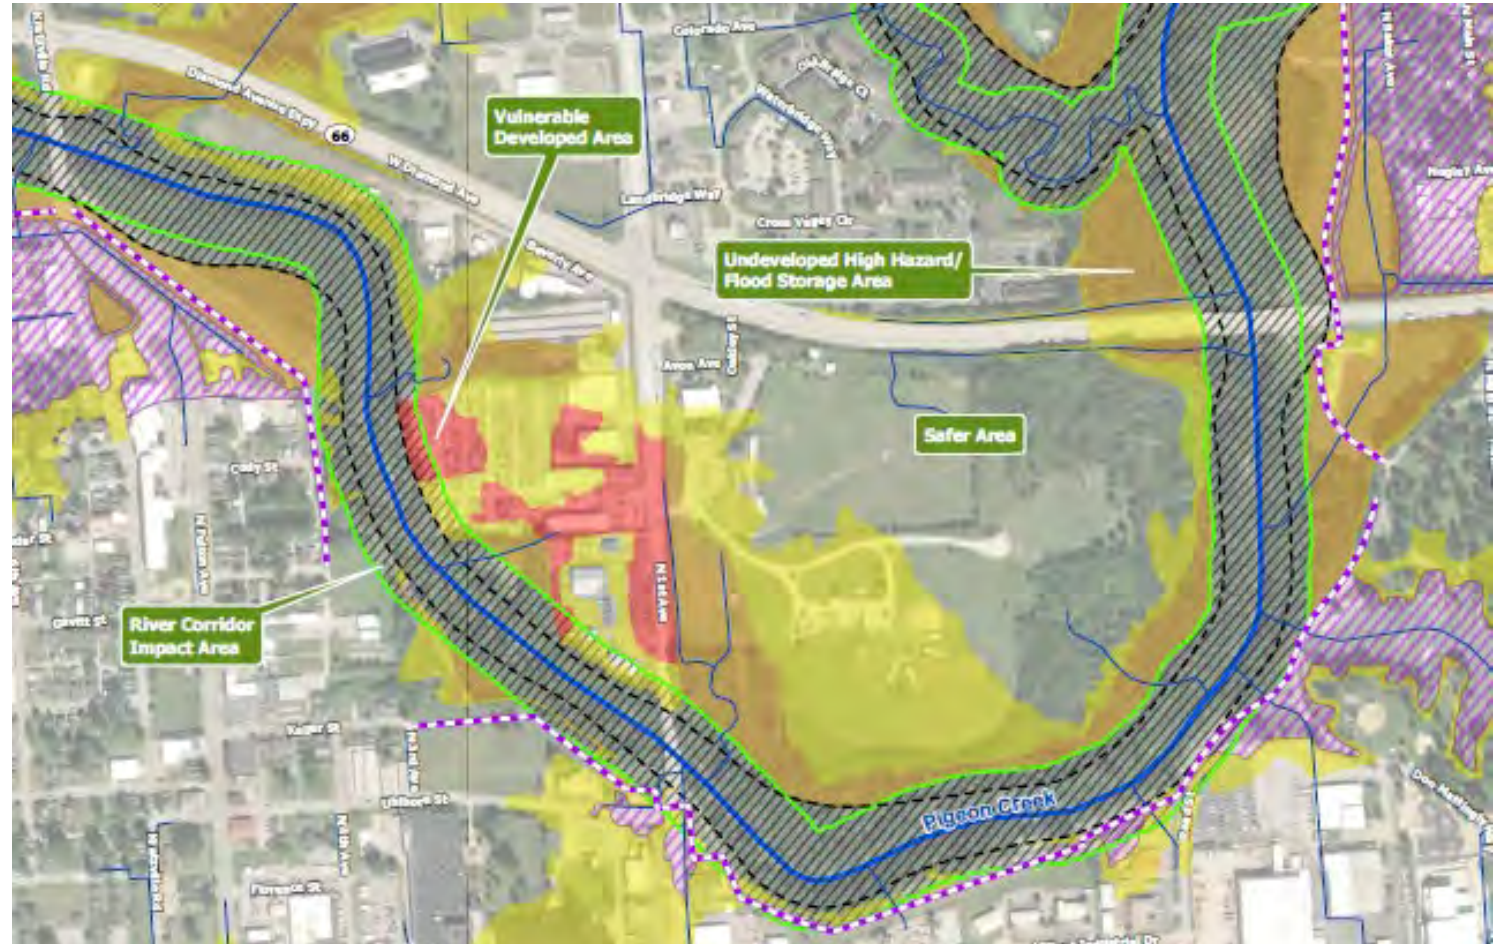
Adopt Flood-Conscious Development Plans

Resiliency maps identify developed areas that are currently at risk, undeveloped areas that would be at risk, and undeveloped areas with lesser risks where future development may be promoted

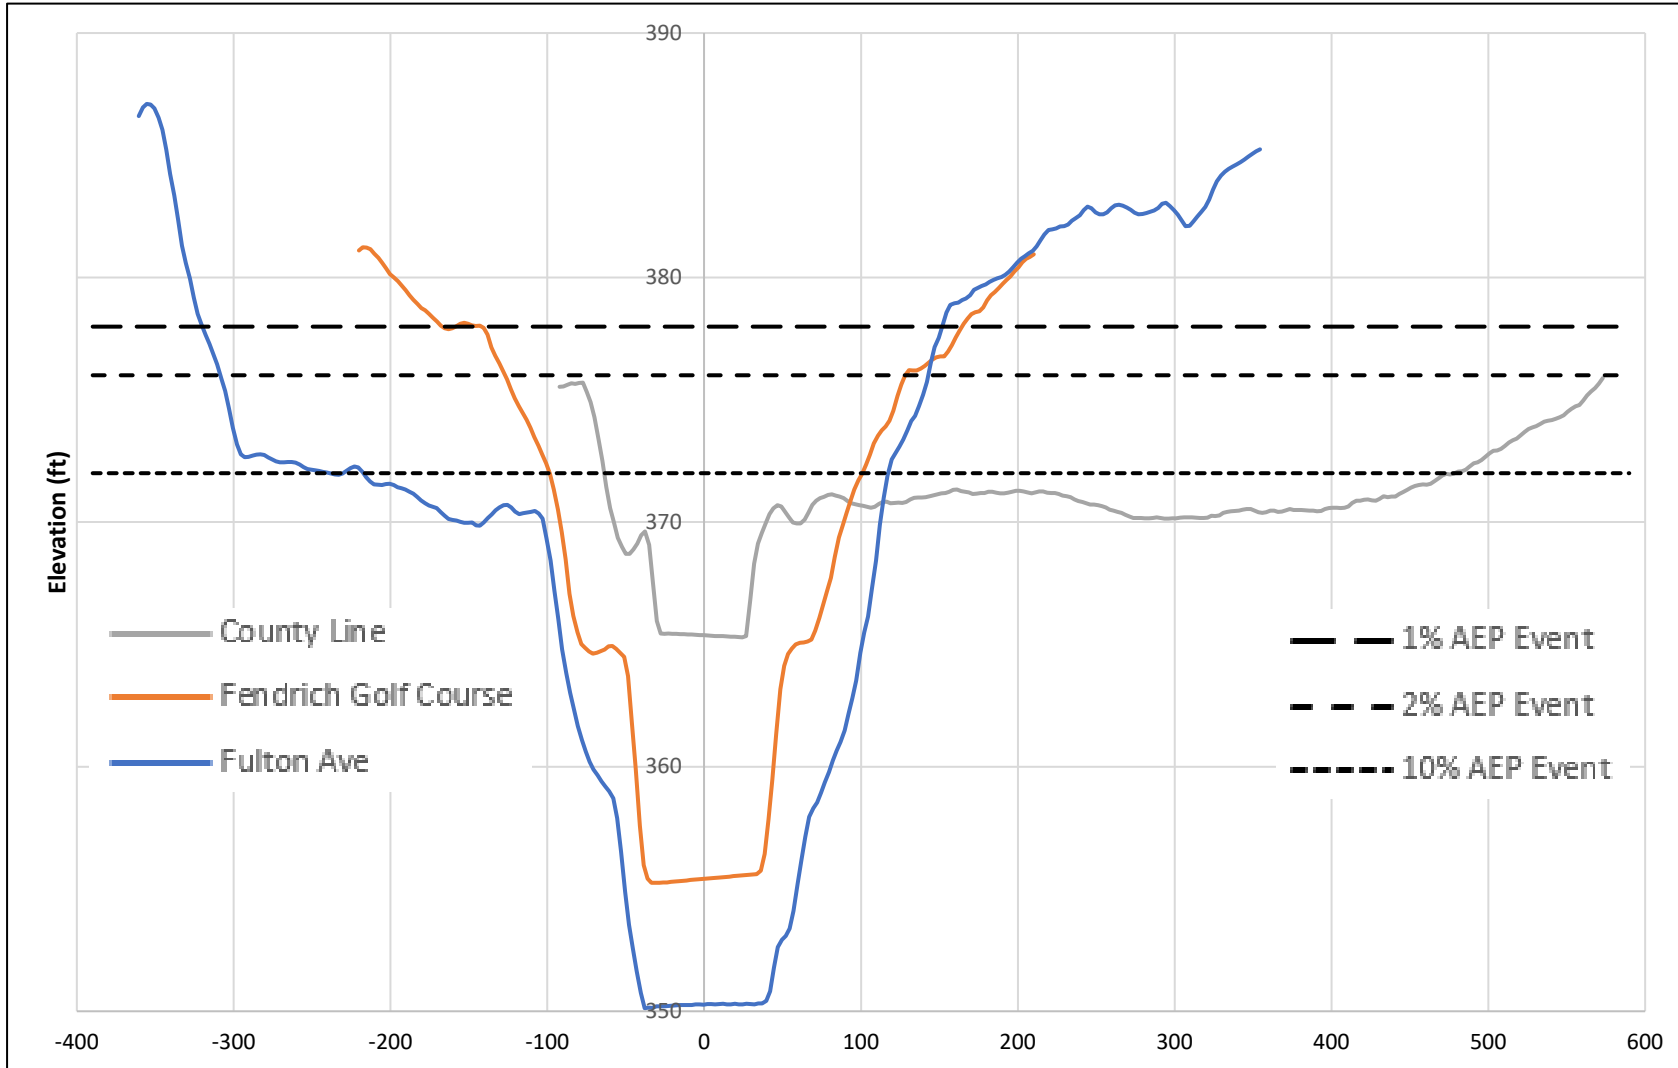
Ohio River Backwater

- ## Notes
- 1. Backwater influence extends throughout County*
 - 2. Flooding is largely contained within wooded corridor d/s of Green River Rd*
