Pigeon Creek Corridor Flood Risk Management Plan

Evansville, IN – Vanderburgh Co. Commissioners
Ian Hahus & Bob Barr

May 9, 2023

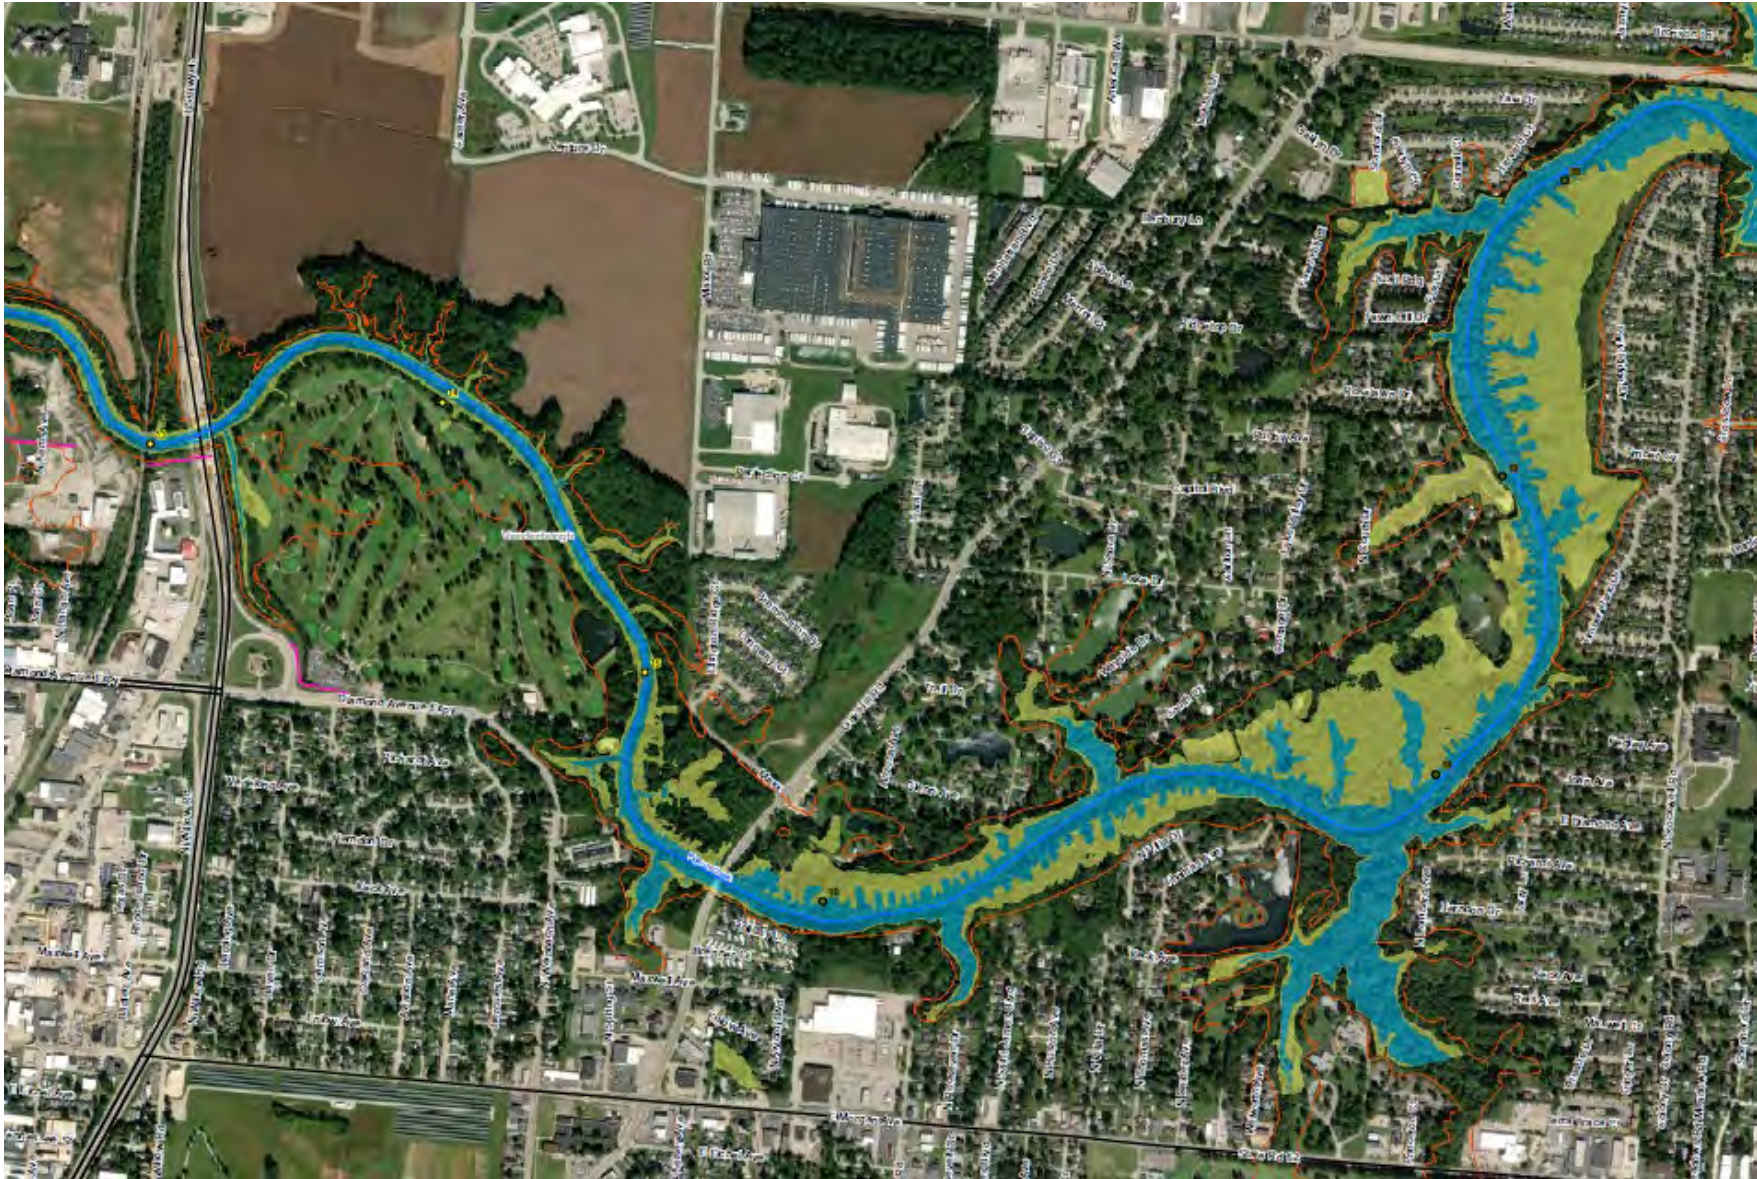
Floodplain Connectivity

- 1. Stream more confined in leveed portion and up to Oak Hill Rd*
- 2. Much more storage / stress relief upstream of Oak Hill Rd*

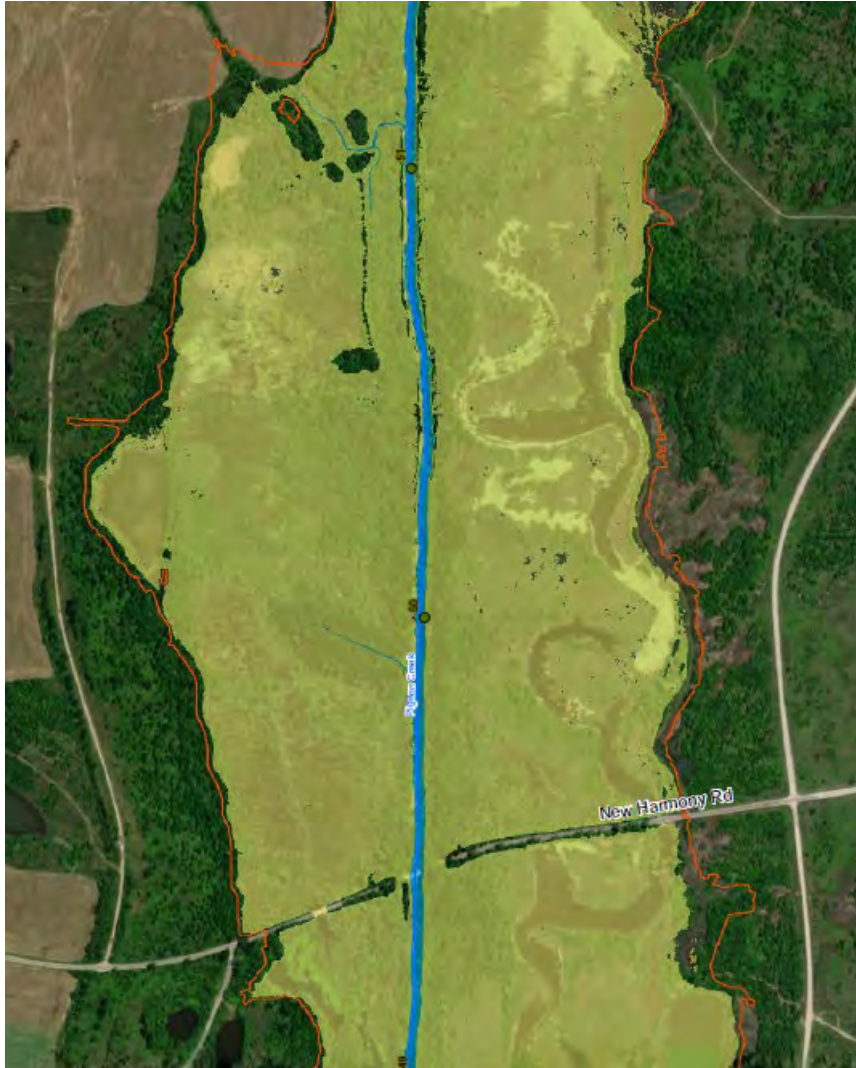
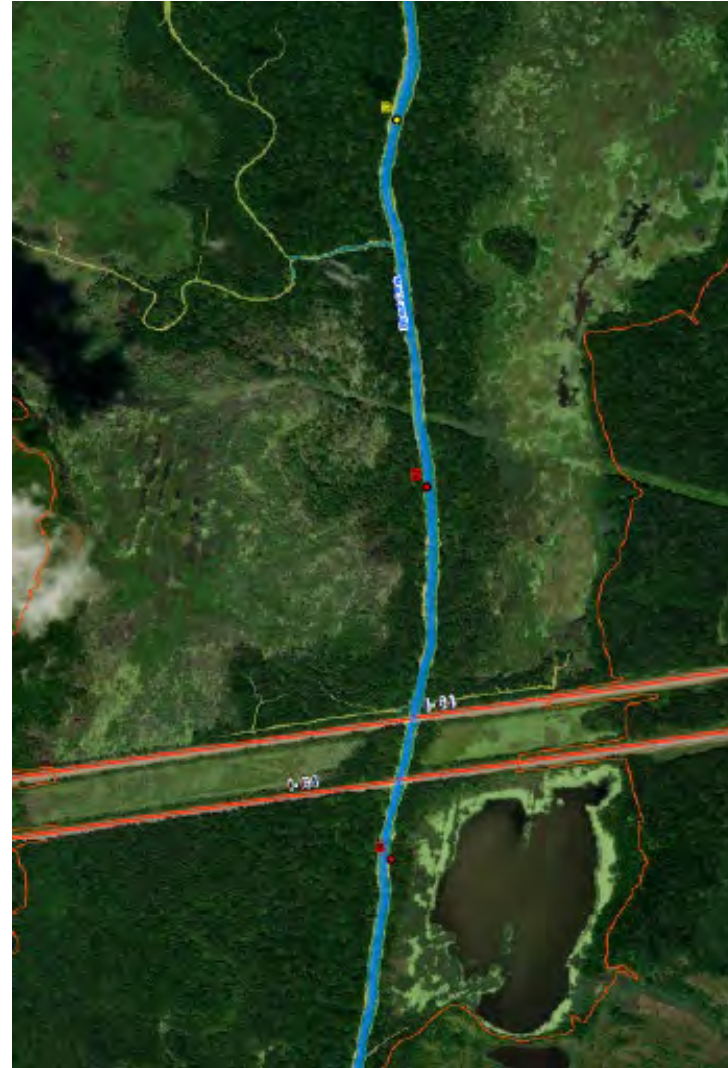
Floodplain Connectivity

- 1. Pigeon Creek dramatically straightened through mid-upper Warrick*
- 2. Connectivity in Warrick generally good past New Harmony Rd; connectivity greatly reduced N of I-64*

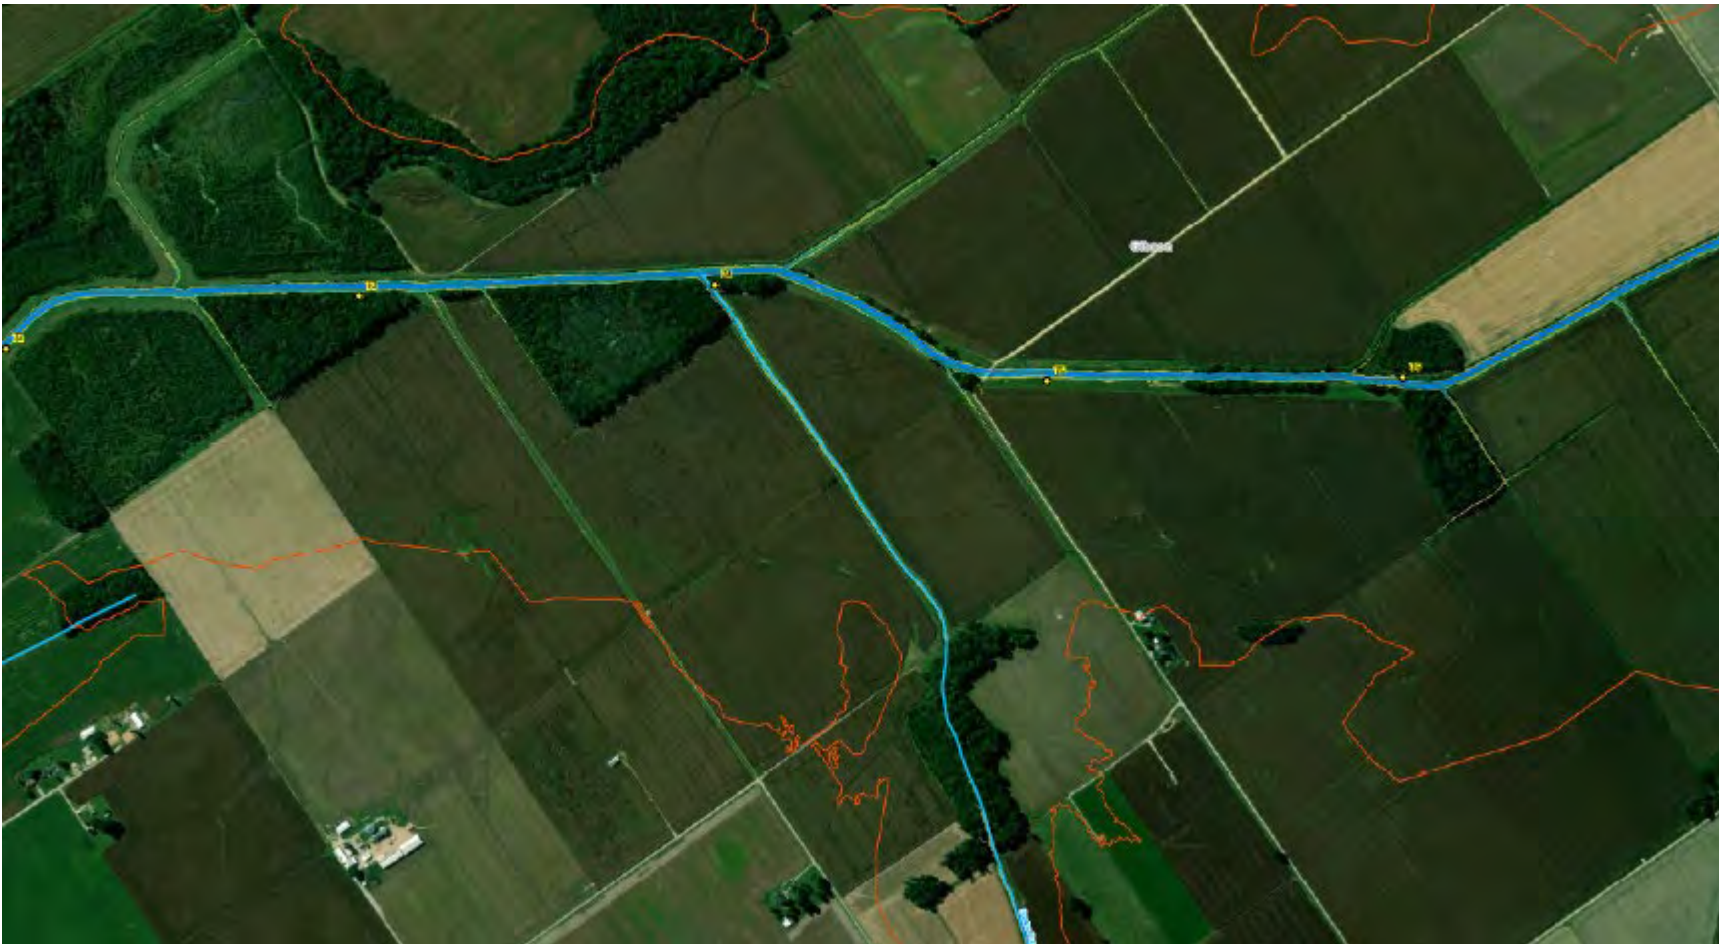
Floodplain Connectivity

- 1. Floodplain connectivity nearly absent at lower stages in Gibson County*
