**LOWER PIGEON CREEK WATERSHED MANAGEMENT PLAN
VANDERBURGH, GIBSON AND WARRICK COUNTIES, INDIANA**

6 MARCH 2023

**A PROJECT OF THE
VANDERBURGH COUNTY SOIL AND WATER CONSERVATION DISTRICT
921 PARK DRIVE
EVANSVILLE, INDIANA 47710**

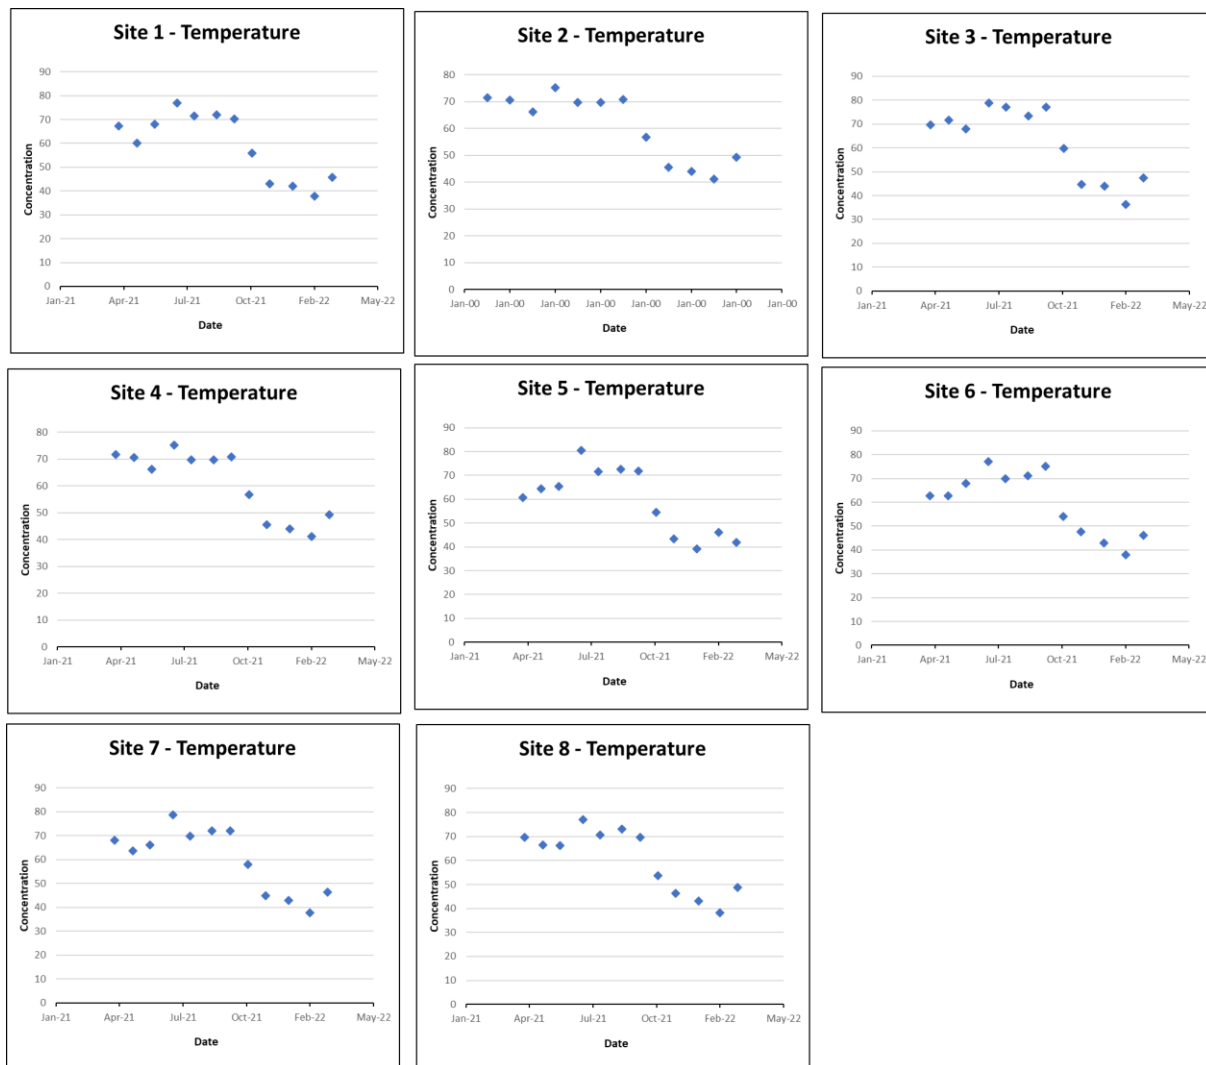
Figure 30. Temperature measurements in Lower Pigeon Creek Watershed samples sites from April 2021-March 2022. Note differences in scale along the concentration (y) axis.

Figure 30 illustrates the monthly temperature measurements in the watershed streams. As shown, temperatures measure approximately the same at each of the stream sites with seasonal changes in temperature creating major differences in temperature throughout the sampling period. Temperatures measured between 36.3 to 80.6 °F in all streams. The highest temperatures occurred during the July, August and September assessments depending on riparian cover and stream depth present at each location.

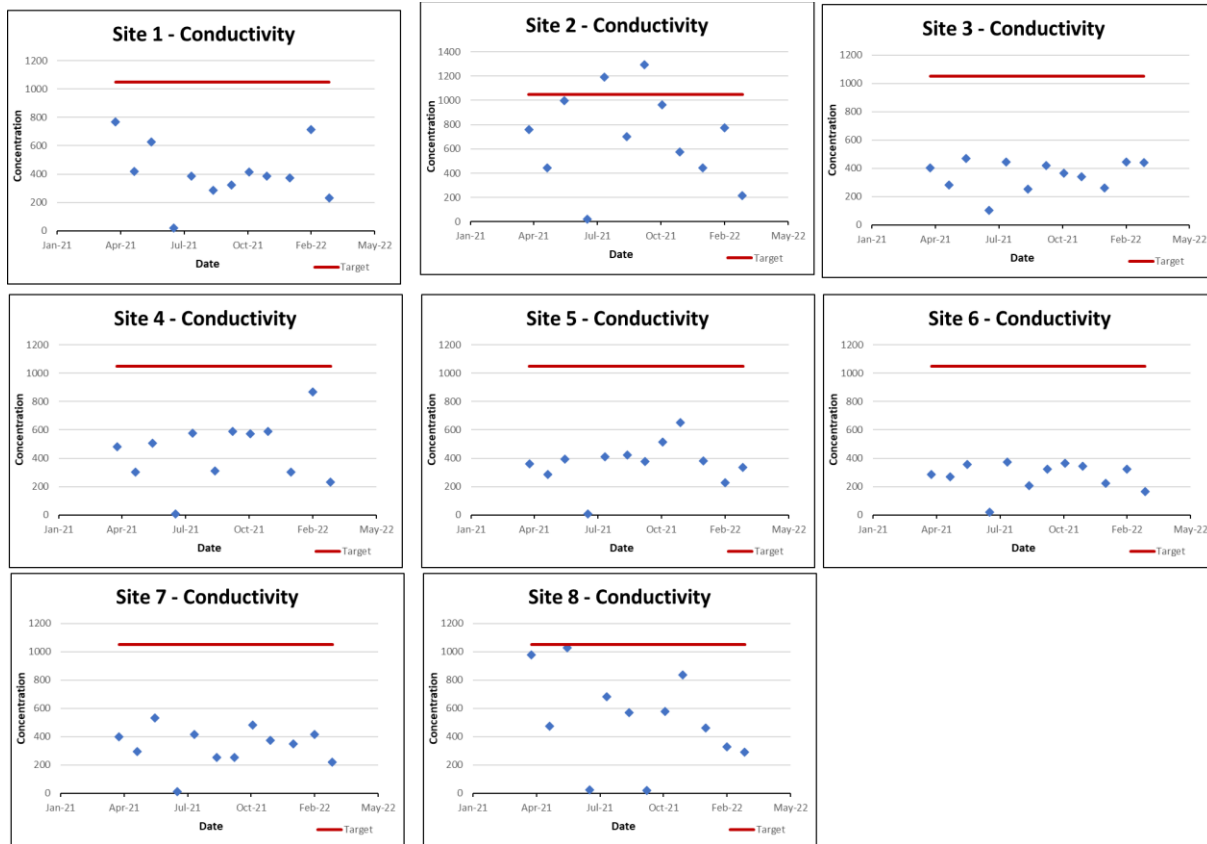
Figure 33. Conductivity measurements in Lower Pigeon Creek samples sites from April 2021-March 2022.

Figure 33 displays conductivity measurements in the watershed streams. Conductivity measurements varied greatly over the sampling period. Conductivity exceeded state standard (1060 S/cm) three times: Site 8 during the June 2021 sampling event and Site 2 during the August and October 2021 sampling events. Conductivity did not exceed state standards at any other sites.

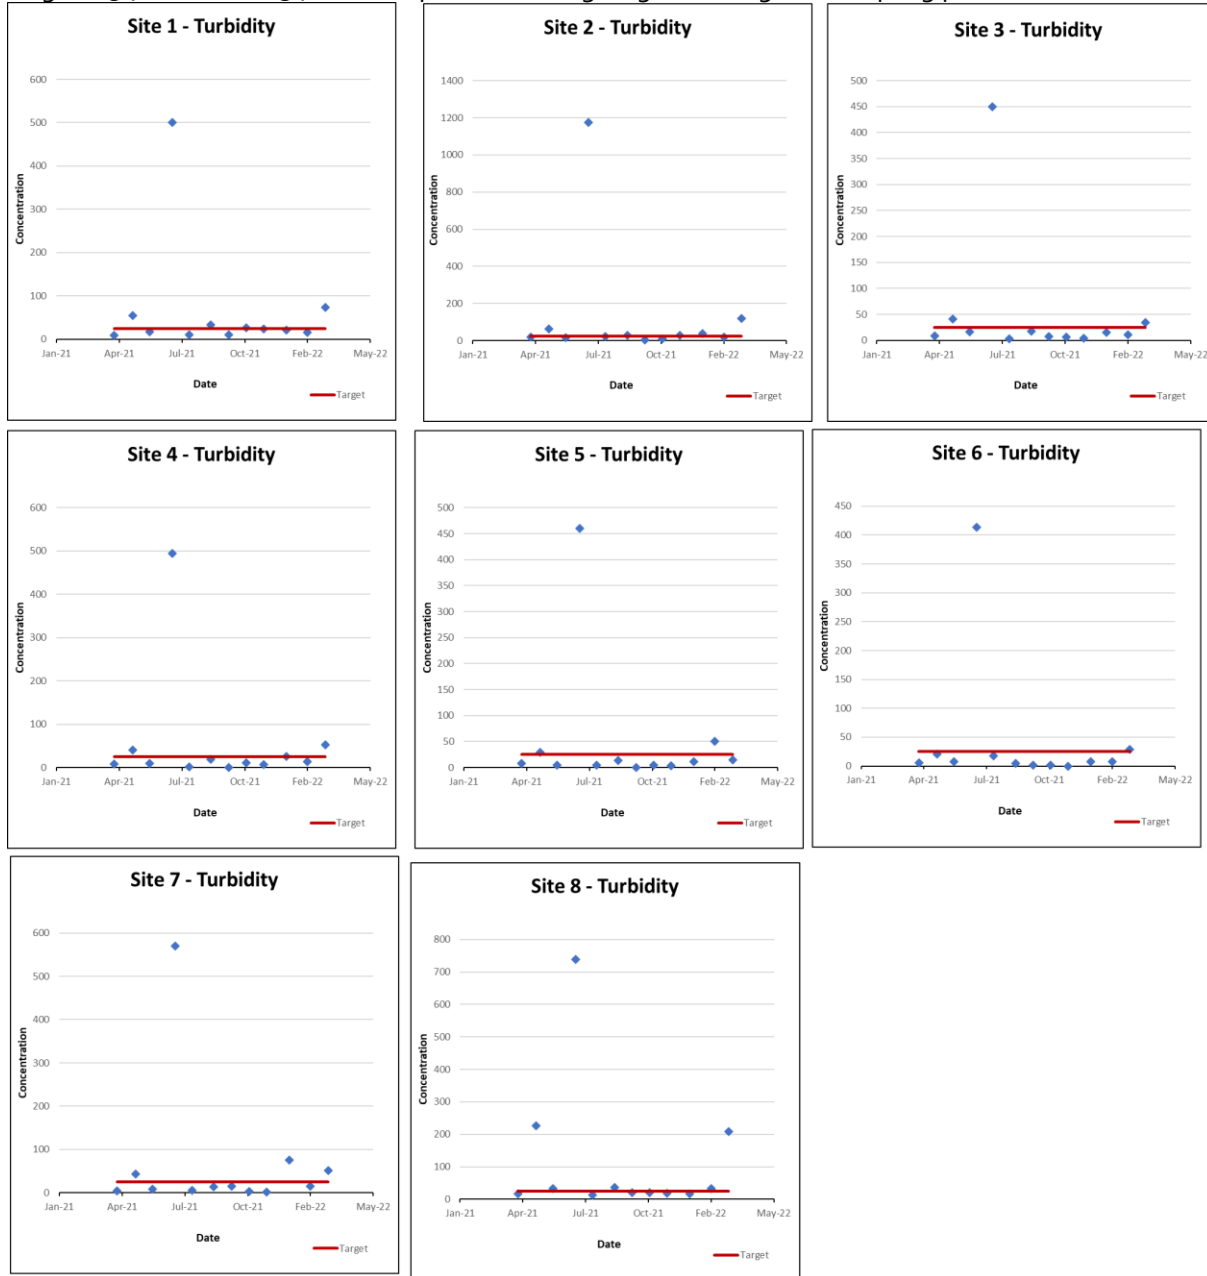
Figure 34. Turbidity measurements in Lower Pigeon Creek samples sites from April 2021-March 2022.

Figure 34 displays conductivity measurements in the watershed streams. Turbidity measurements varied greatly over the sampling period. Turbidity exceeded target levels at all sites during the July 2021 sampling event, which occurred following 1.2 inches of rain. In total, 33 of 96 samples exceeded turbidity targets (5.7 NTU) with 34% of samples exceeding targets during the sampling period.

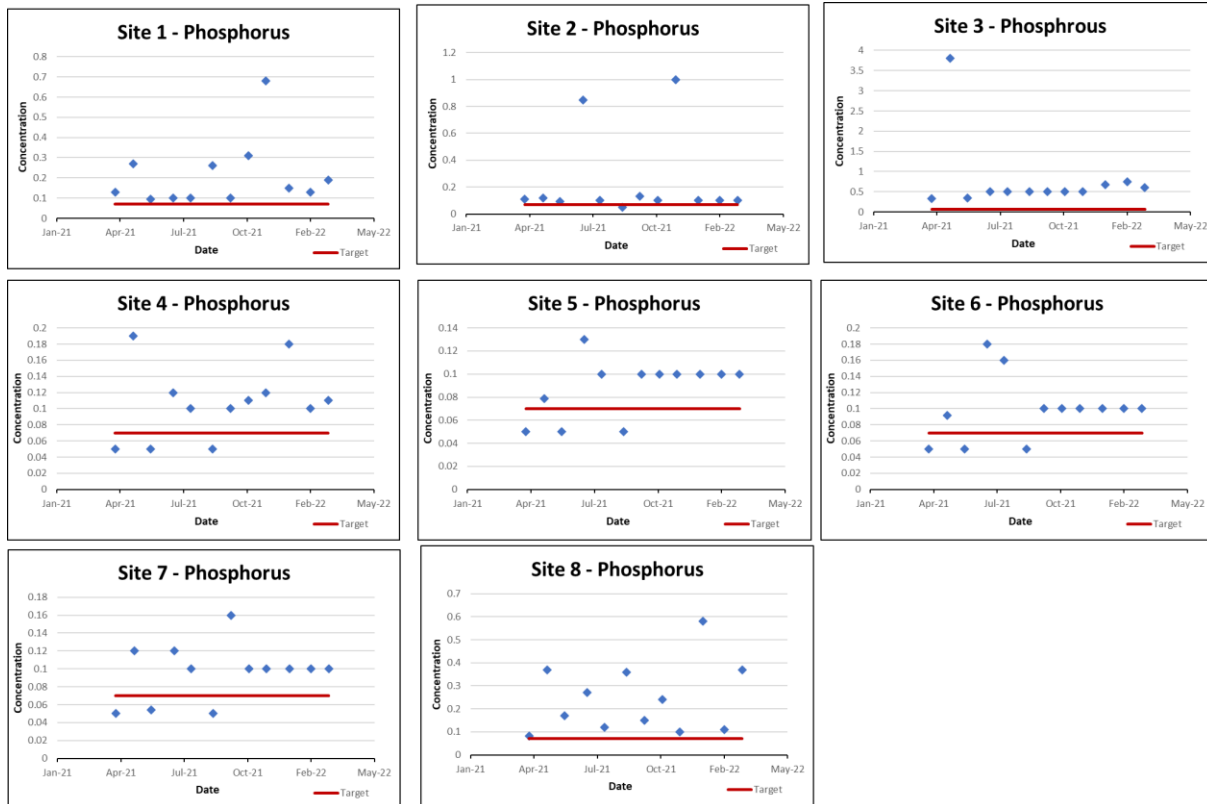
Figure 36. Total phosphorus concentrations measured in Lower Pigeon Creek samples sites from April 2021-March 2022. Note differences in scale along the concentration (y) axis.

Total phosphorus concentrations exceed target concentrations in 85% of samples (82 of 96 samples; Figure 36). The highest average concentrations occurred at Sites 1, 3 and 8 with concentrations exceeding 0.2 mg/L. Concentrations measured throughout the watershed measured in excess of the level at which total phosphorus concentrations impair biological communities (0.08 mg/L) with exceedances under all flow conditions. All sites possess average total phosphorus concentrations in excess of the level at which biological impairments occur (0.08 mg/L).

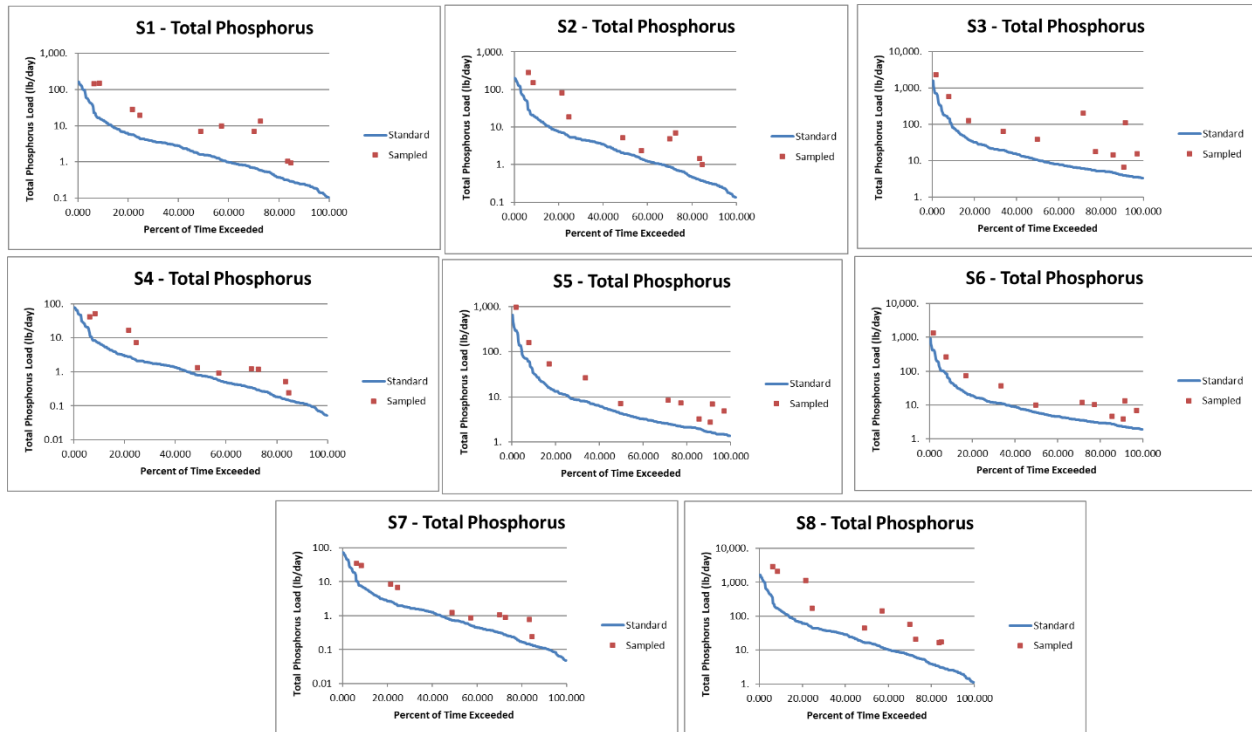
Figure 40. Total phosphorus load duration curves for Lower Pigeon Creek samples sites from April 2021-March 2022.

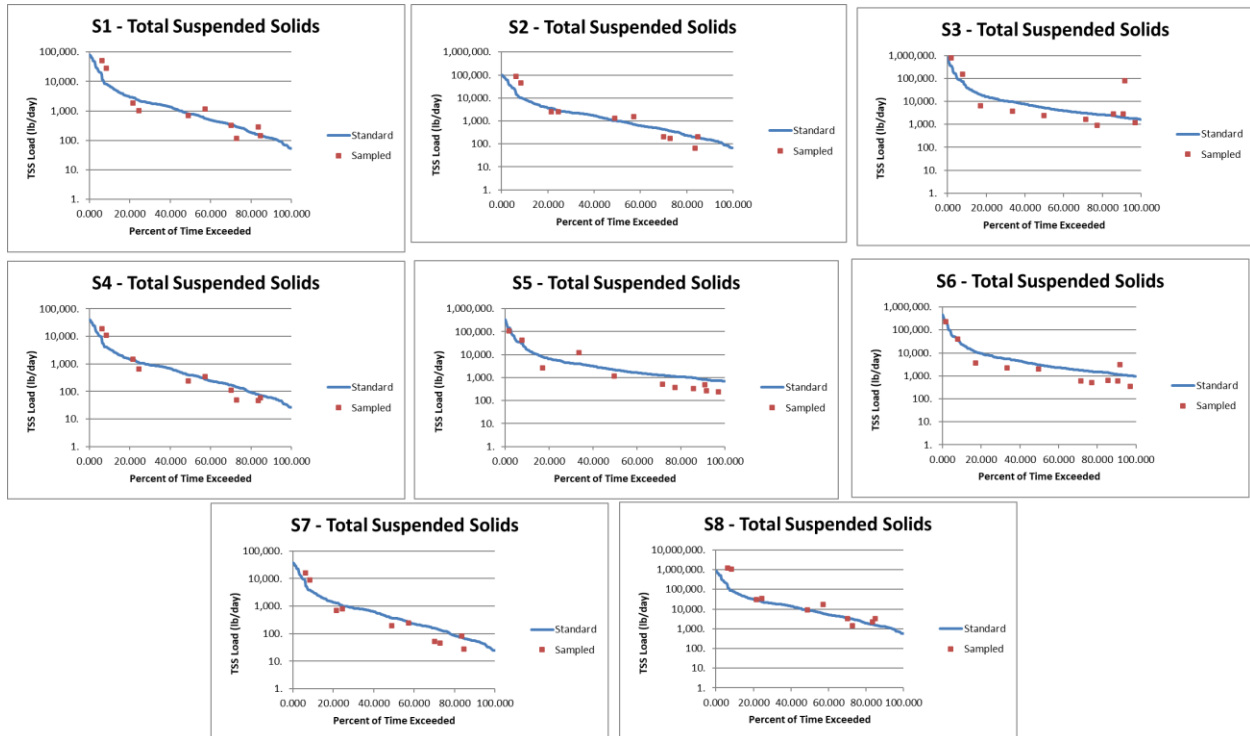
Figure 4.1. Total suspended solids load curves for Lower Pigeon Creek samples sites from April 2021-March 2022.

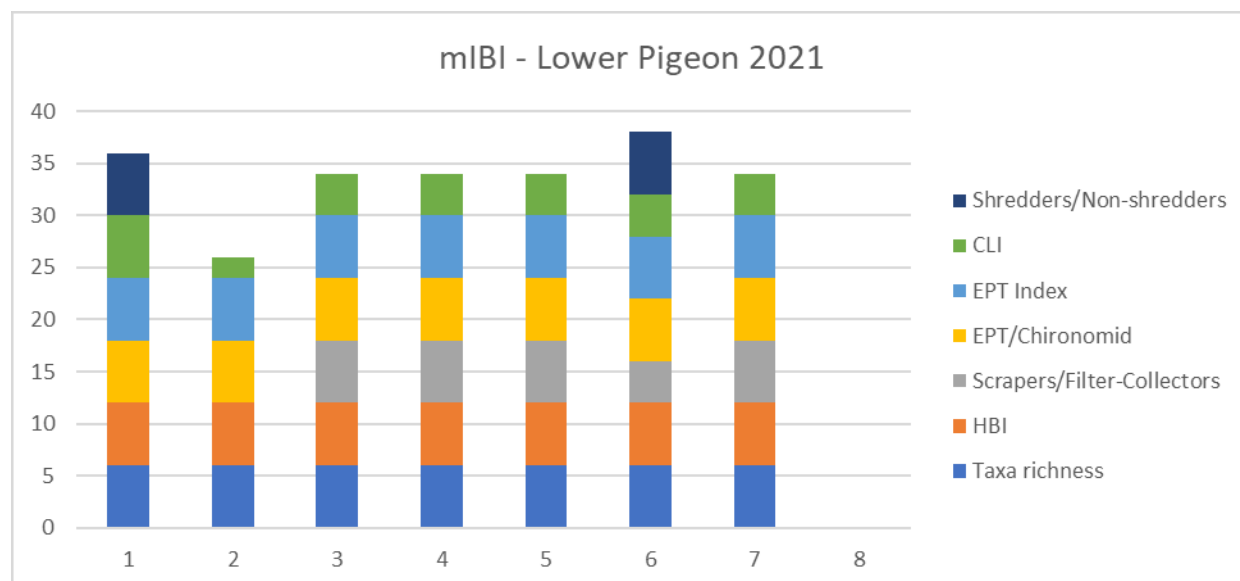
Figure 43. Cumulative metrics used to calculate mIBI scores for Lower Pigeon Creek Watershed streams in 2021.
