1813 N Heidelberg

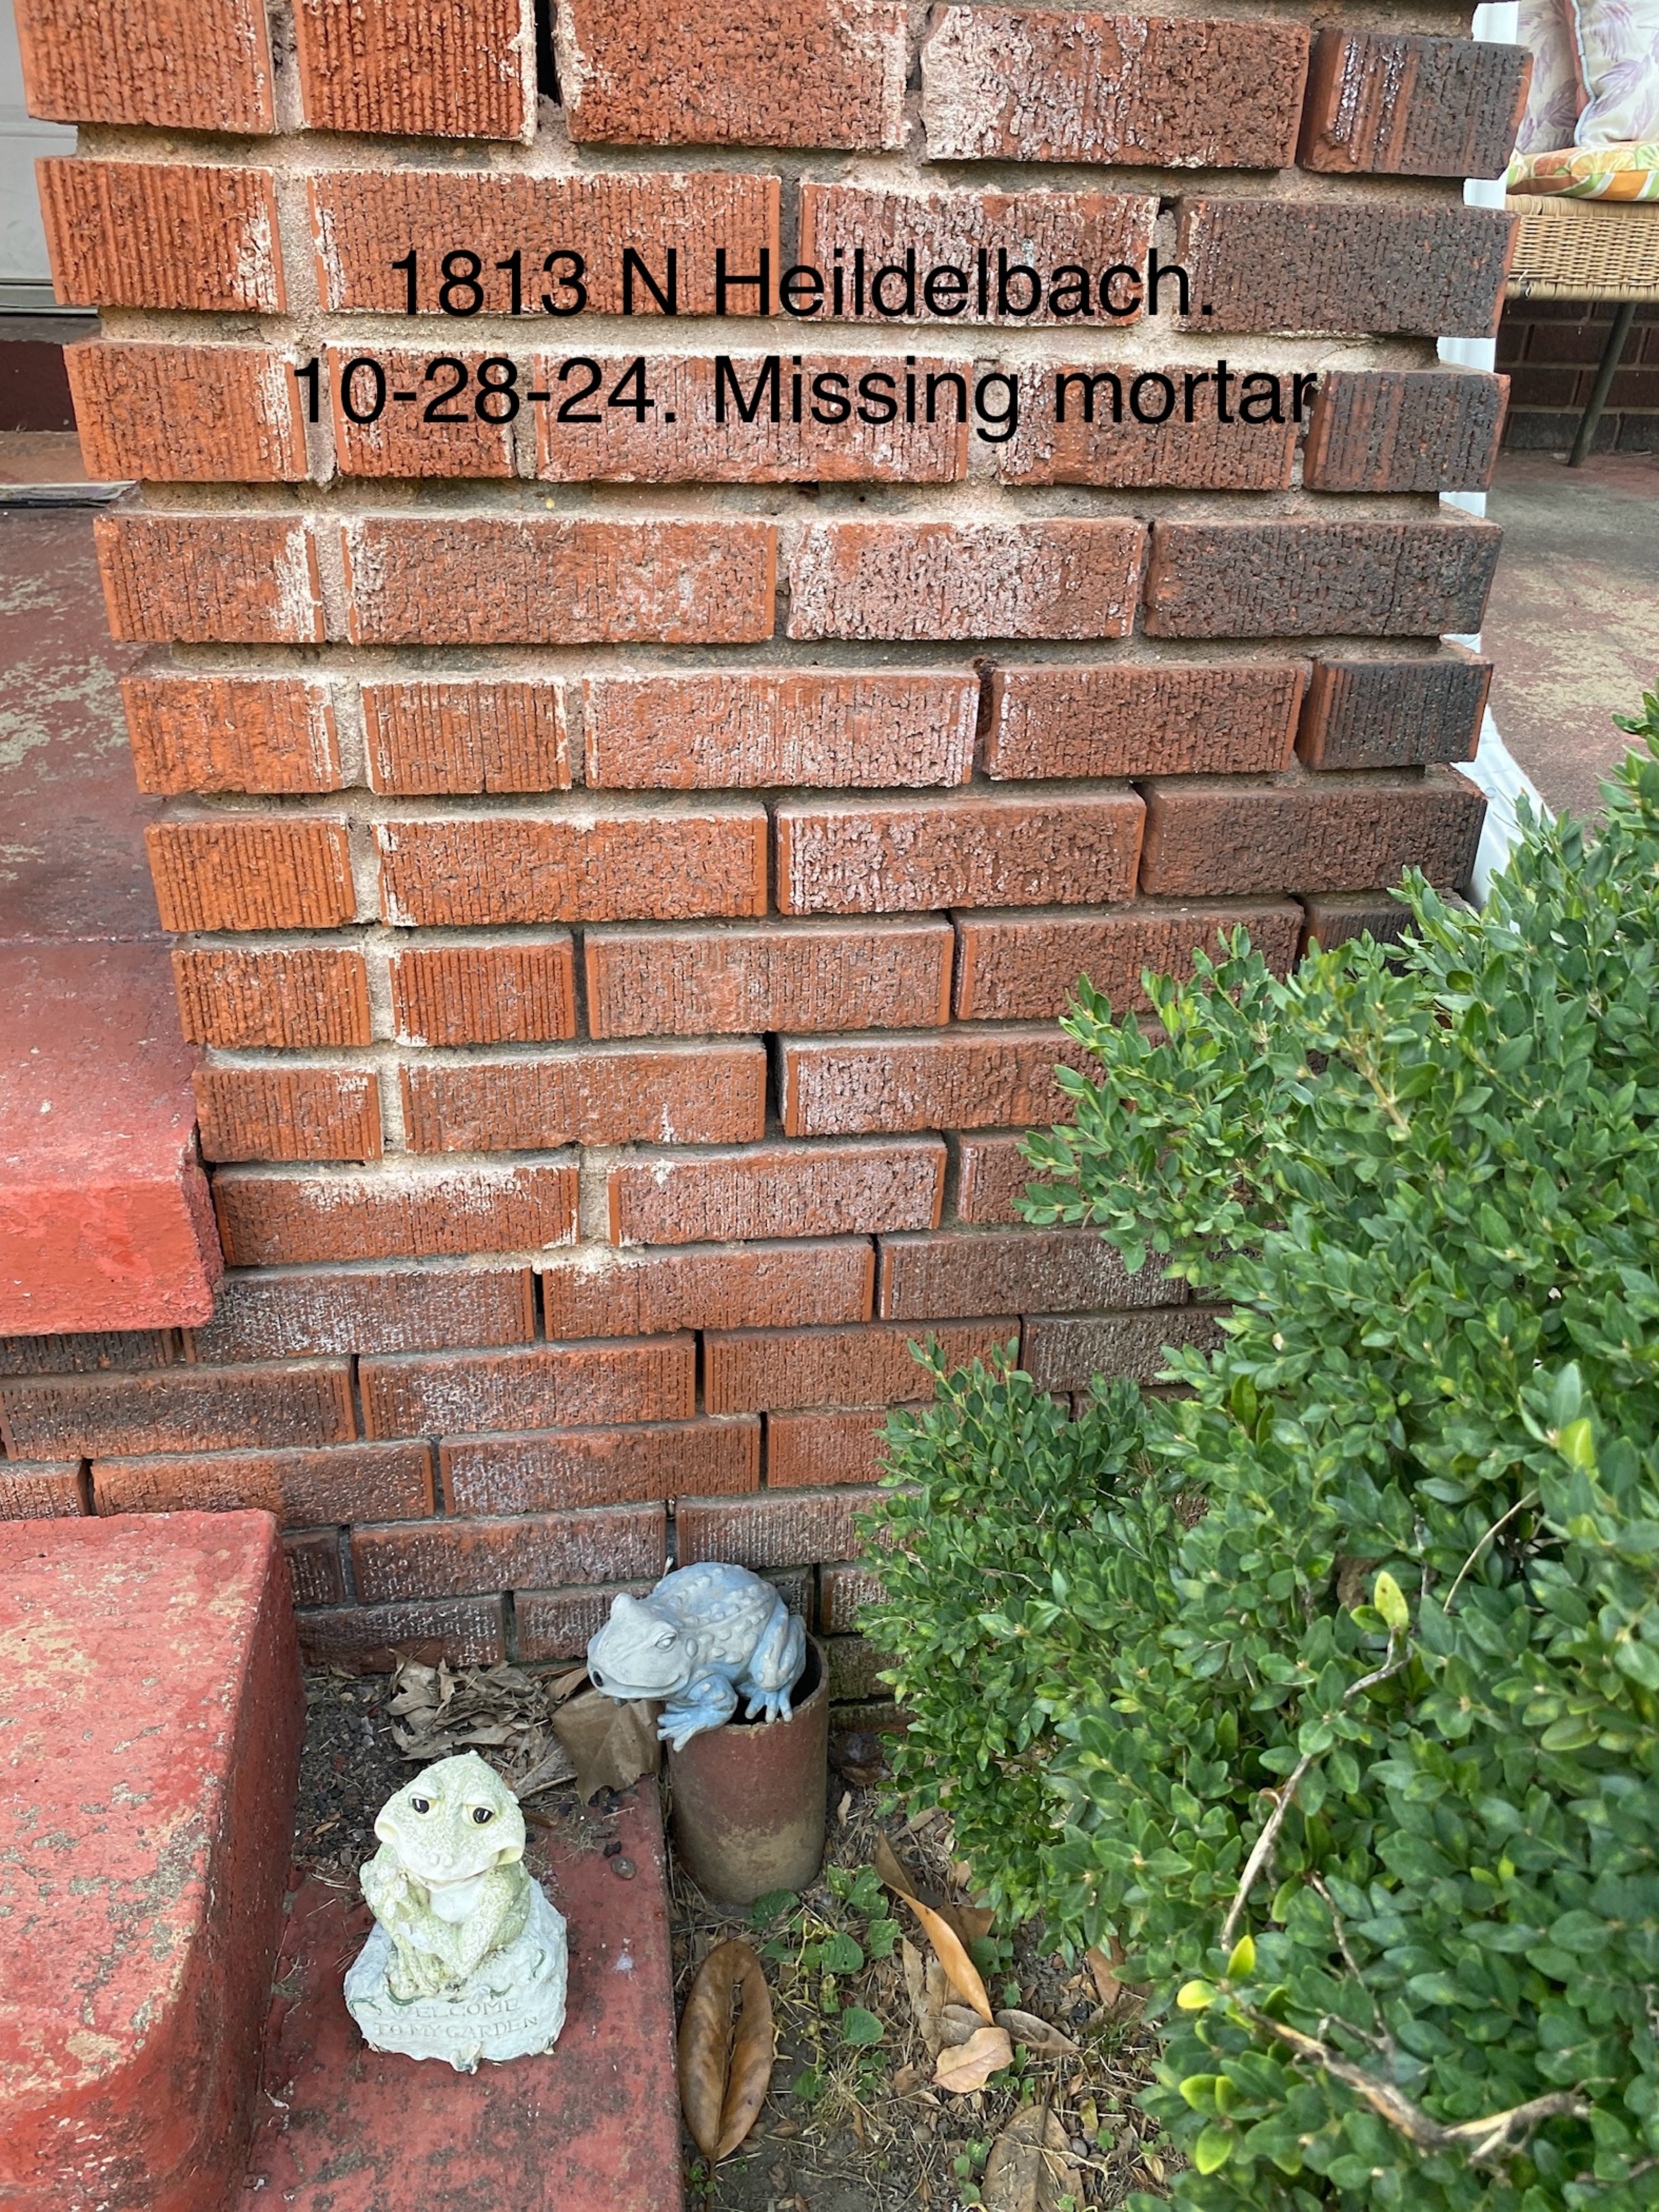
1813 N Heidelberg.
10-28-24. Missing mortar

1. Remove and replace any loose or missing mortar around the home's exterior foundation, walls, chimneys, windows and porch areas. The new mortar is to match the original mortar in style & color as close as possible. Remove the ivy away from the front of the home to check for damaged or missing mortar and repair as needed. Repair areas are to be clean of debris when completed. Include all materials and labor needed to complete.

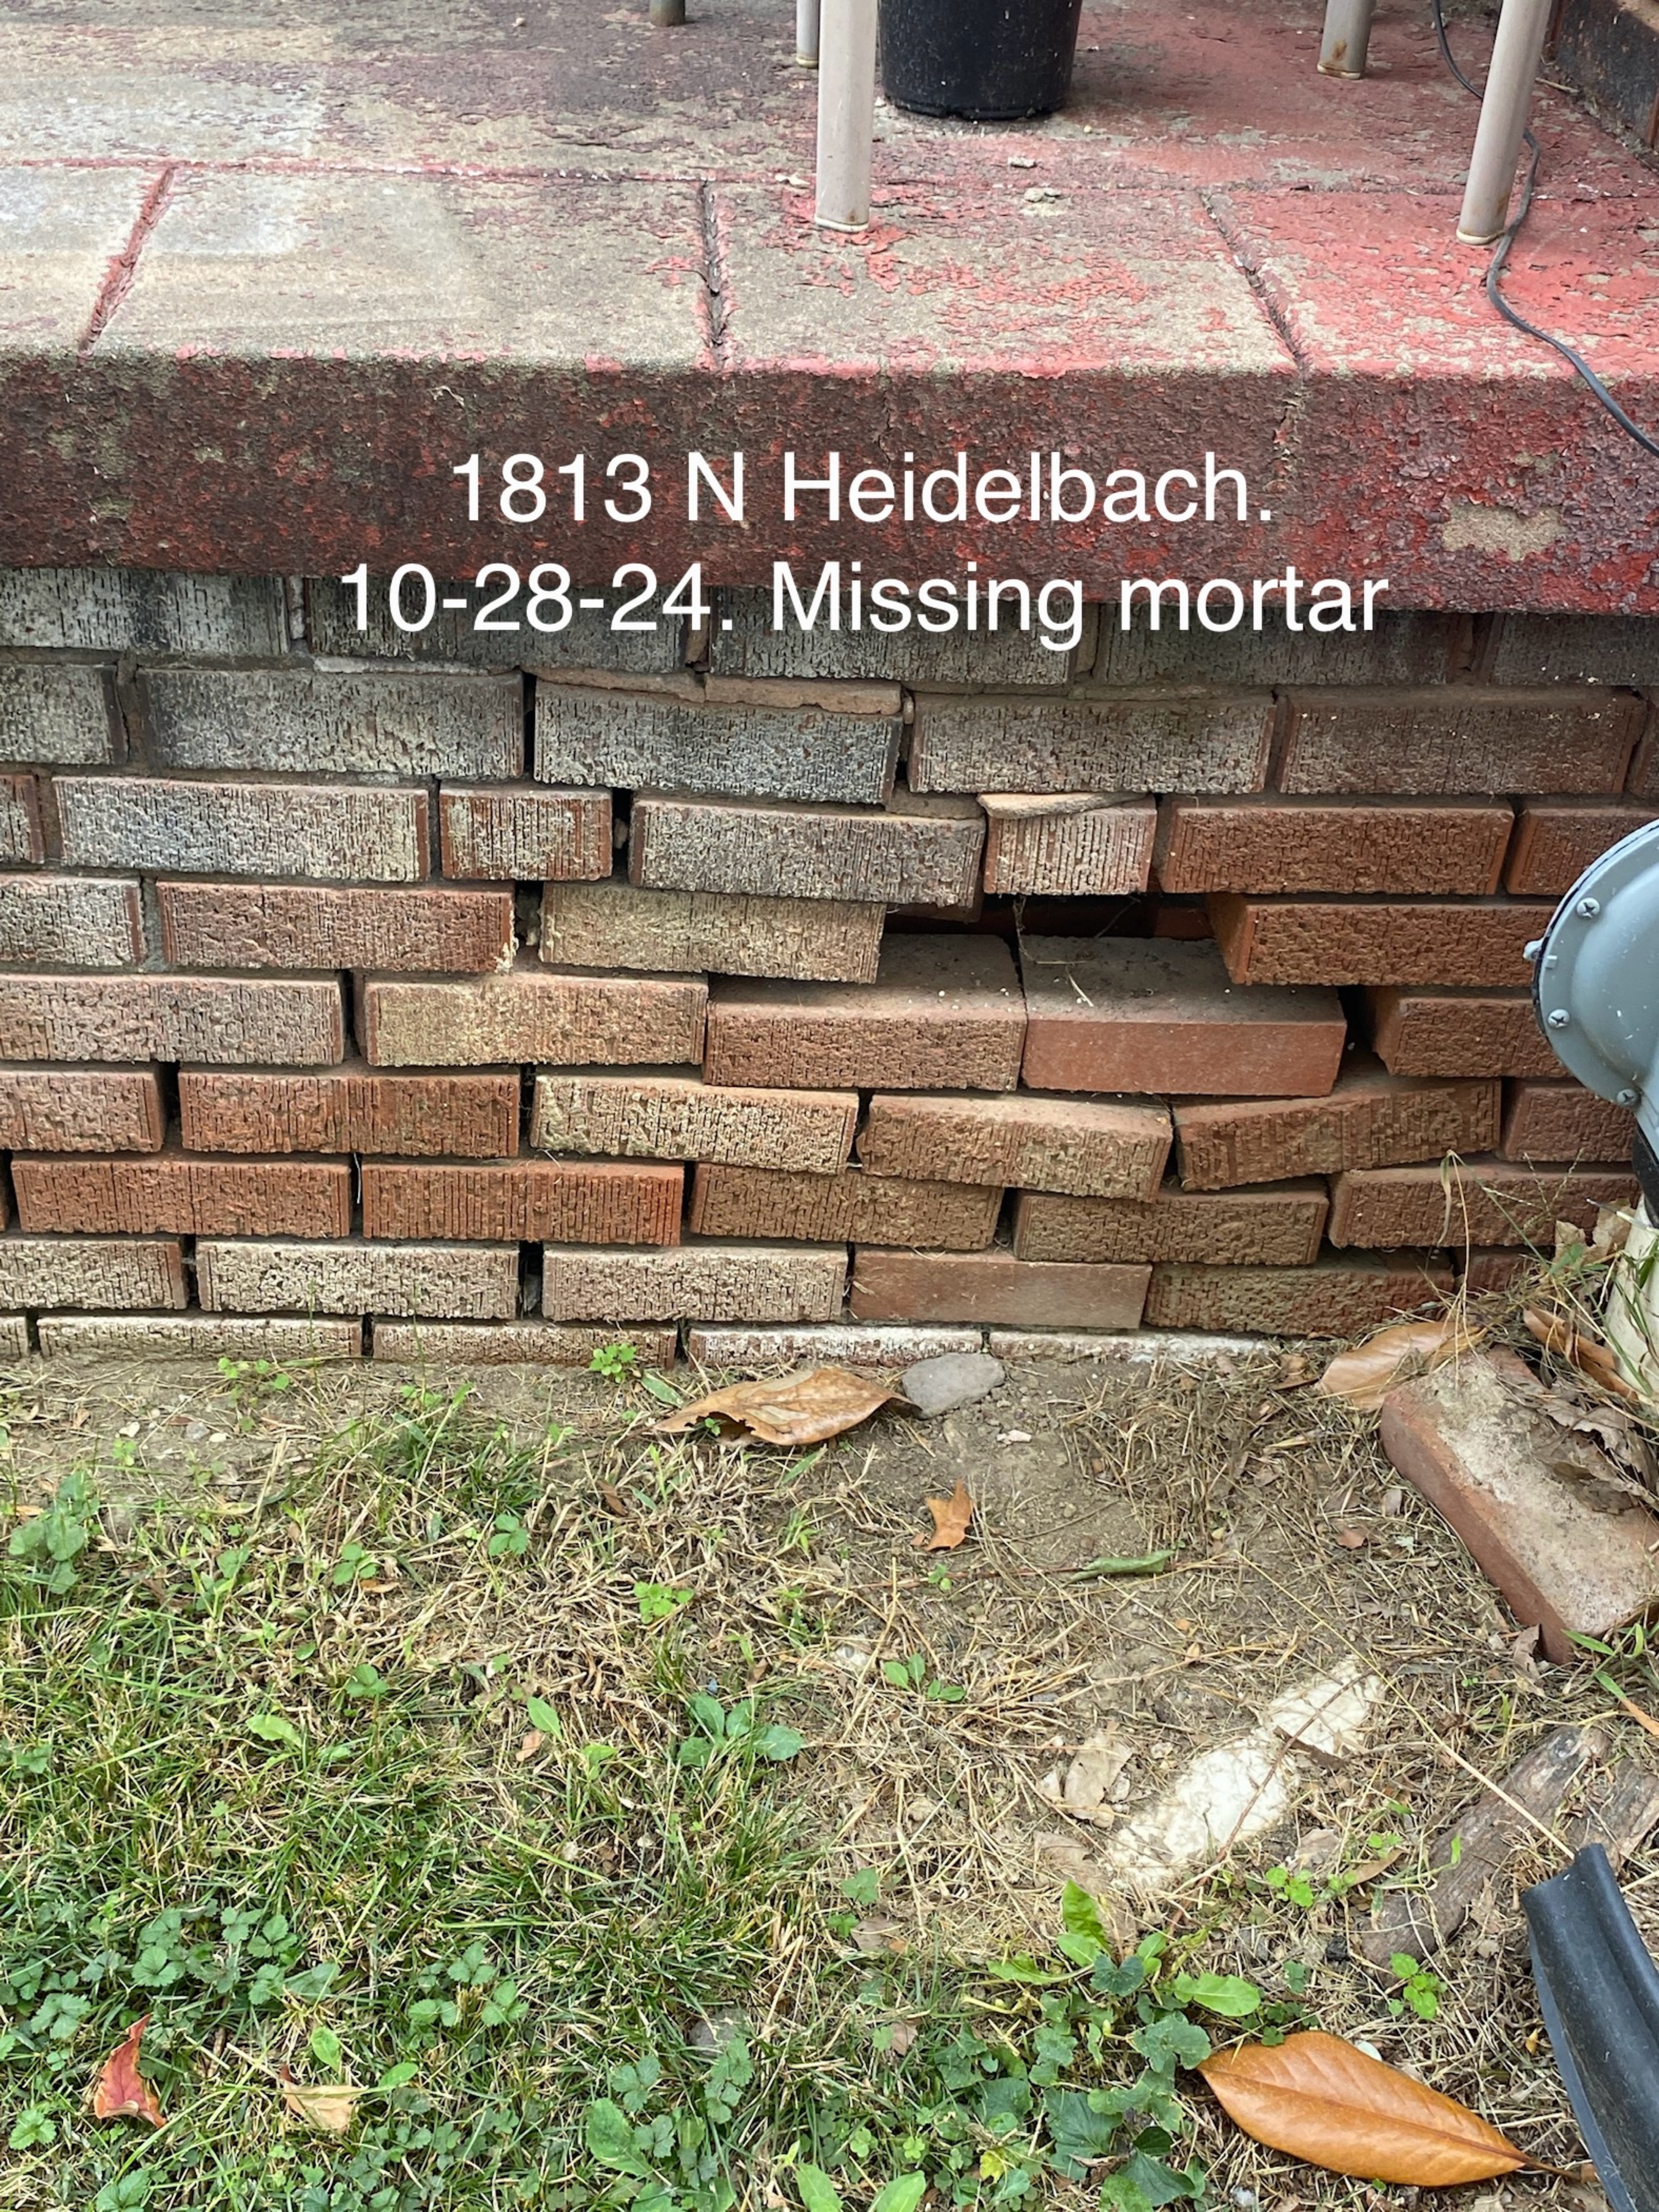
1813 N Heidelberg.
10-28-24. Missing mortar

A close-up photograph of a brick wall. The bricks are reddish-brown and arranged in a standard running bond pattern. There are several areas where the mortar is missing, particularly in the lower right section. A single brick has been dislodged and lies on the ground in the bottom left corner. The ground is a mix of concrete and dirt, with some small green weeds growing. The text "Missing mortar. 10-28-24. 1813 N Heidelberg." is overlaid in white on the lower half of the image.

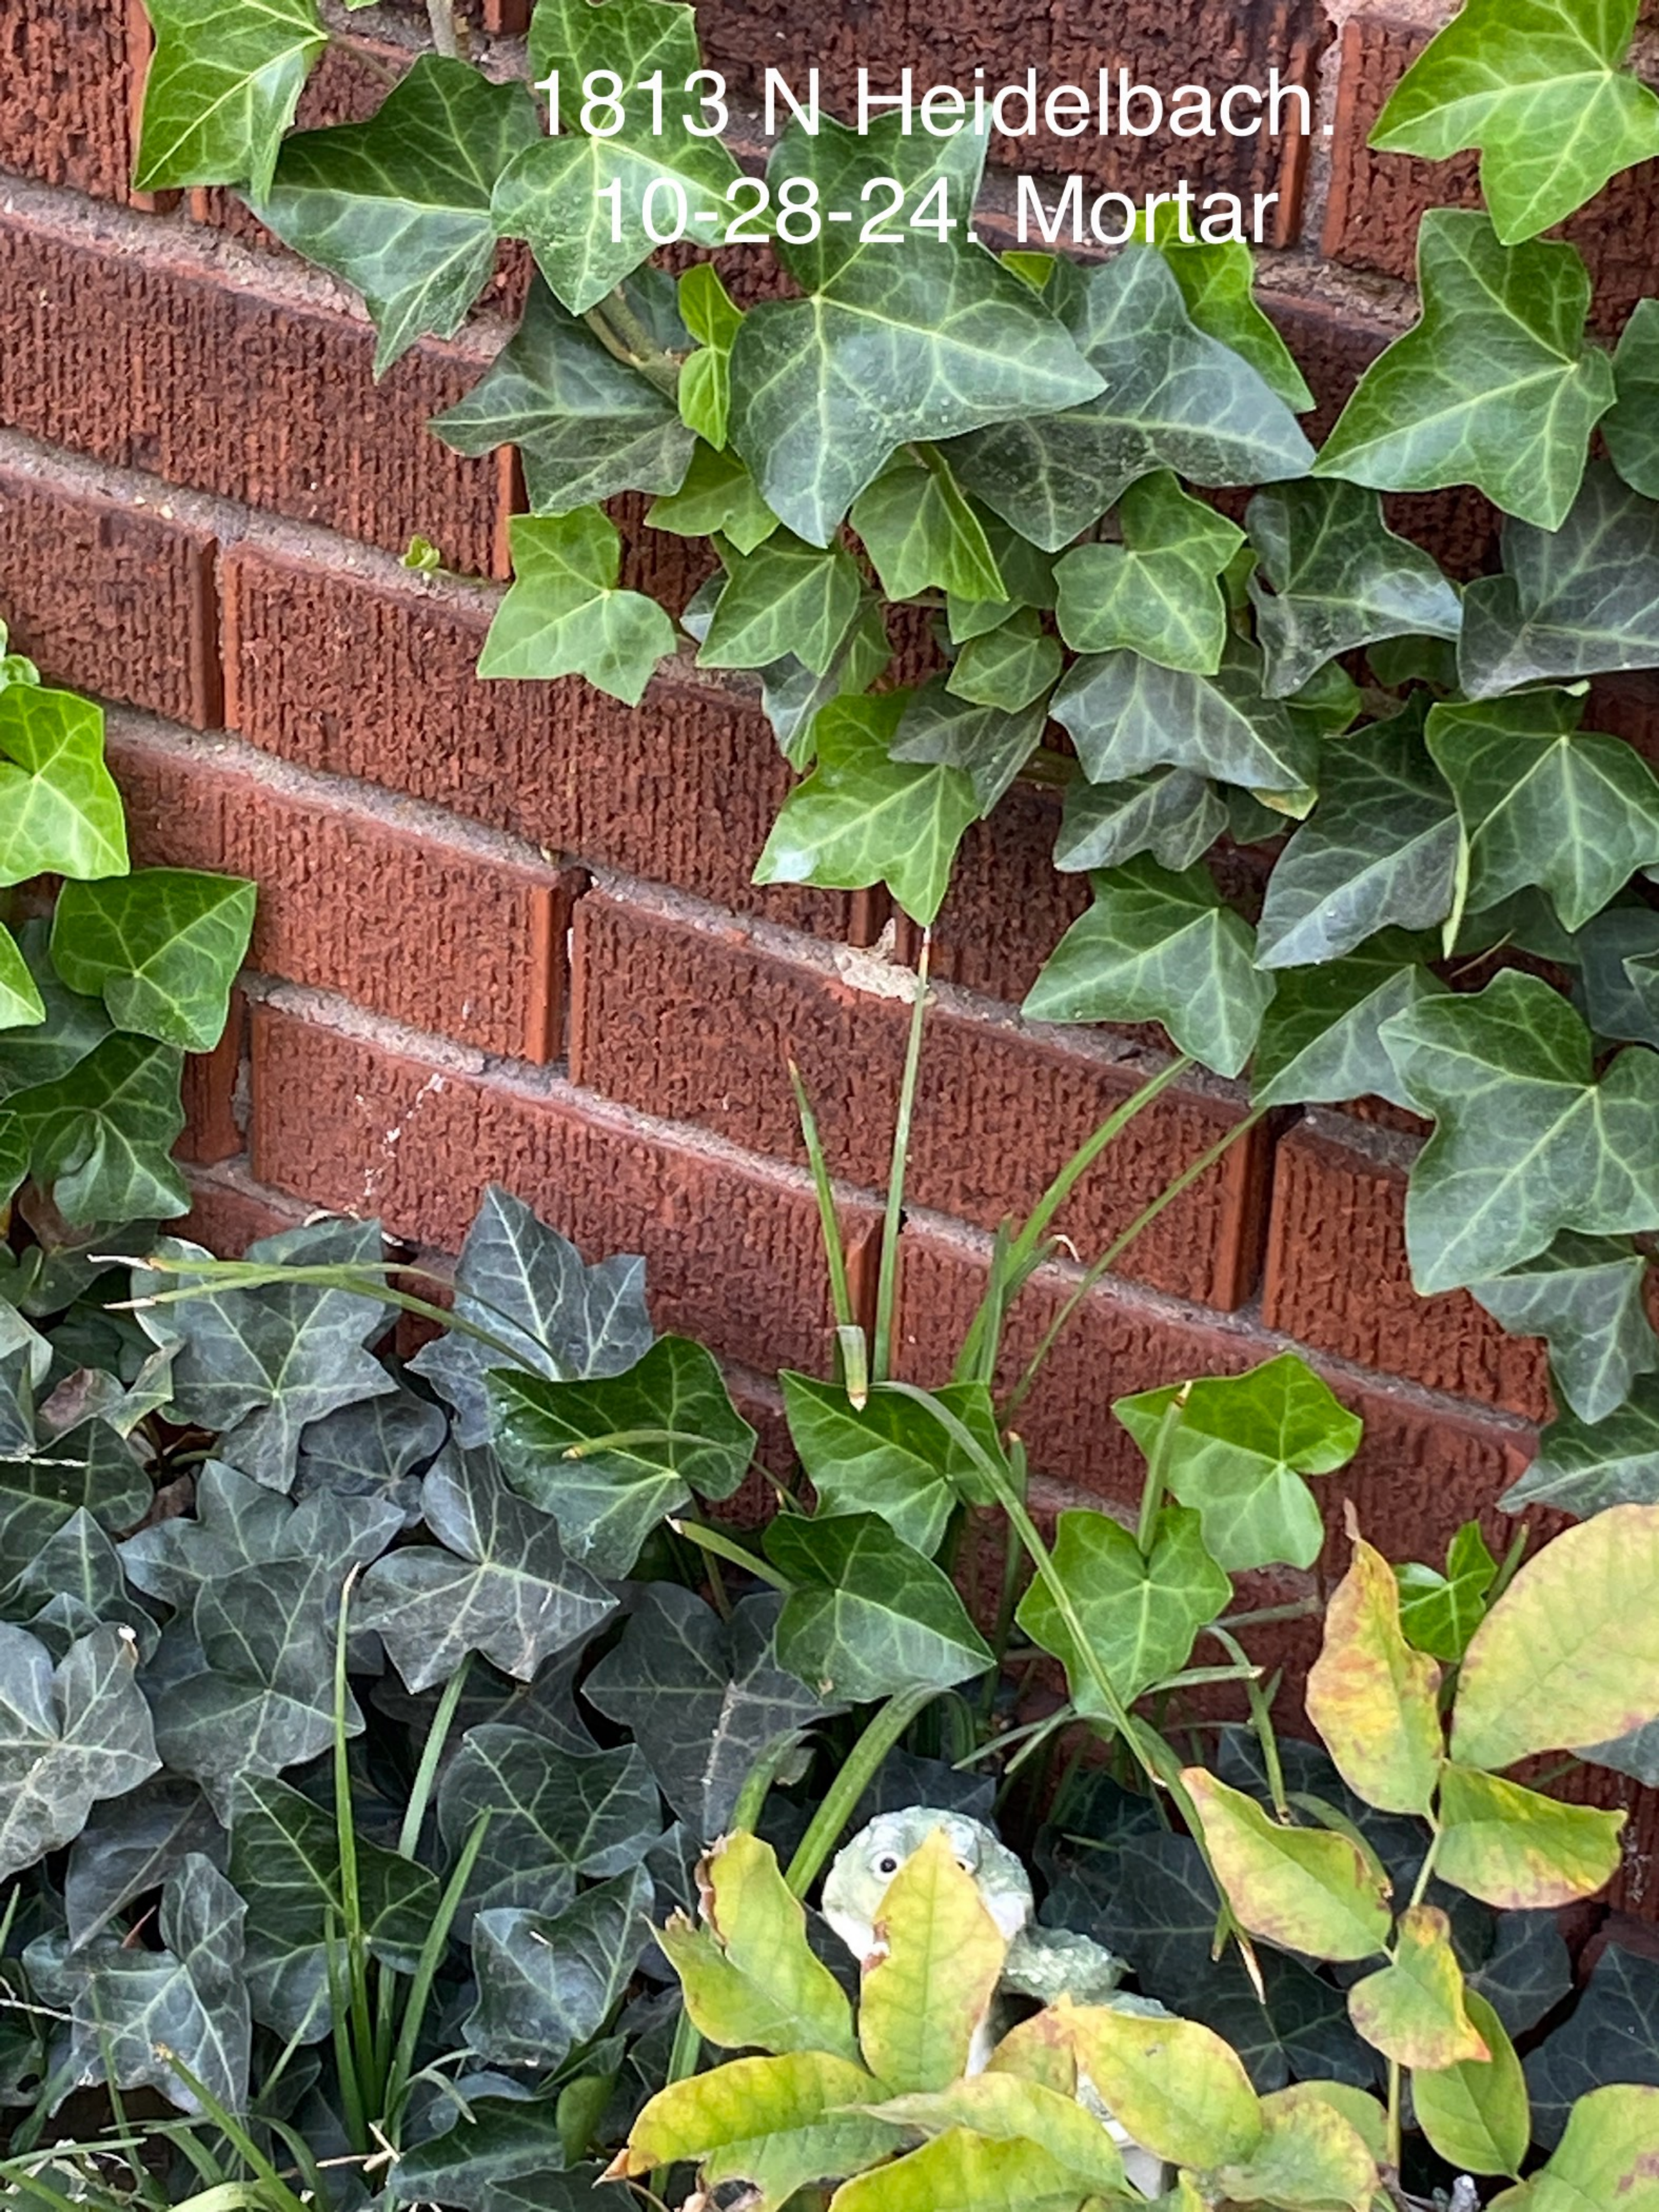
1813 N Heidelberg.
10-28-24. Mortar

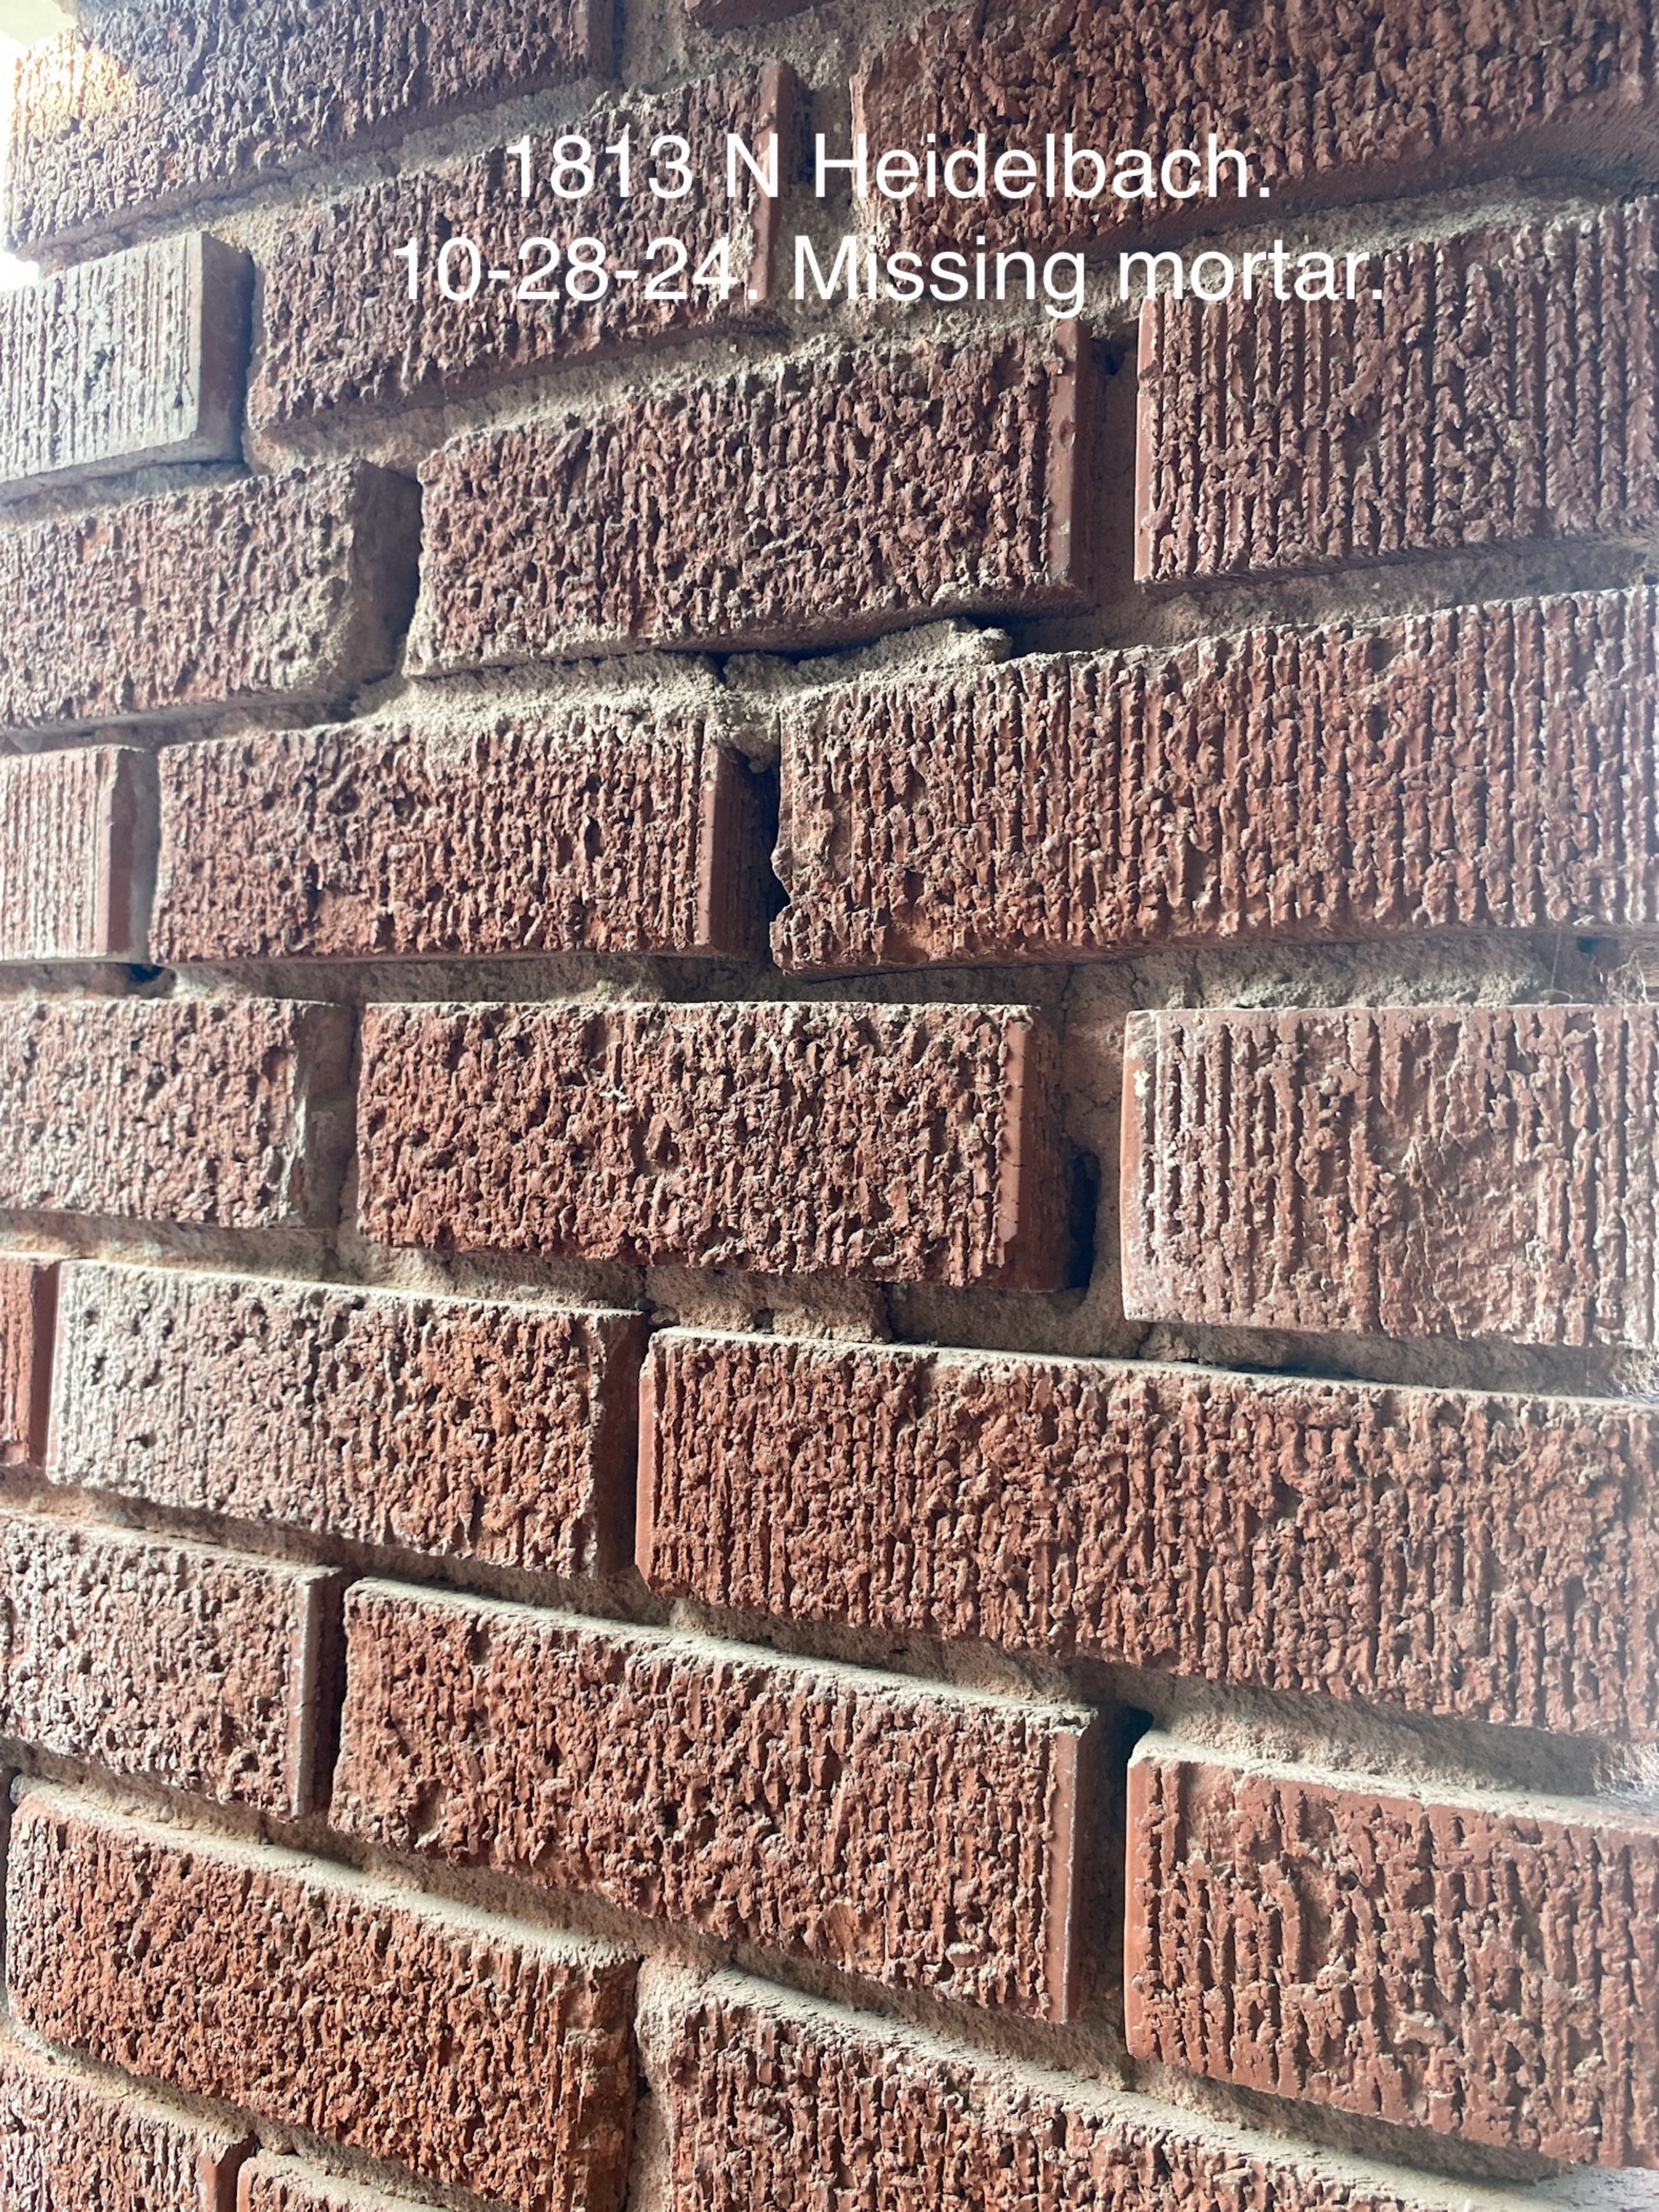
1813 N Heidelberg.
10-28-24. Missing mortar.

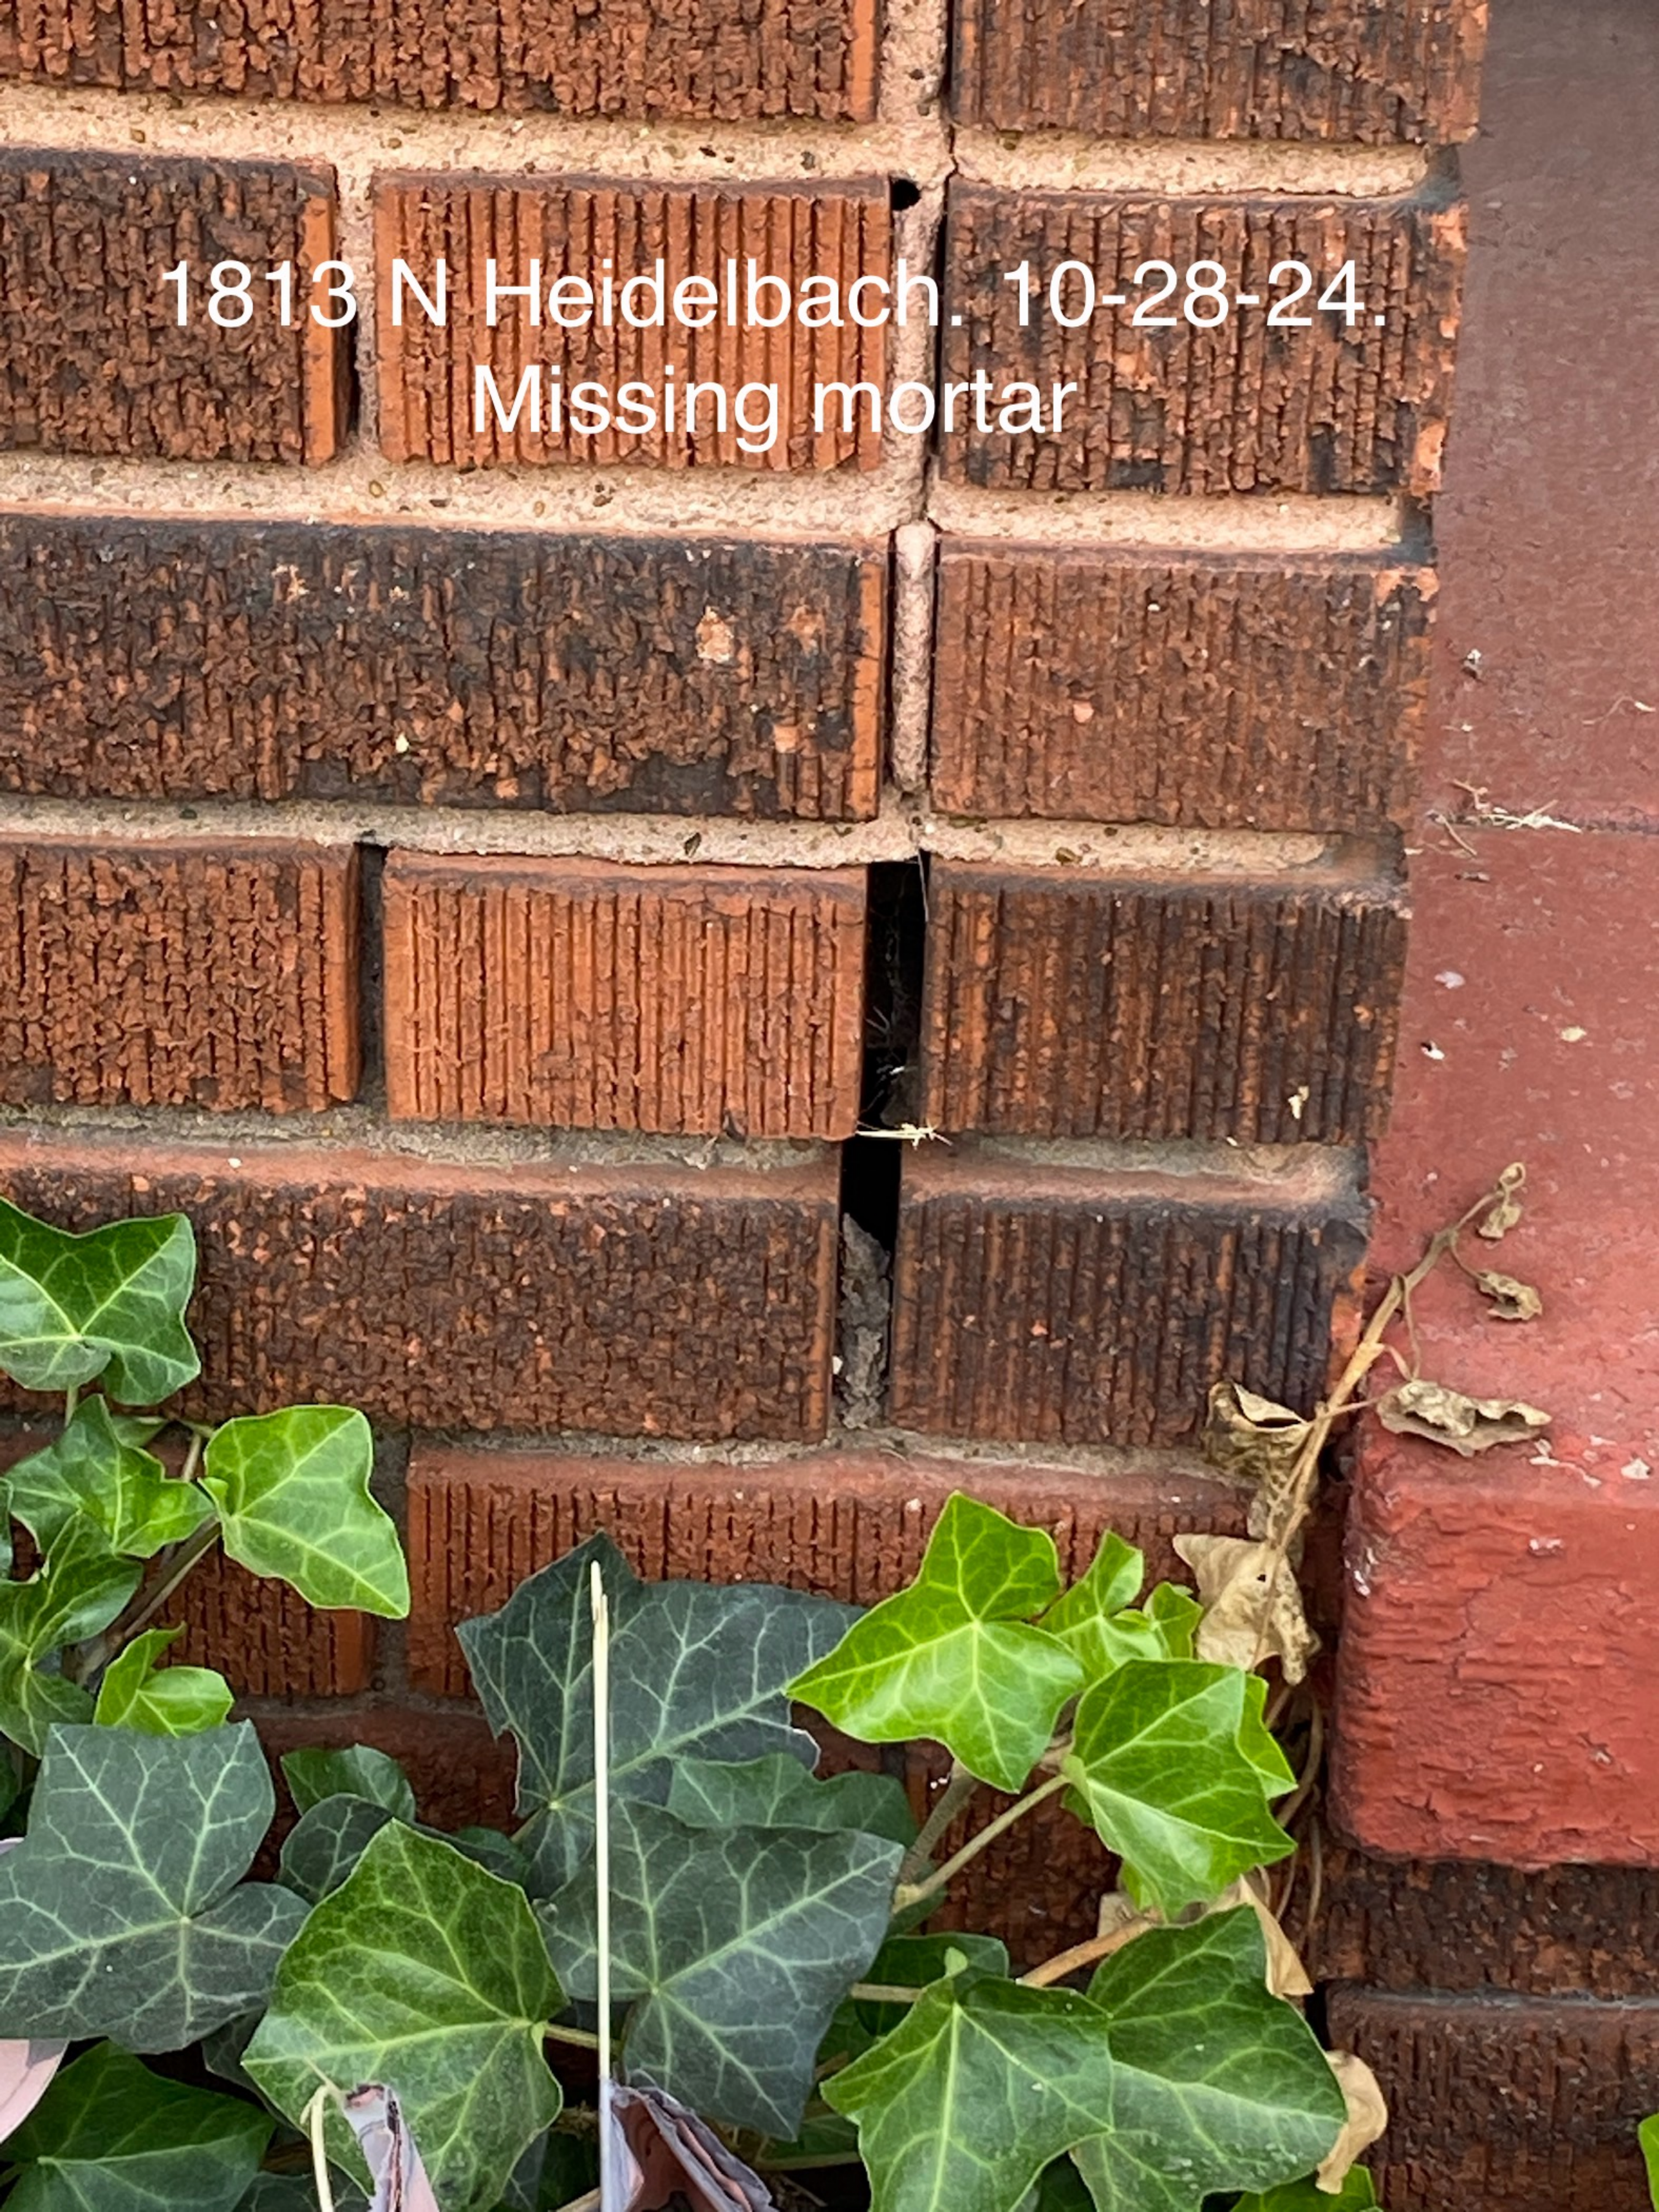
1813 N Heidelberg. 10-28-24.
Missing mortar

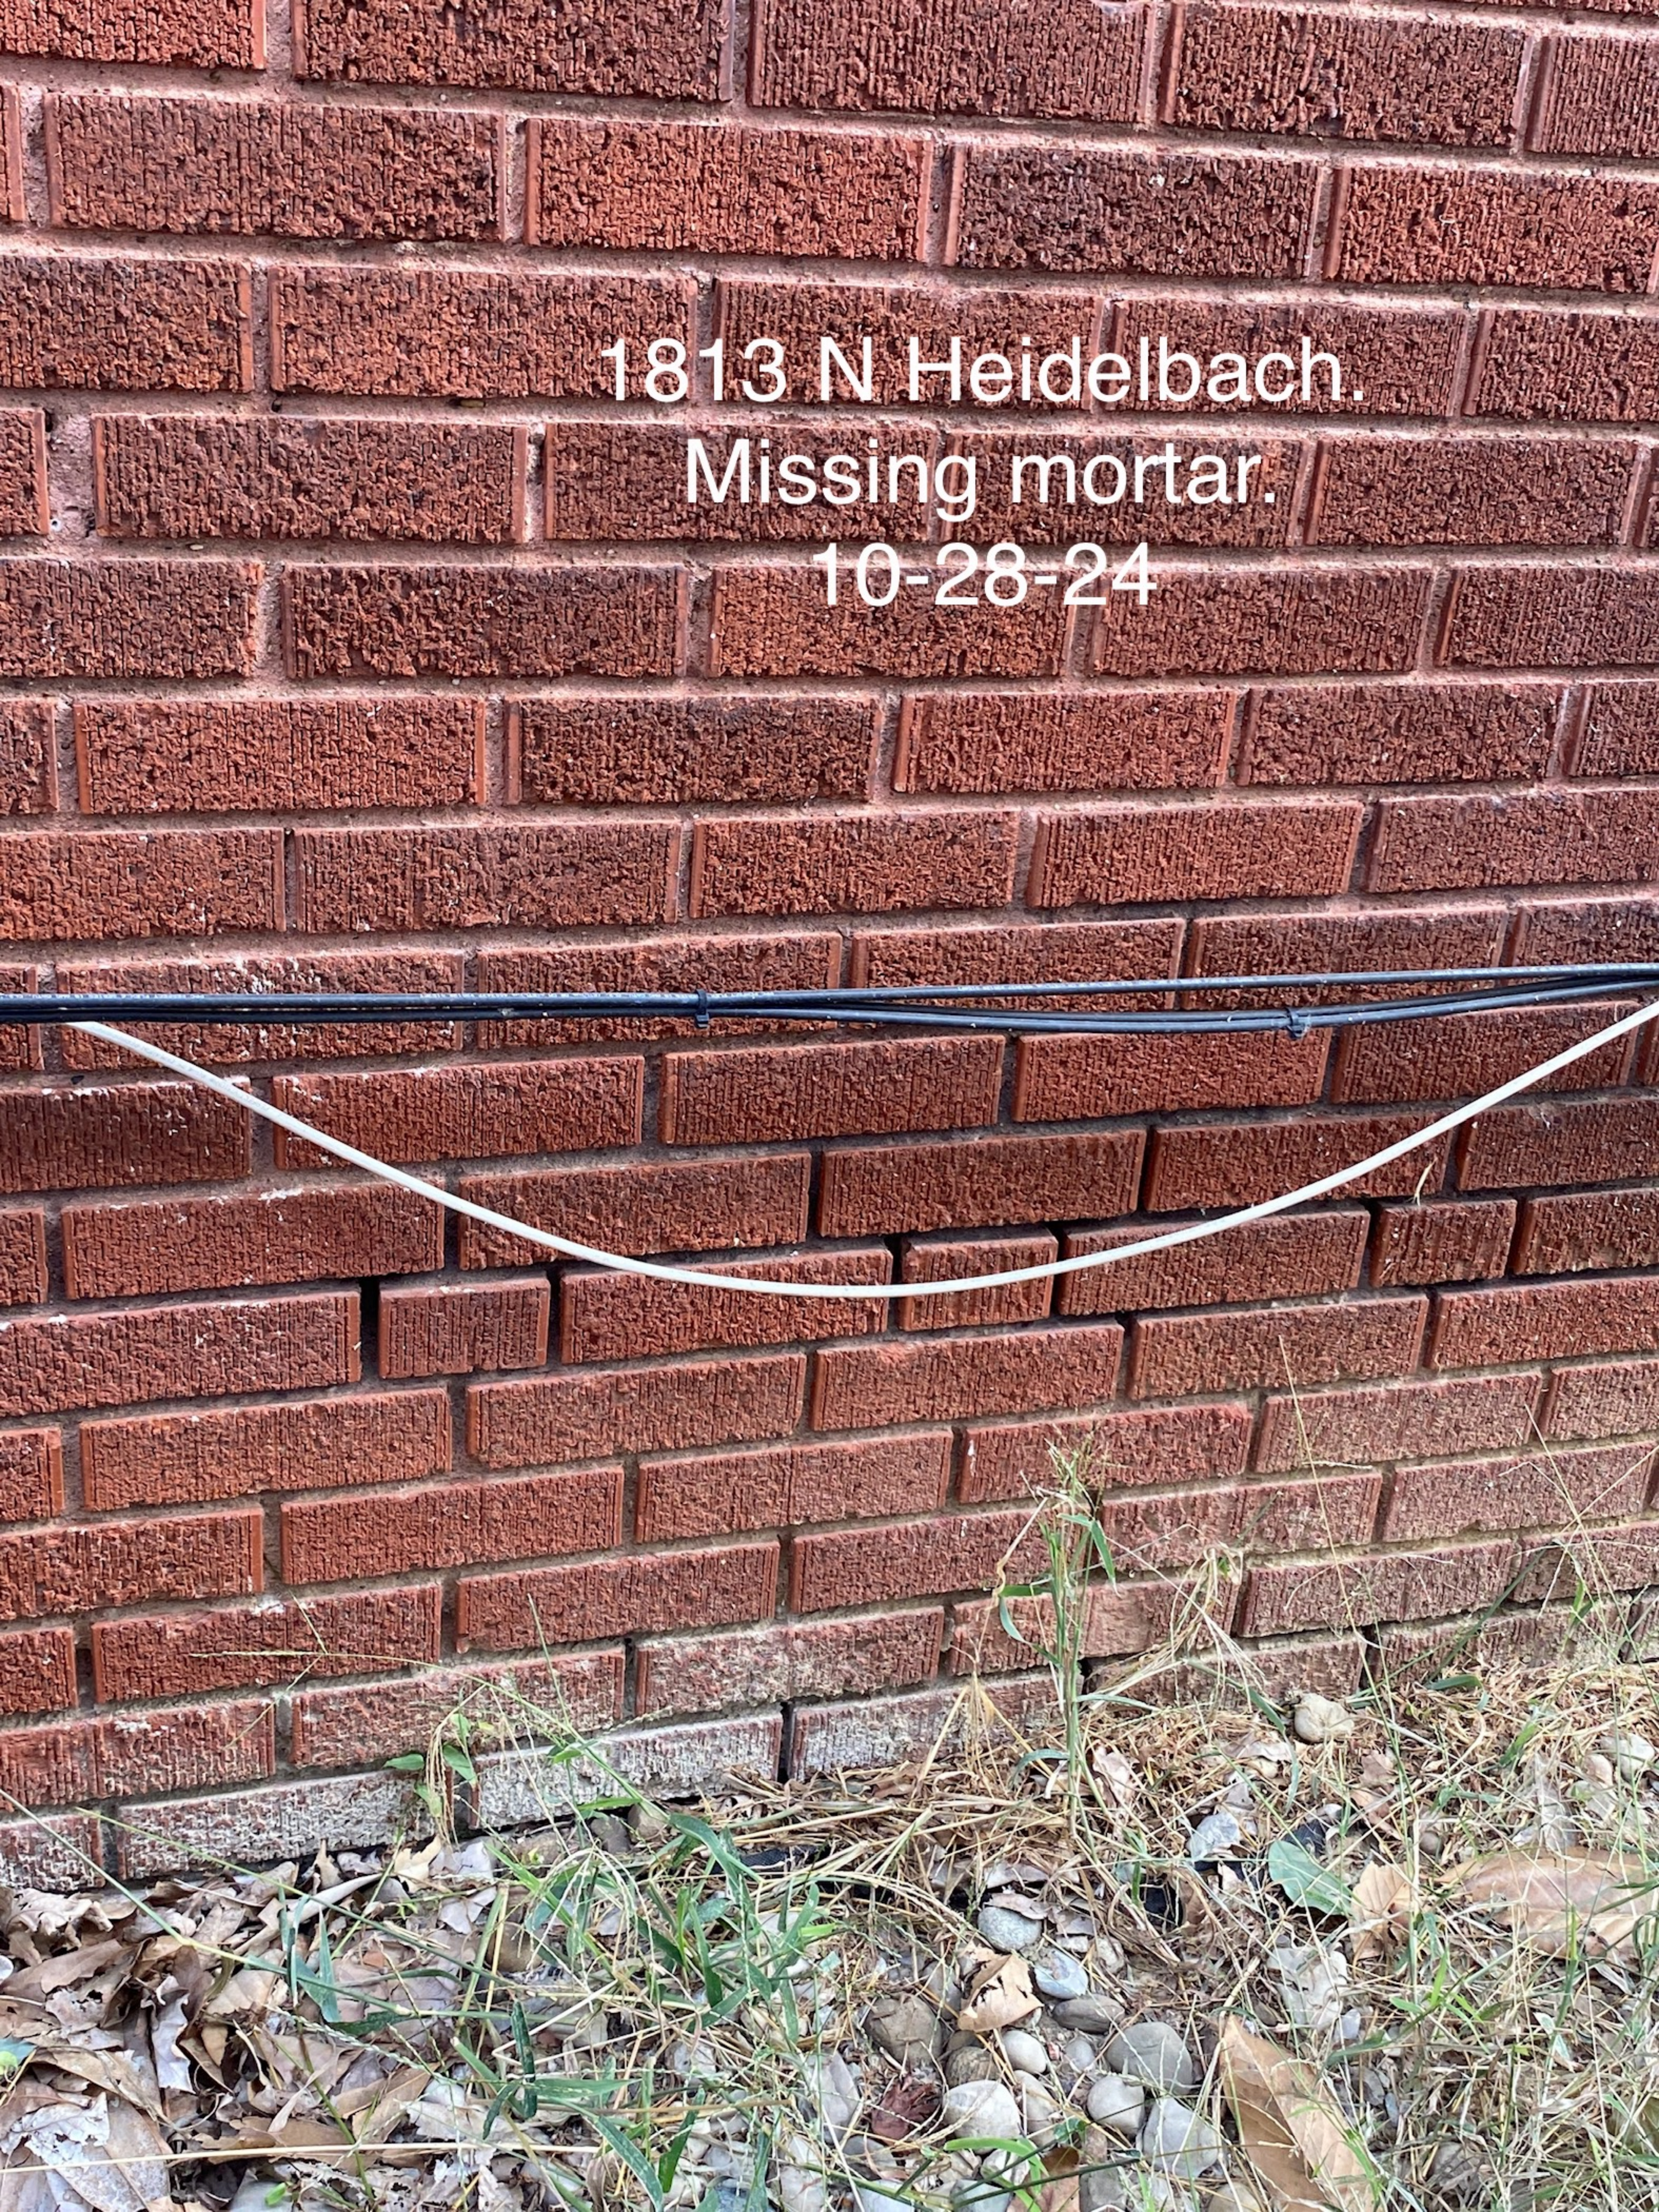
1813 N Heidelberg.
Missing mortar.
10-28-24
