1813 N Heidelberg

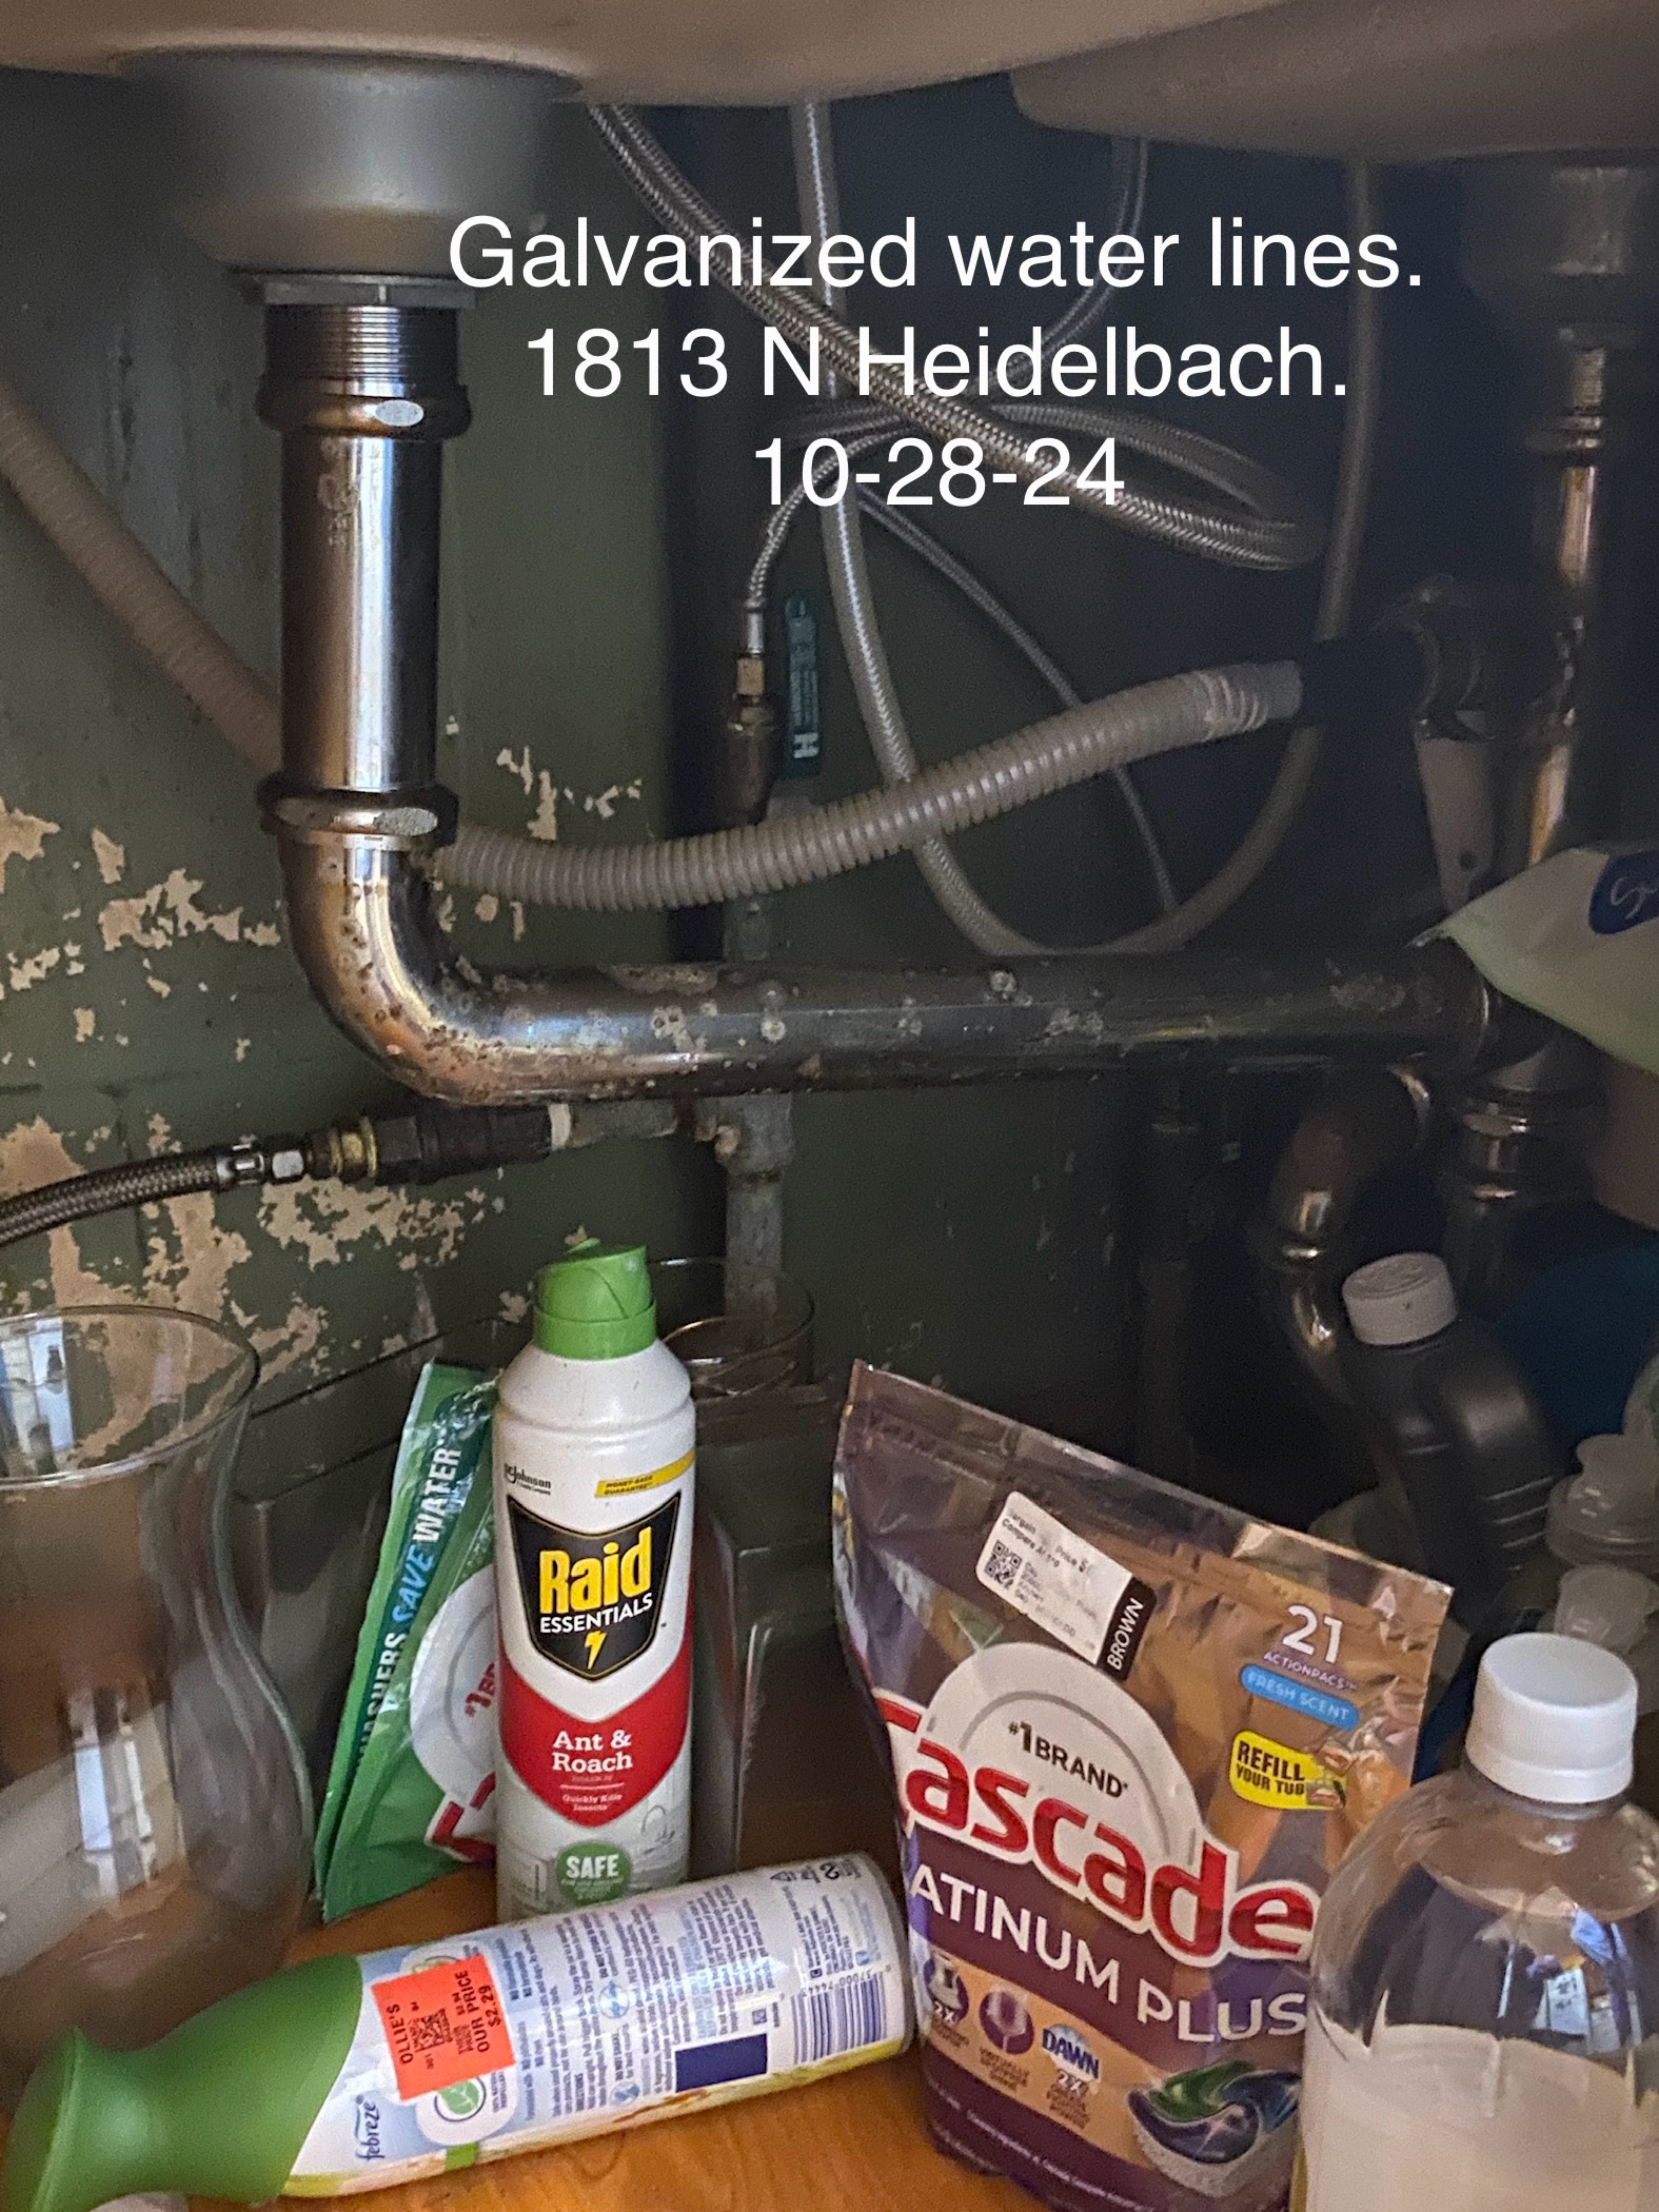
Galvanized water lines.
1813 N Heidelberg.
10-28-24

2. Replace all the accessible galvanized water lines in the home. The new water lines are to be PVC. The home, when complete, is to have adequate water pressure throughout and all fixtures work as they should. All new piping is to be secure and installed in a professional manner. Include all materials and labor needed to complete.

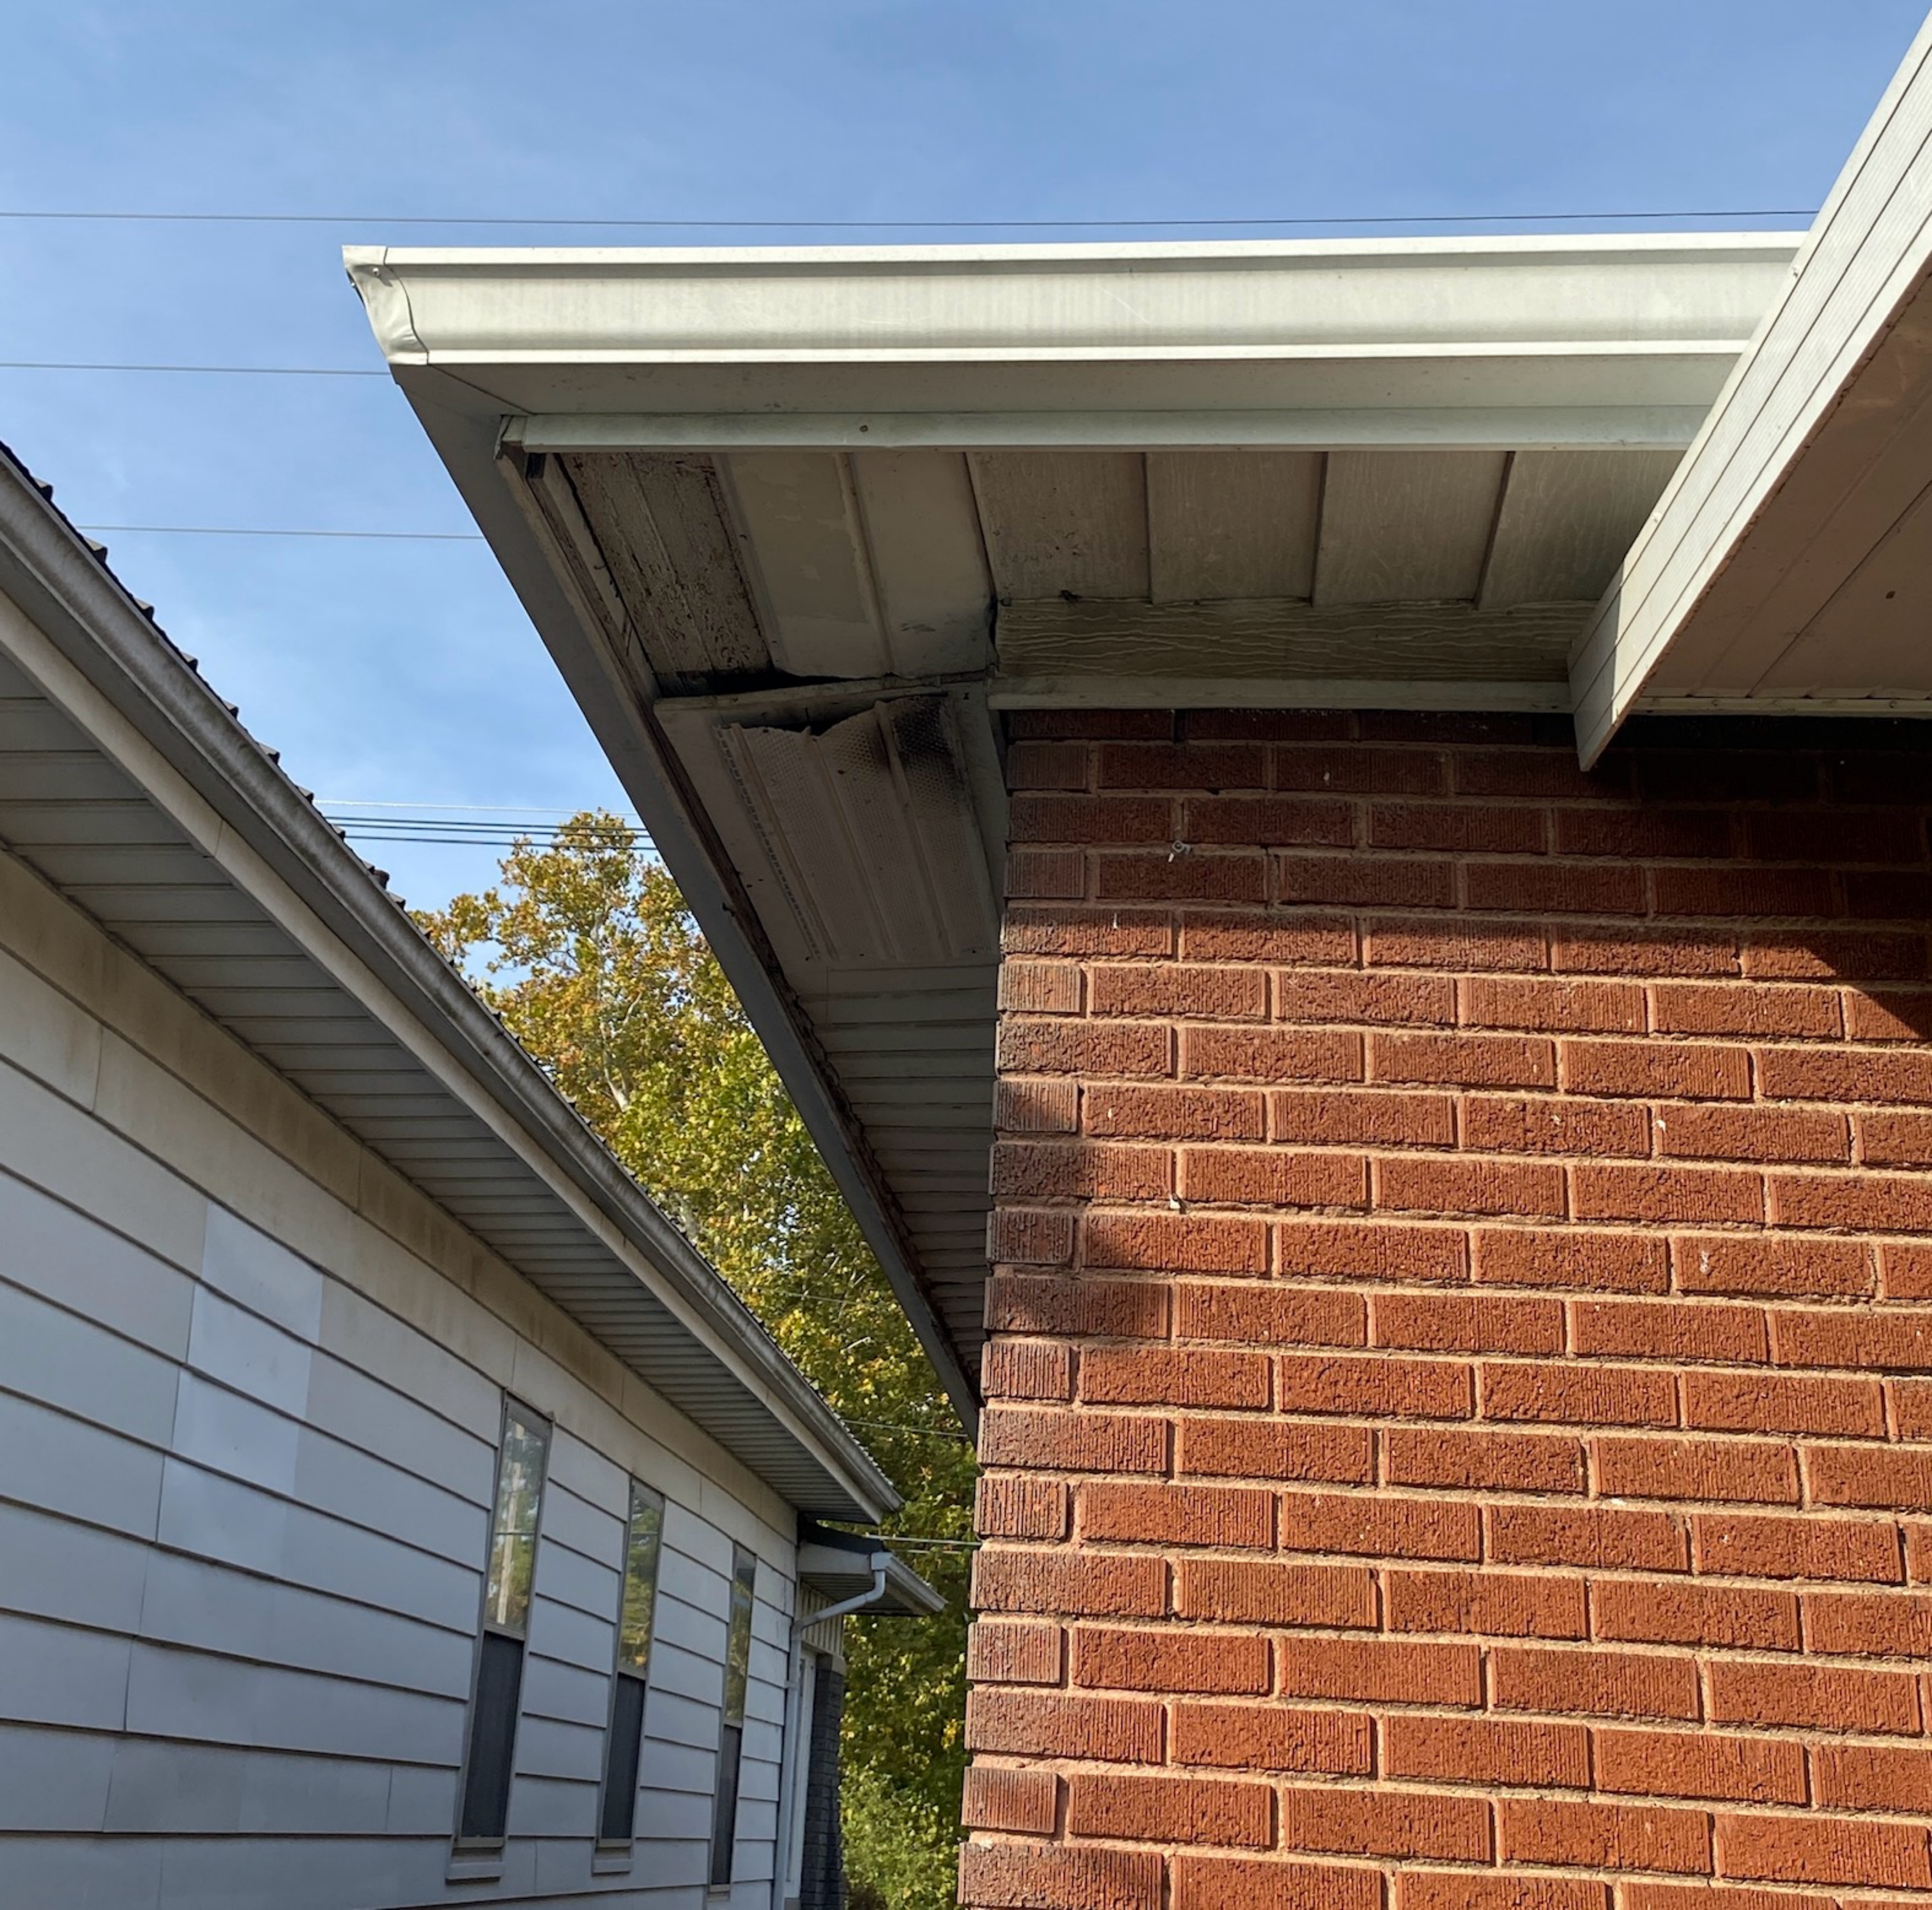
1813 N Heidelberg.
Damaged soffit.
10-28-24

3. Repair and/or replace the damaged or missing soffit on the rear corner of the home. The repairs are to be completed with the same materials as the existing soffits around the home. All repairs are to be completed in neat fashion and eliminate the possibility of animal intrusion. Include all materials & labor to complete.

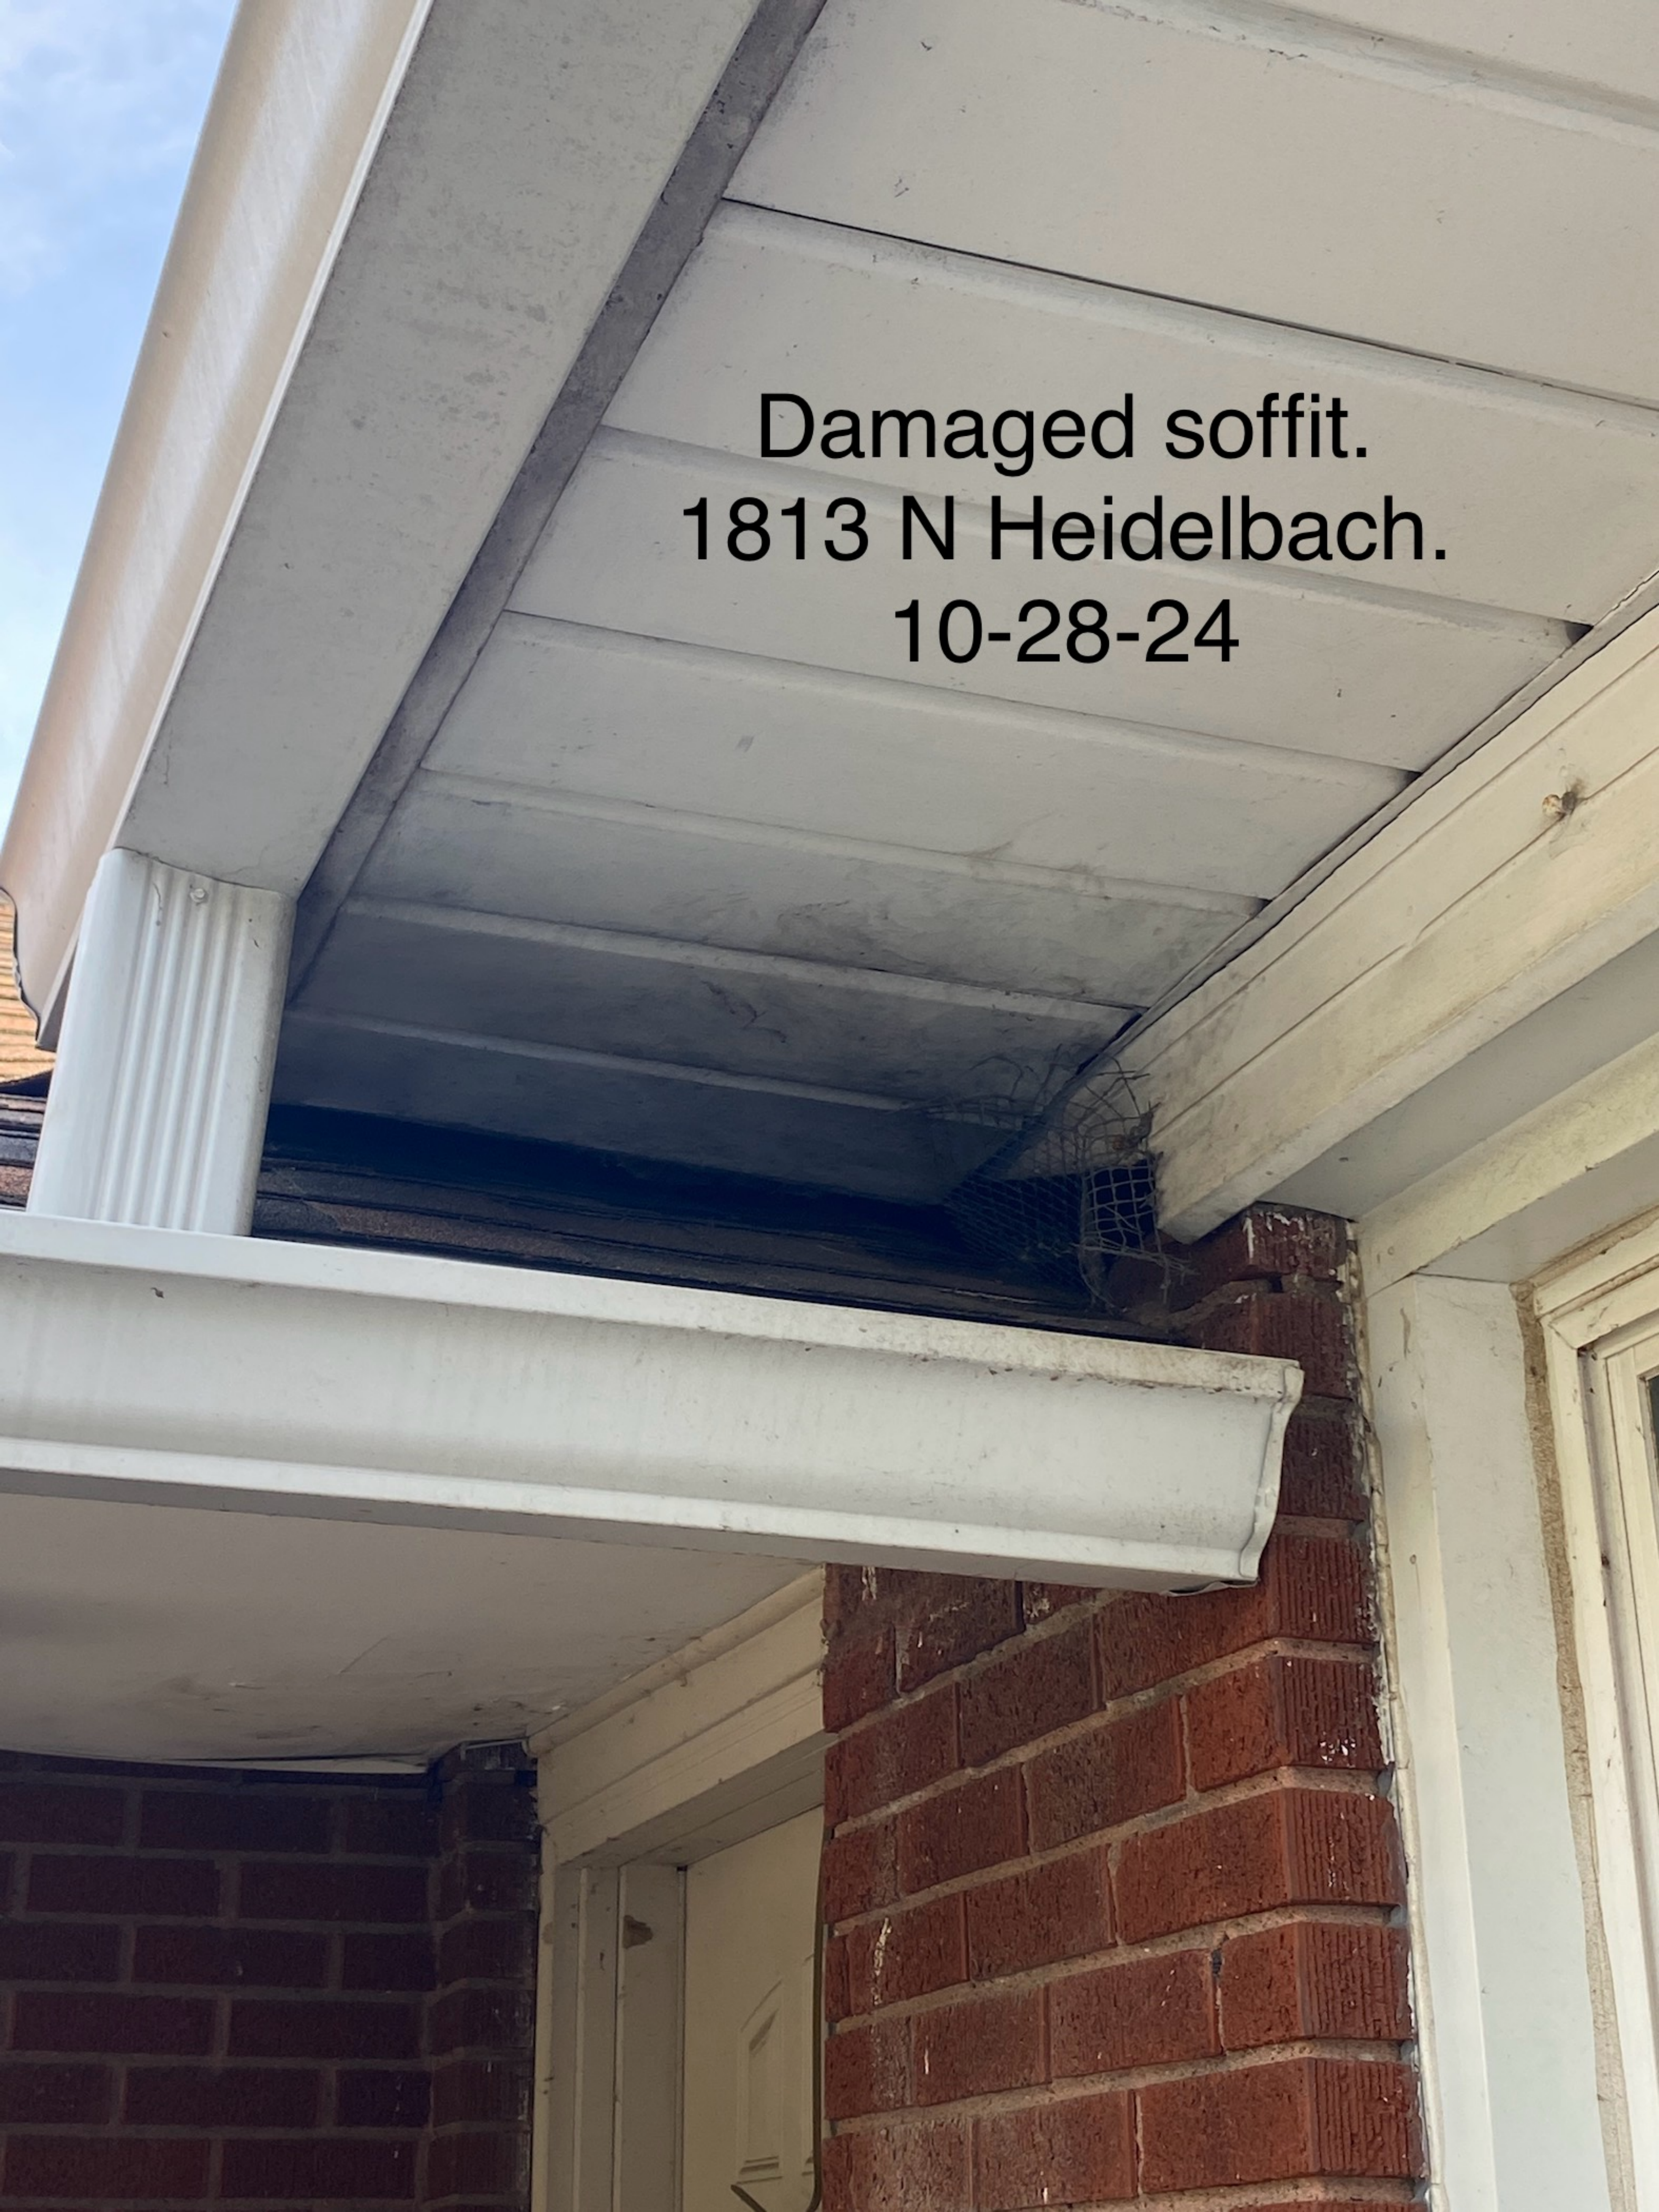
Damaged soffit.
1813 N Heidelberg.
10-28-24

4. Repair the soffit area to the right of the front door and over the porch roof. The repair is to be completed with proper bracing and boxed in with solid white aluminum to keep animals from entering attic area of the home. Repairs are to be secure and functional when complete.
