# **Pigeon Creek Channel Review**

**Warrick County, Heim Road to  
Vanderburgh County, Green River Road**

**Indiana Department of Natural Resources**

October, 2000

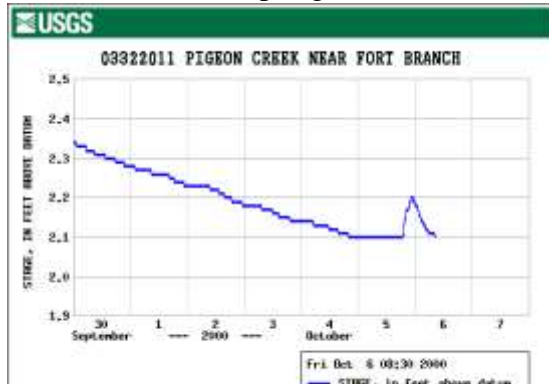
Figure 3, USGS Stream Gage Upstream of Site  
The graph indicates the decline in the stage at a gage several miles upstream from the area of concern.

week (figure 3). The stream was at approximately 30 to 40 percent of bank full stage with 3 to 5 feet of water in the channel and a level 4 to 7 feet below bank full.

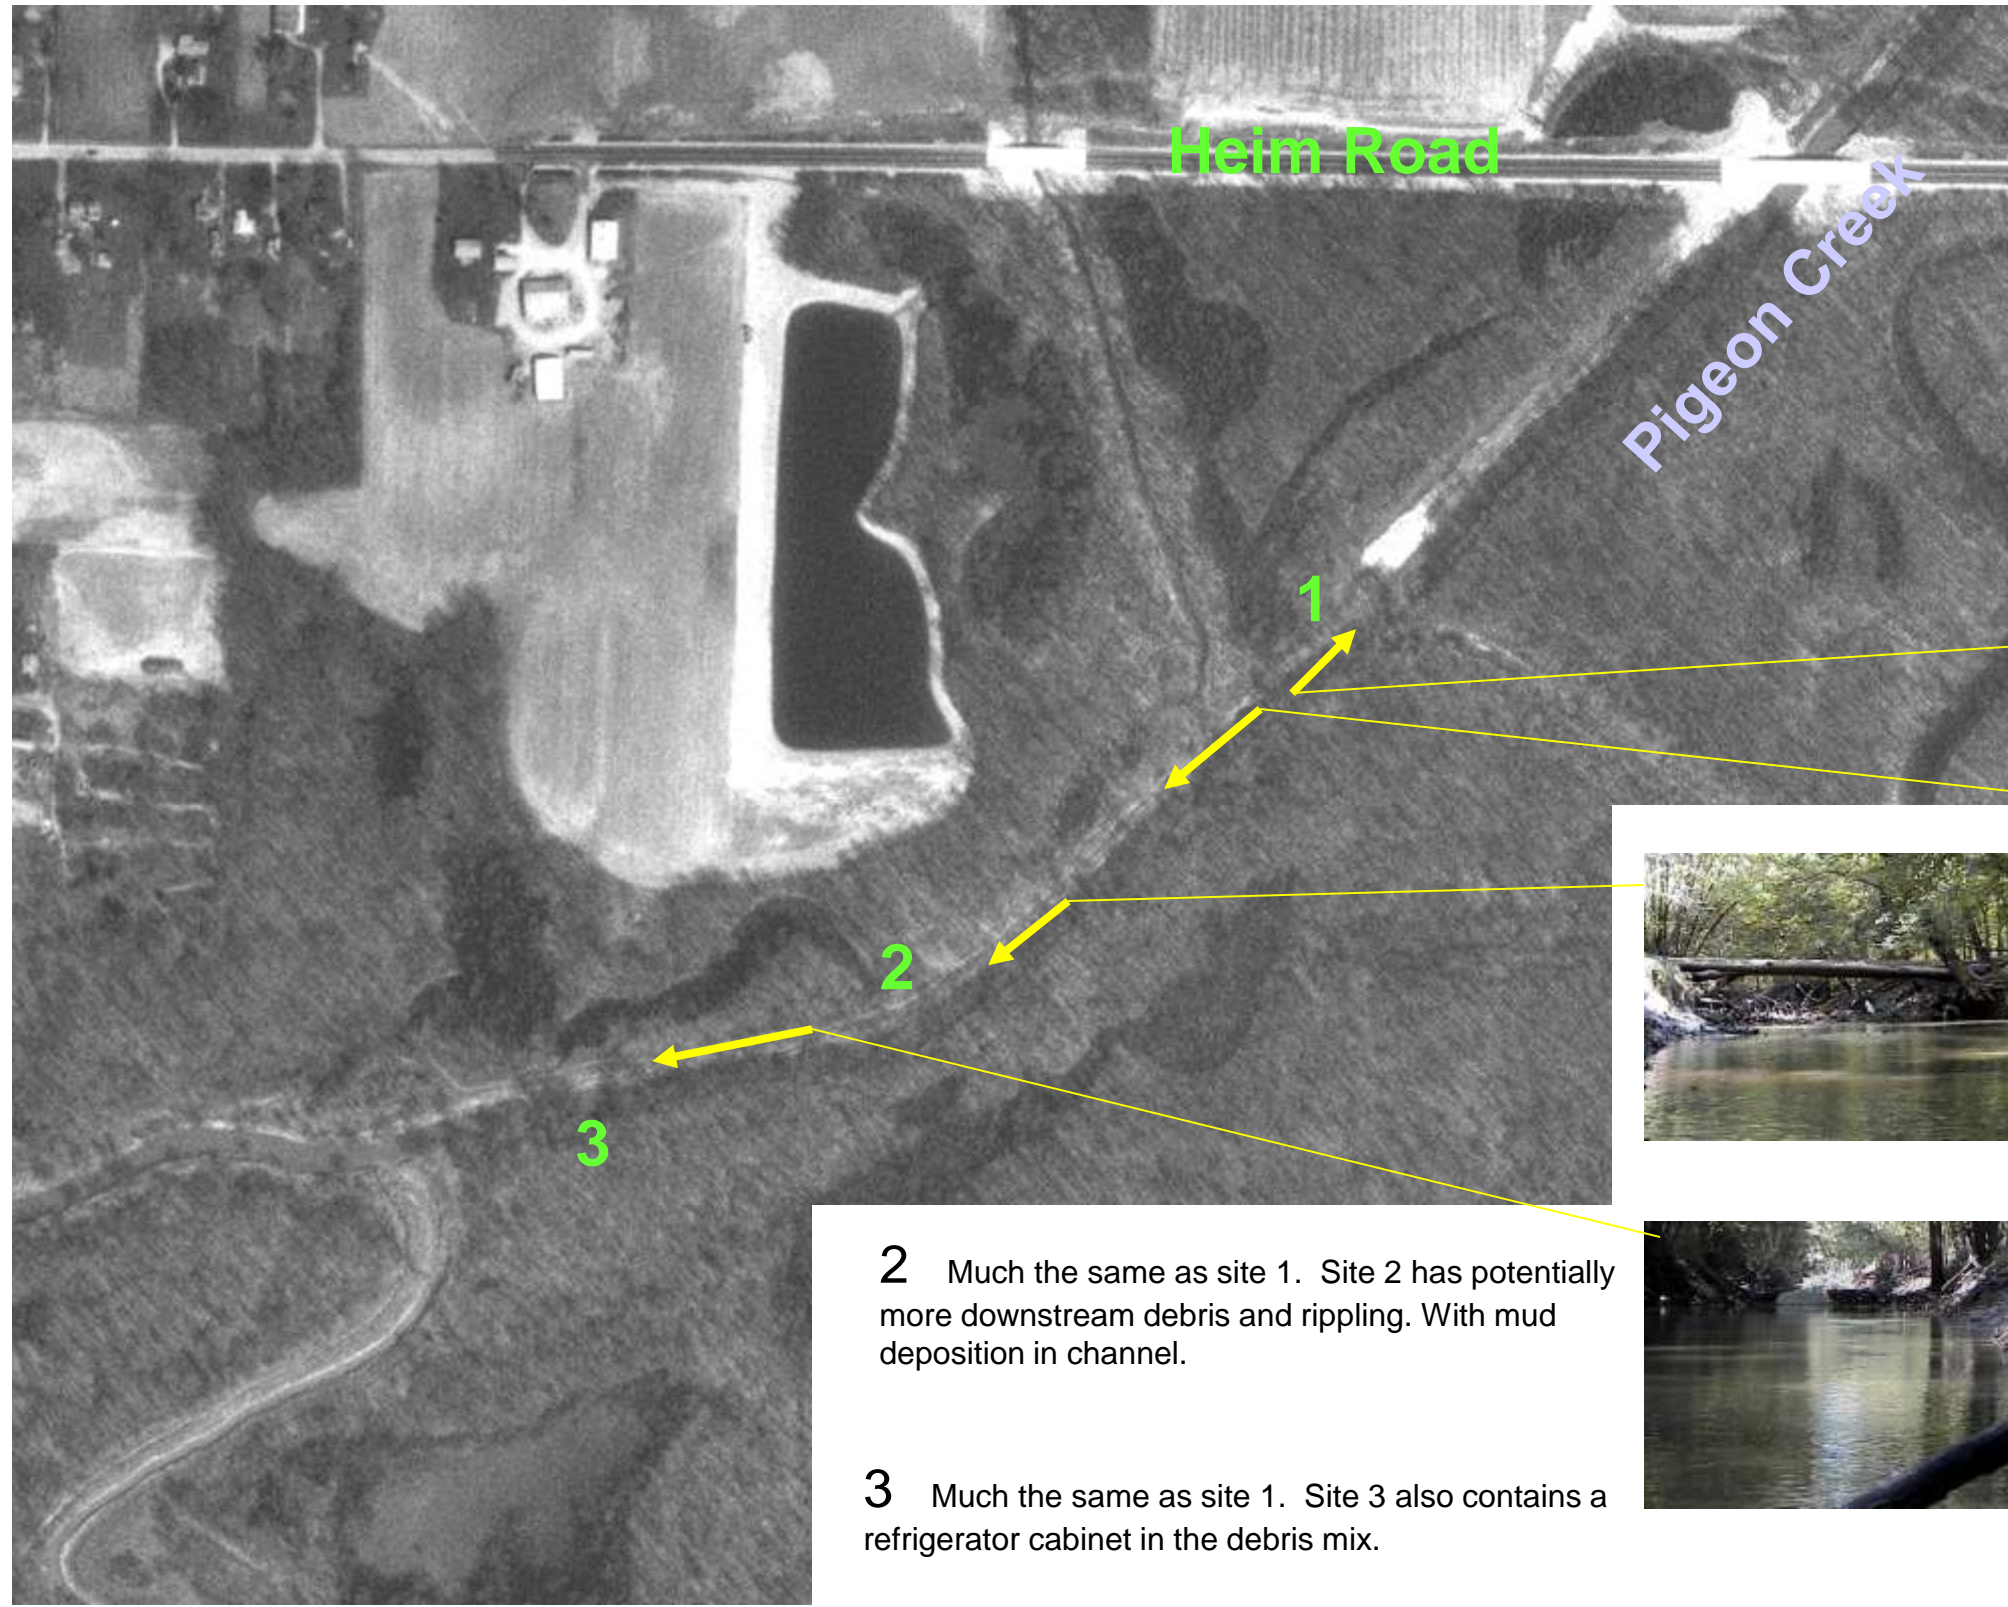
This site is located approximately ¼ mile downstream of the Heim Road bridge. A significant logjam was found at this location. The material consisted of smaller structural logs with a considerable amount of smaller debris. The site was less than 15 feet thick parallel to flow. Stream flow appeared to be passing through the material with little resistance. No significant bank erosion was observed. Some downstream debris was found associated with the site. Removal and reorientation of the debris is recommended for this site.

**1** Site 1 consists of a cross channel log jam containing several logs, brush and debris. No associated erosion was observed. Water was moving effectively through or under the pile and the pile was only 1 to 3 feet above water level in a channel 4 to 5 feet above water level. The water depth exceeded 4 feet. Heim Road bridge was observed from the log jam. Crossed by dragging the canoe over the log jam.

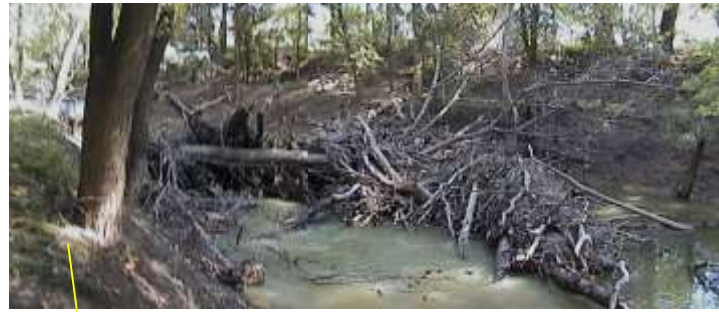
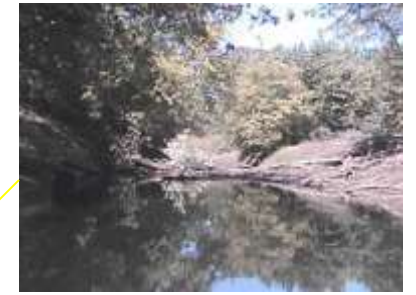
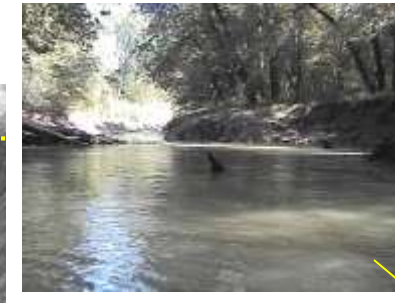
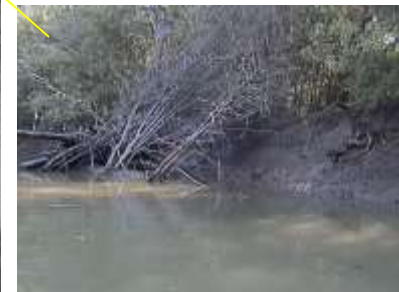
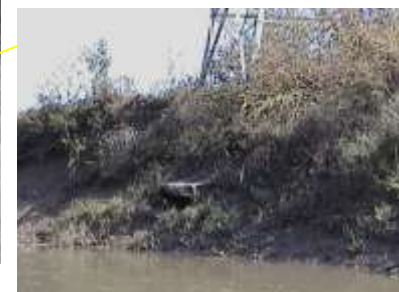
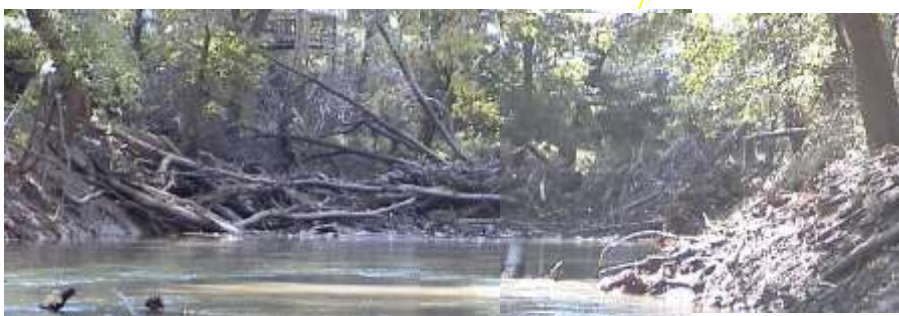
- Site 6 has a bank failure on the left, cut bank side.
- Site 7 has some bank erosion associated with logs in channel.
- Site 8 is a minor log jam that is blocking the channel but not flow.
- Site 9 is much like 8 with more brush associated with the log jam.

- Site 10 is an area 100 to 200 feet long with extensive logs and brush. Some bank erosion is associated with the site.
- Site 11 contains an extensive log jam. Flow is partially blocked with the channel fully blocked to boating.

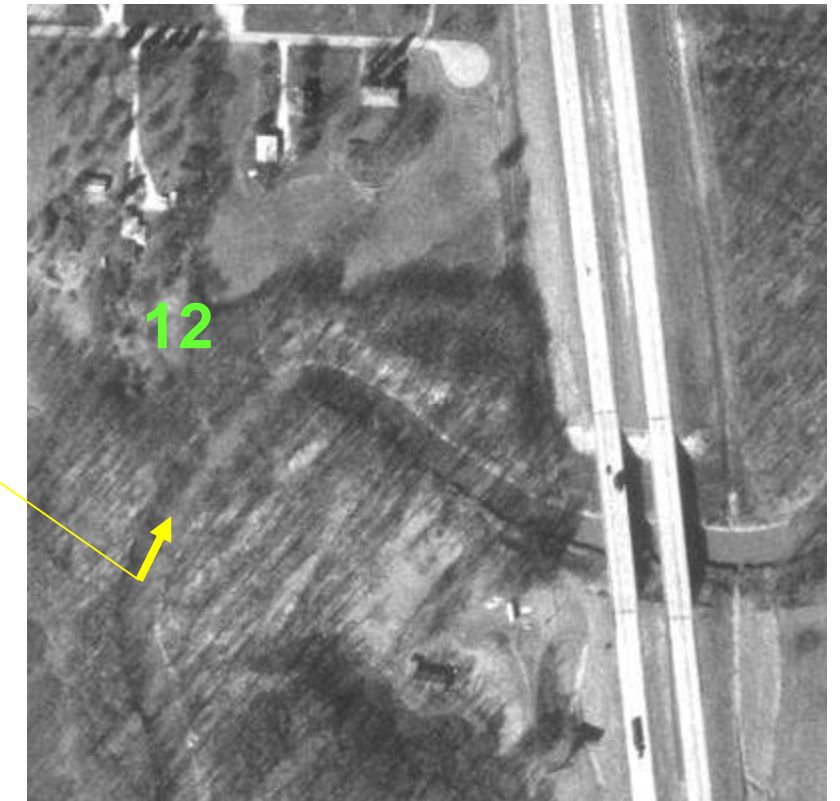
NE 1/4 of the NE 1/4 of Section 1, T. 6 S., R. 10 W.

Site 12 contains extensive brush and logs along the right, cut bank. One tree lies across channel just downstream of the site.
