3020 Lake Dr.

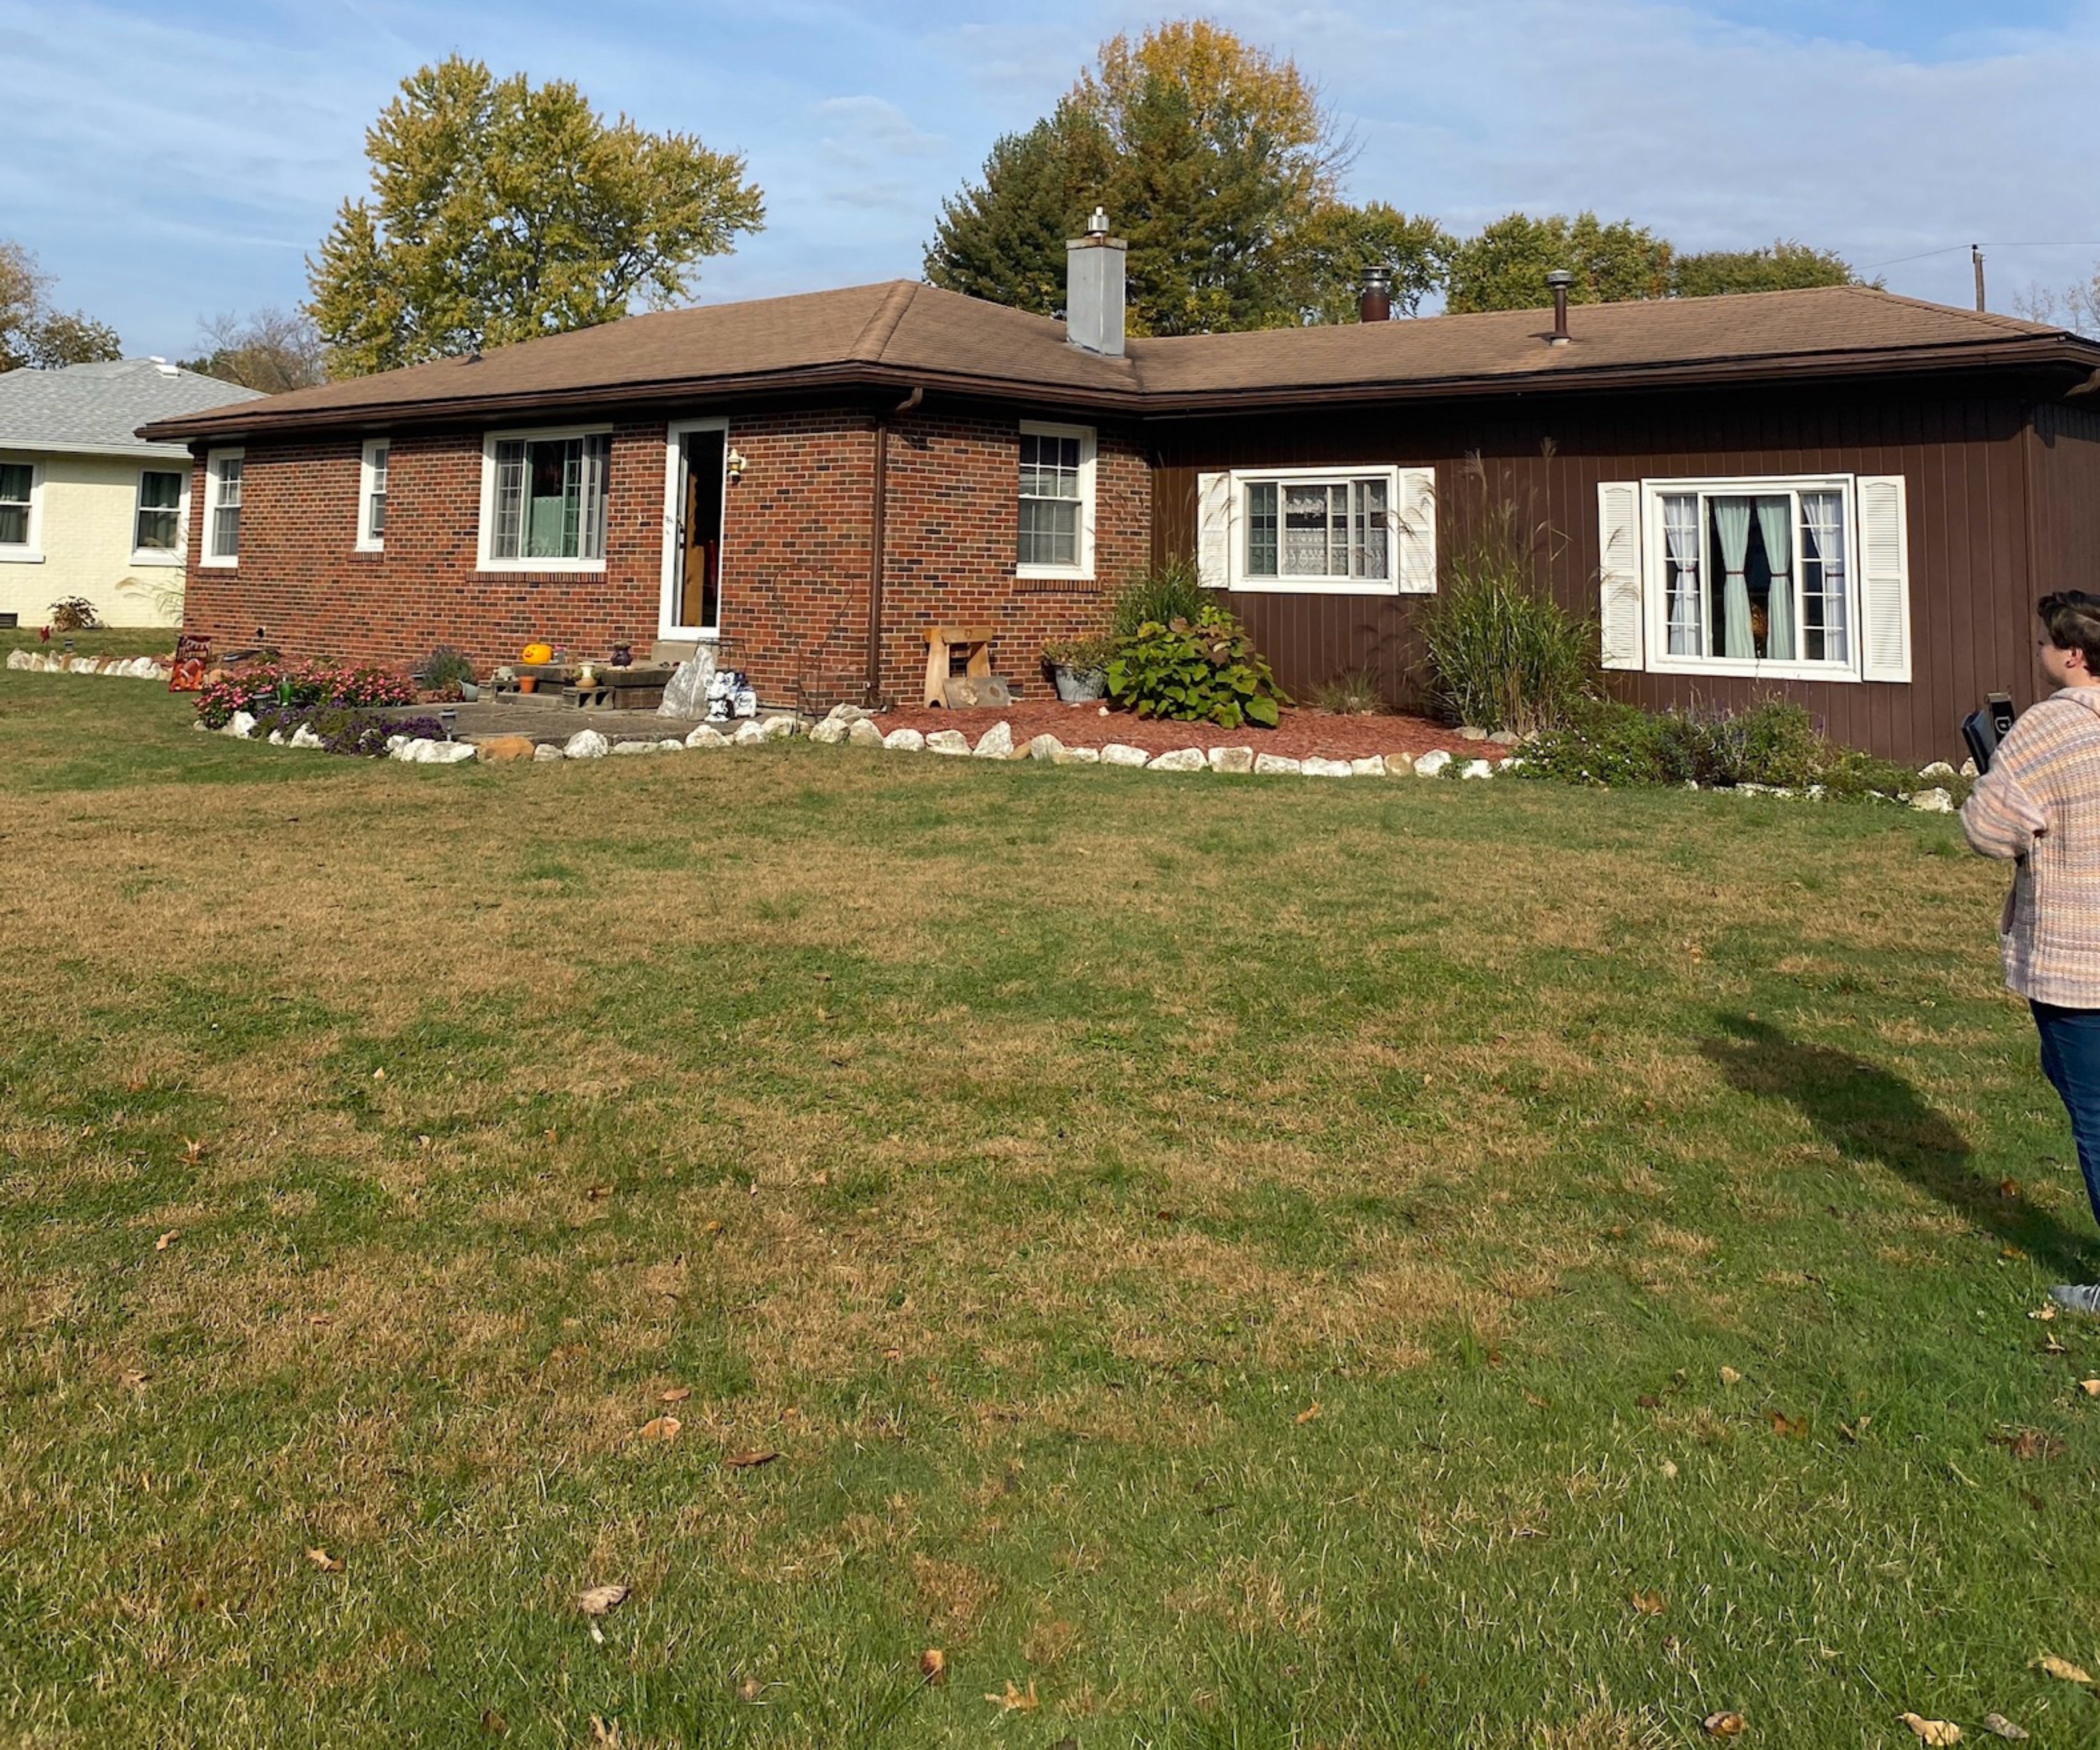
3020 Lake Dr. 10-28-24. Roof bad.

1. On all roof sections 3/12 pitch or greater, remove existing roof down to the decking. Protect the attic from debris. New decking shall match the existing. Any new framing shall be to code. Recover entire roof with the #20 felt paper and 25-year Tamko or equal asphalt seal down shingles. Install new metal starters, metal flashing, and counter flashing at all intersections and new plumbing vent boots. Install new "Cor-a-vent" ridge vent with ridge caps or approve equal. Assure the gutters and downspouts are clean and free from all debris. Assure area around the home is free from debris as possible when complete. Chimneys are to secure and leak free at completion. Owner to choose in stock roof color. Provide all necessary material to complete this work.

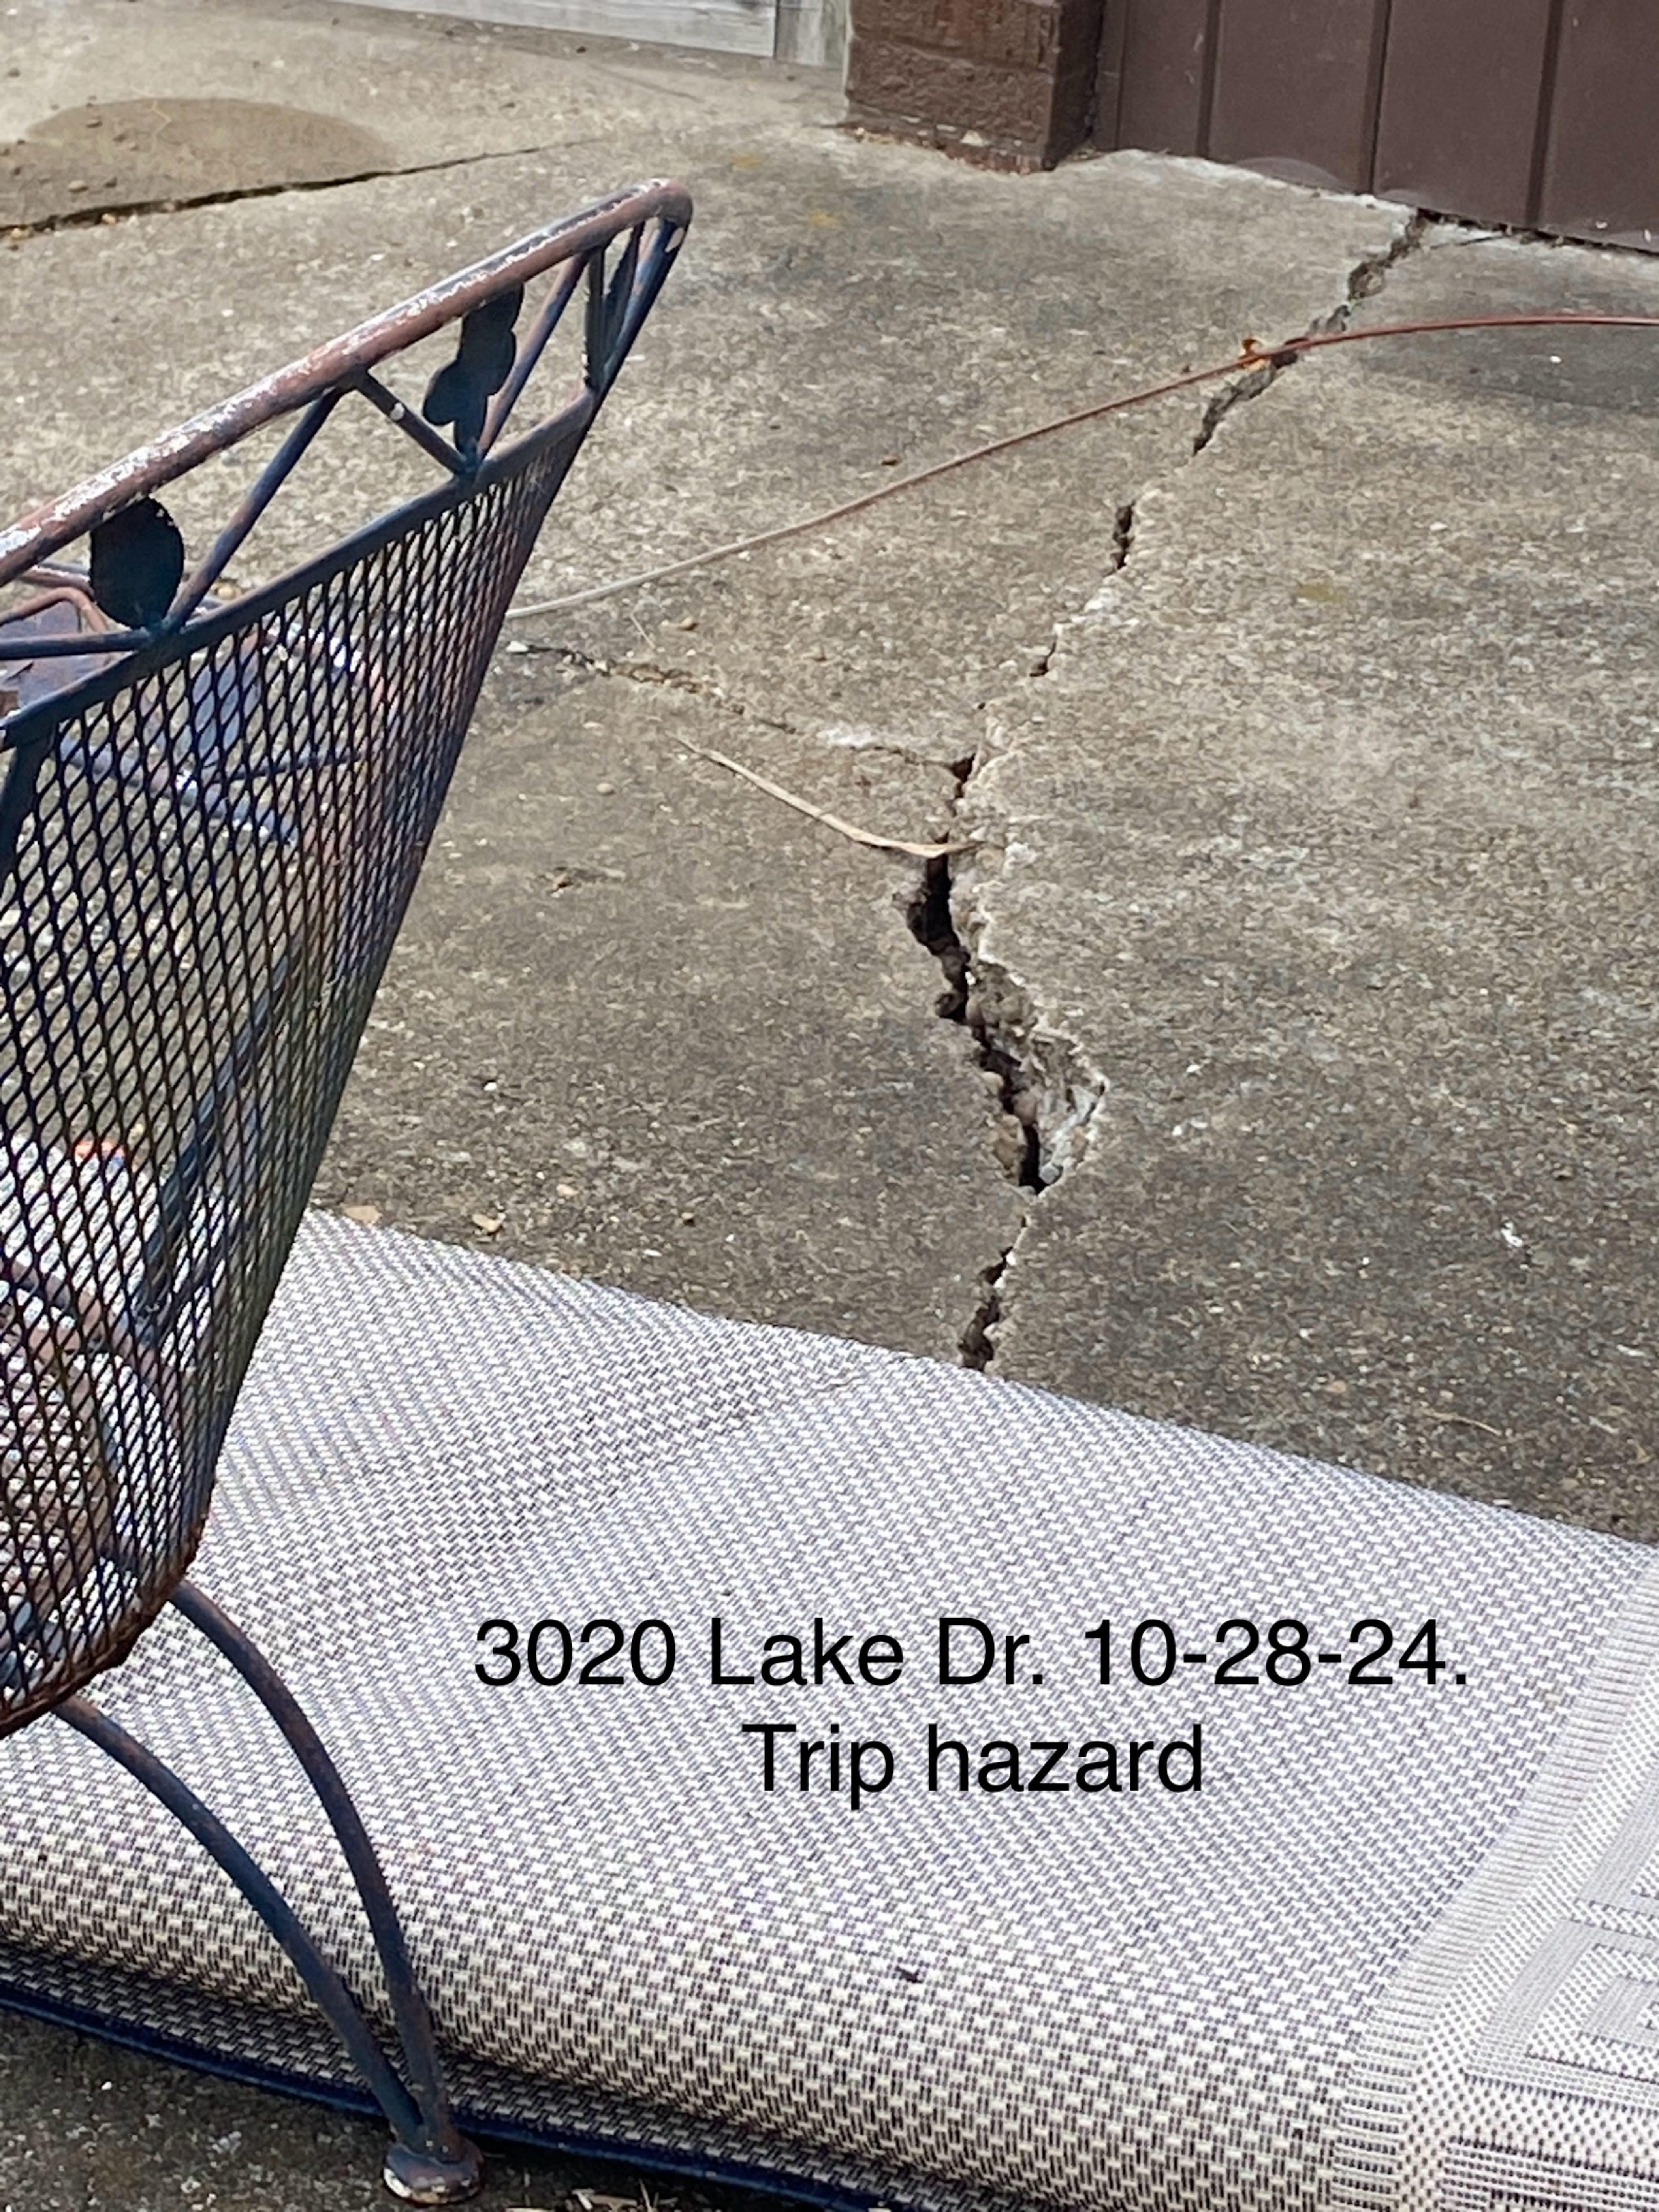
3020 Lake Dr. 10-28-24.
Trip hazard

2. Remove the sunken sections of the rear concrete patio/porch complete. Drill into solid area of remaining concrete porch floor and install rebar to secure new area with old. Install new concrete to replace dilapidated section that was removed. Include any gravel and mesh needed to install new concrete. The new concrete finish is to match existing as close as possible. Use gray Butyl self-leveling caulk between the home and the patio. Finished product is to be completed in a professional manner. Include any yard repair that may be needed after concrete is completed. Include all items that may be needed to complete.

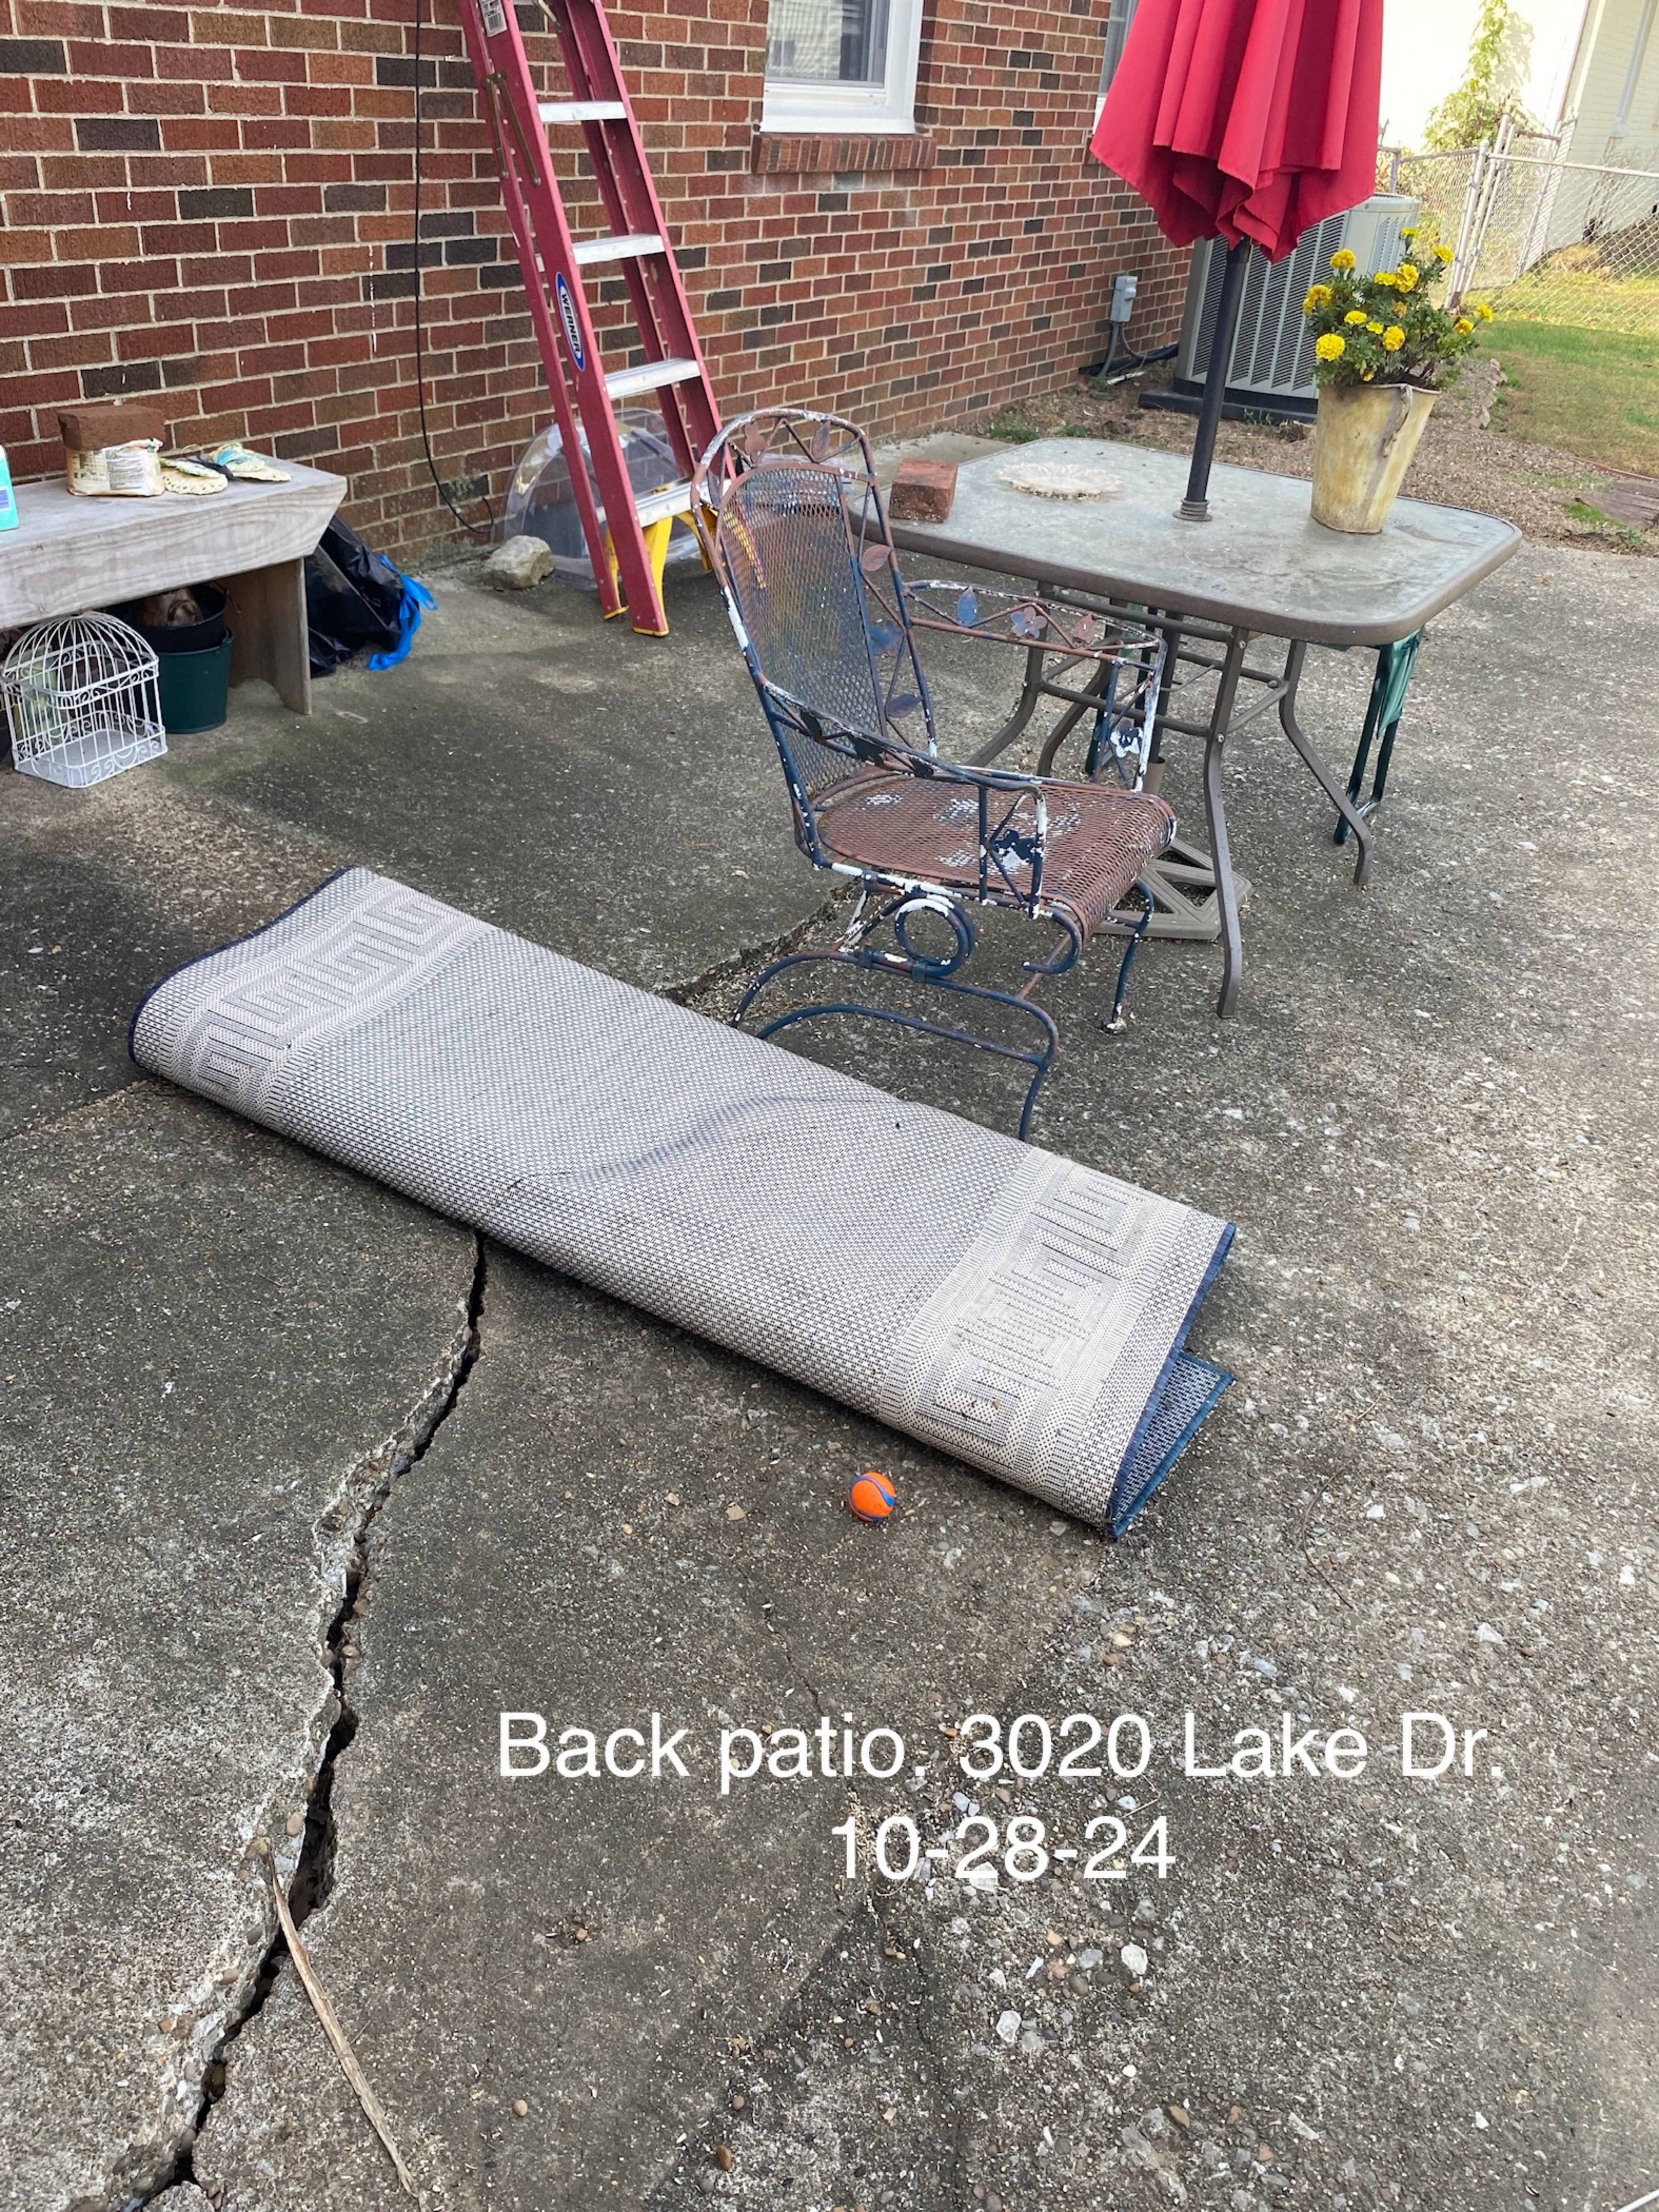
Back patio, 3020 Lake Dr.
10-28-24

A photograph showing a concrete back patio with a significant crack. A person wearing a blue shirt, black pants, and tan shoes stands on the patio. A small orange and blue ball is on the ground near a patterned rug. The background shows a brown wooden wall and a white door.
